HONOAPI'ILANI HIGHWAY IMPROVEMENTS PROJECT,  
WEST MAUI: UKUMEHAME TO LAUNIUPOKO

# Appendix 3.9 – Water Resources, Wetlands, and Floodplains - Supplemental Information

**Honoapiilani Highway Improvement Project  
Preliminary Identification of Waters of the United States  
Technical Report**

**Project # 4692-02**

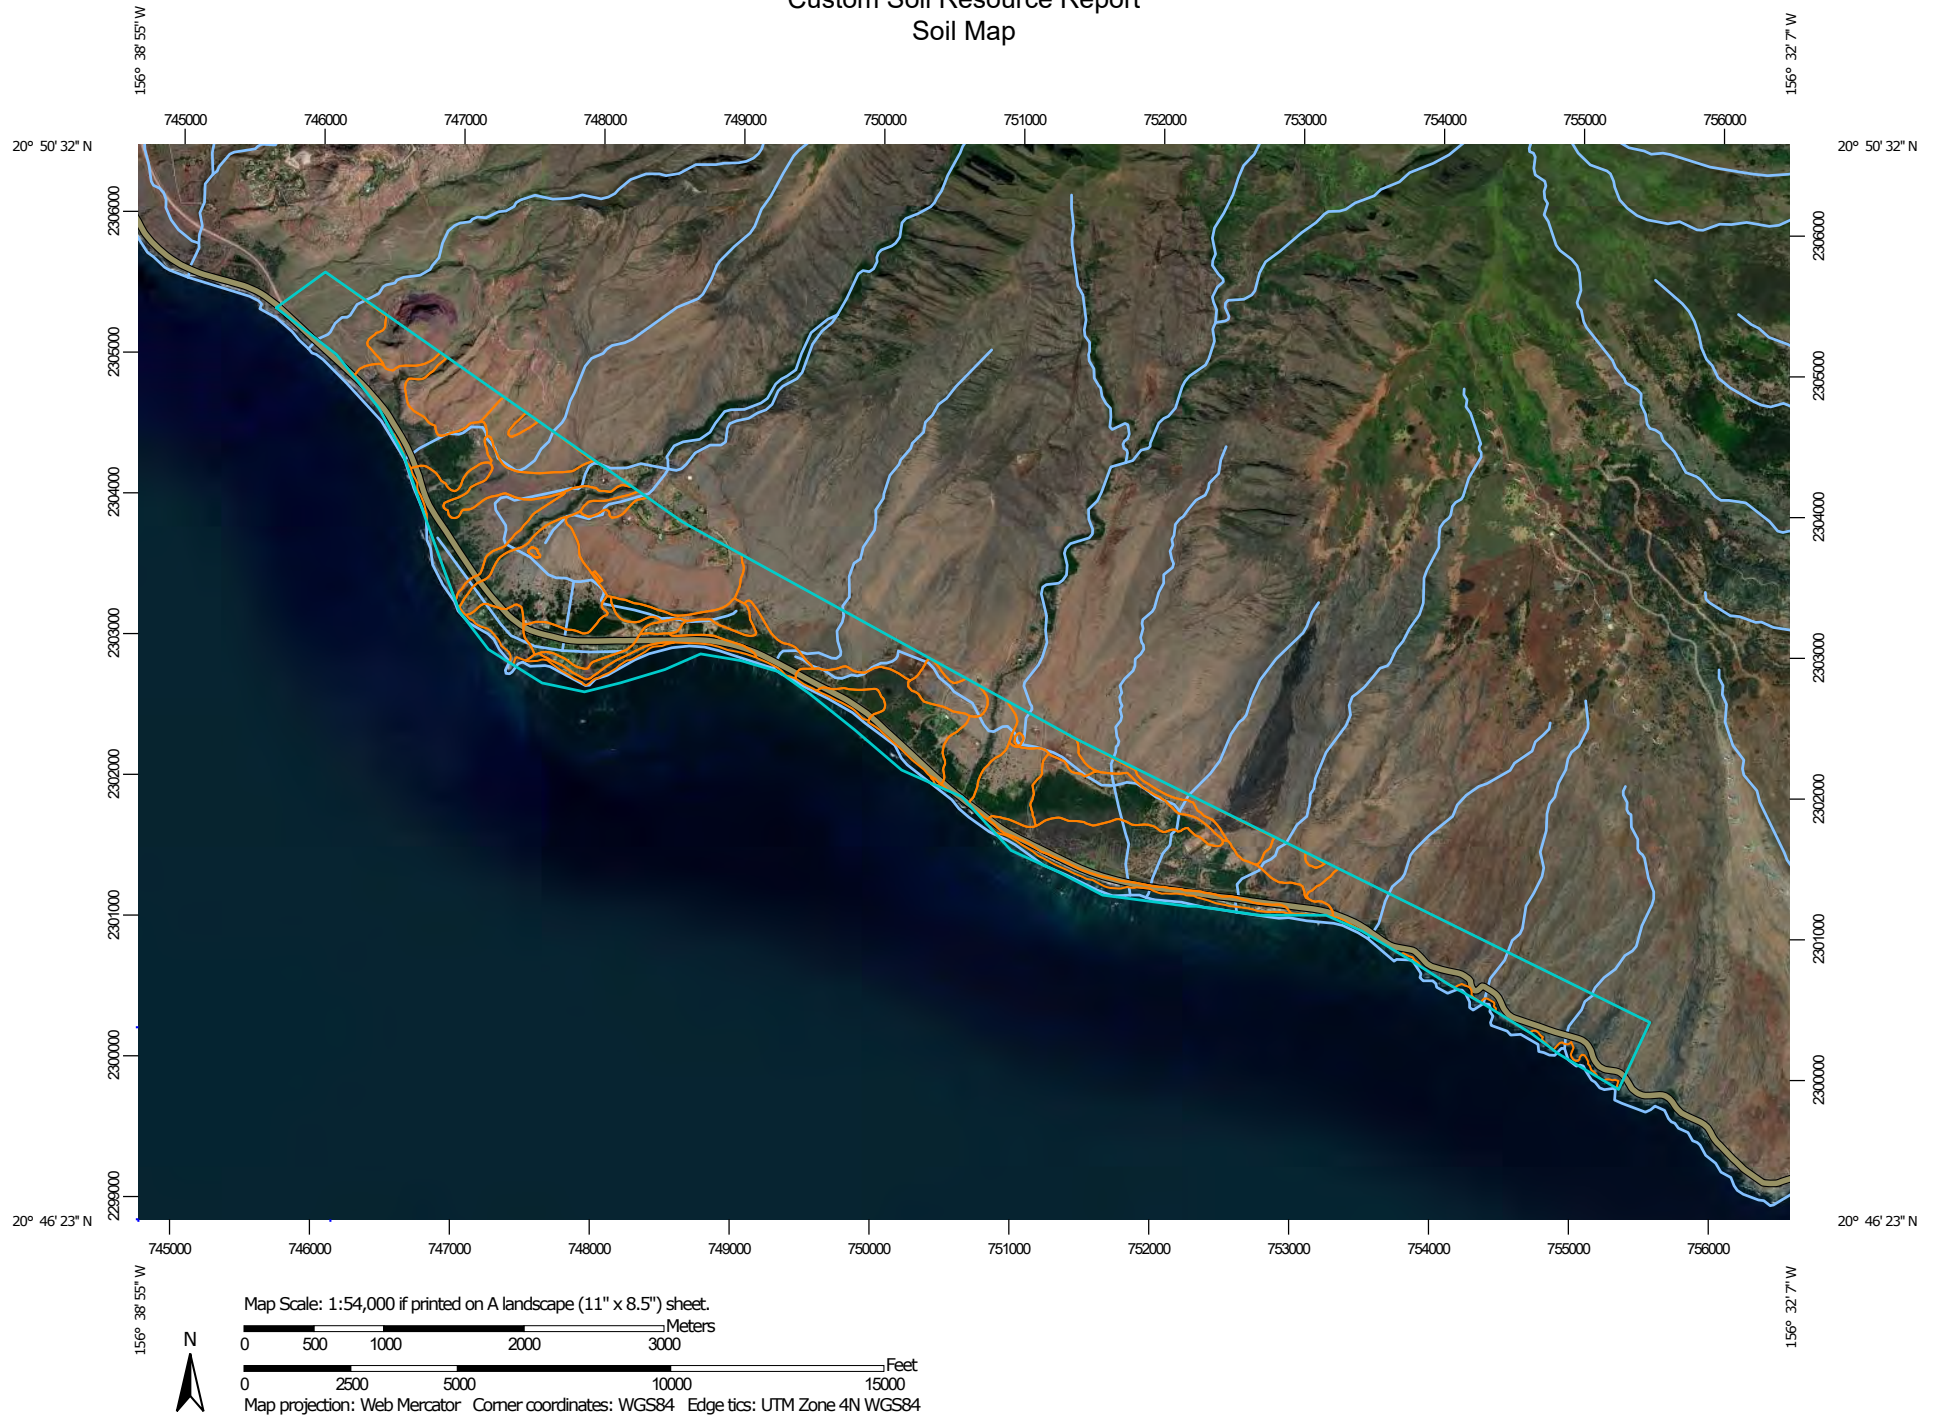
# Custom Soil Resource Report Soil Map

The soil map section includes the soil map for the defined area of interest, a list of soil map units on the map and extent of each map unit, and cartographic symbols displayed on the map. Also presented are various metadata about data used to produce the map, and a description of each soil map unit.

Eleven soil units are mapped by the Natural Resources Conservation Service (NRCS) within the study area (Figure 4). Table 1 summarizes the associated texture, drainage classification, landform setting, and hydric soil status (NRCS 2023a) for these soil types found within the study area.

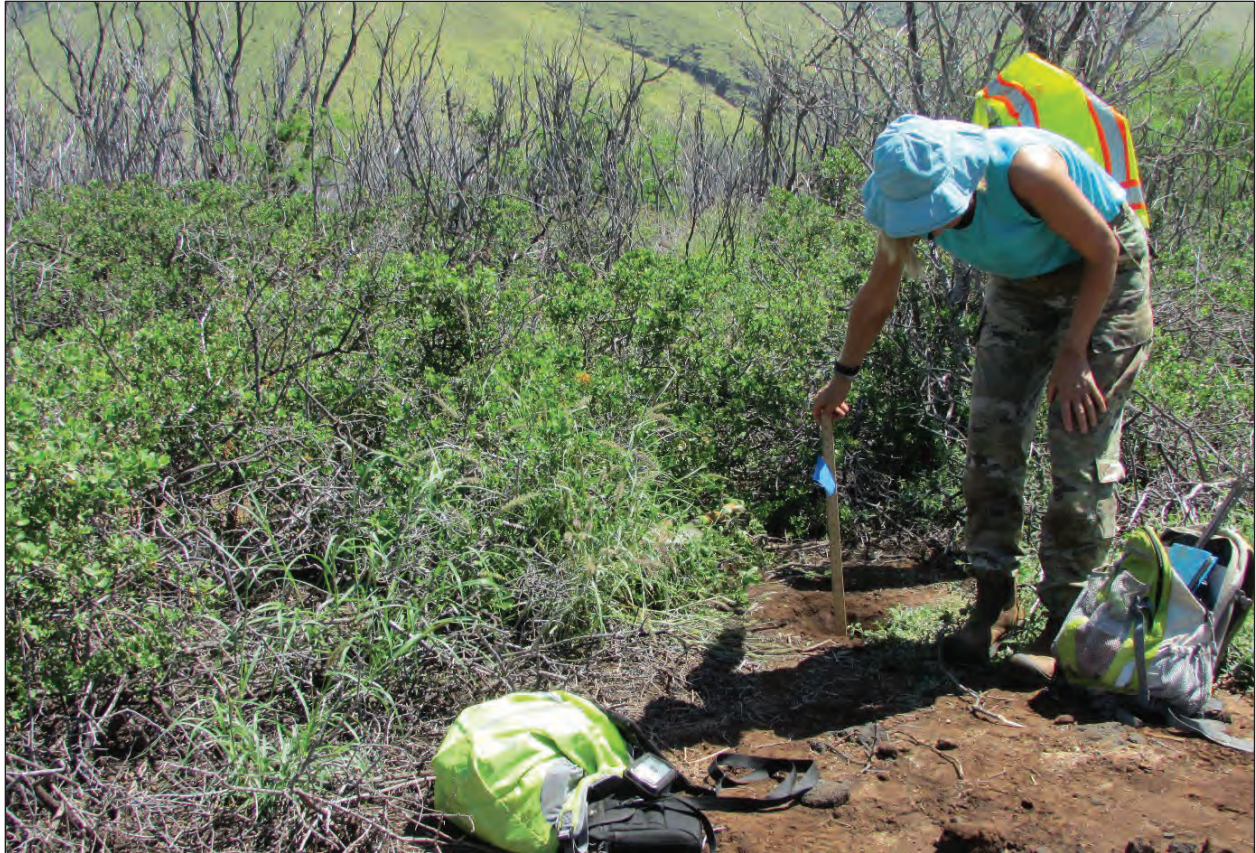
Sand, rubble, cobbles on surface probably from previous disturbance.

Photo 1. At SP1 Facing South; Area Dominated with *Pluchea* spp. (FAC) and Buffel Grass (FACU)

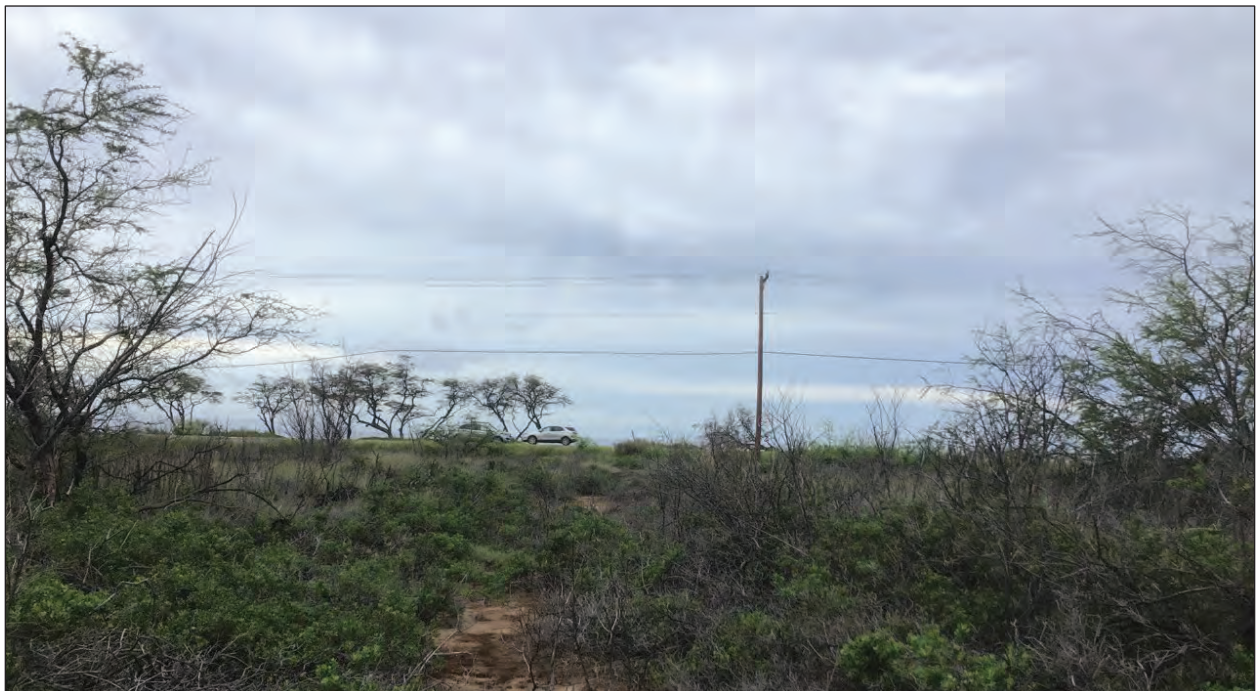
Photo 2. At SP1 Facing West; Representative of Uplands in this Area

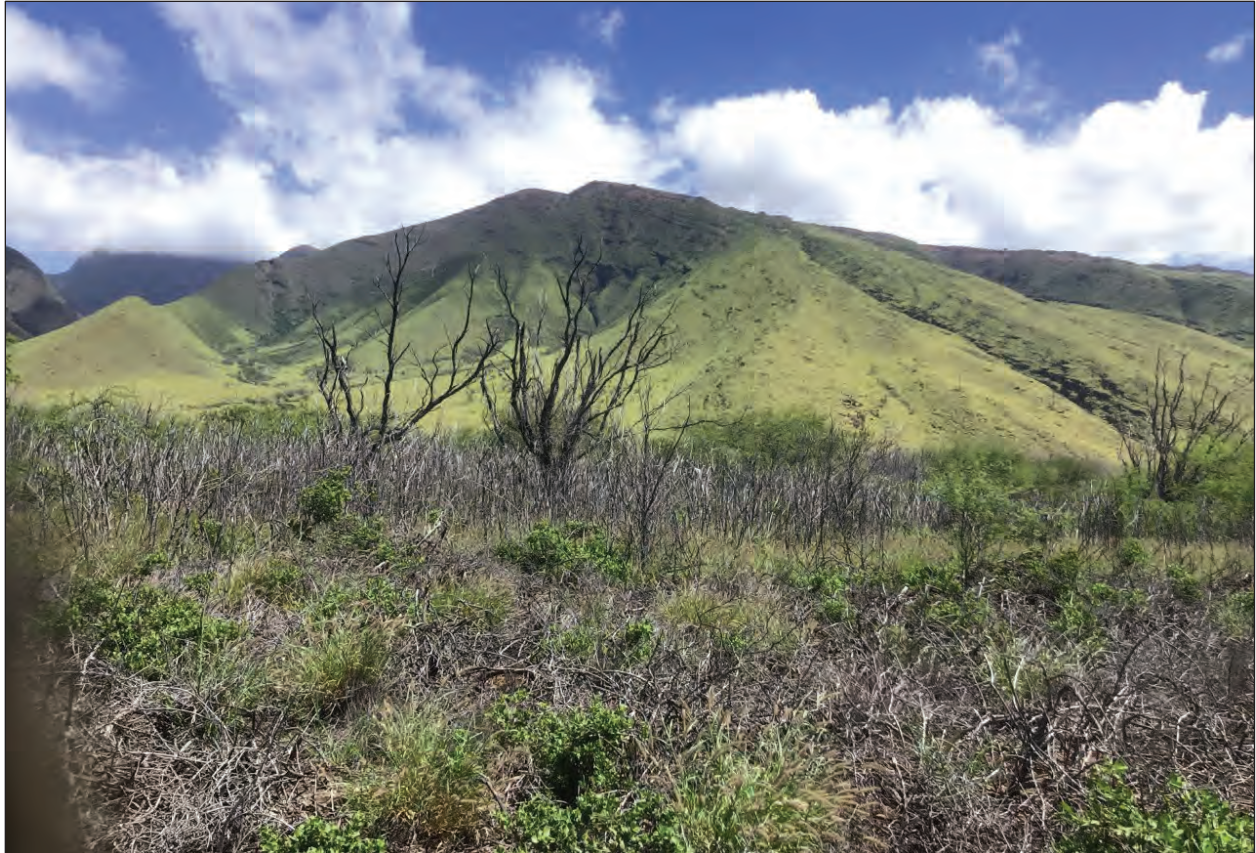
**Photo 3. Area West of SP1 between Existing Highway and SP1; Representative of Upland Conditions Observed at SP1 with Mix of *Pluchea* spp. (FAC) and Buffel Grass (FACU) and Showing no Signs of Hydrology**

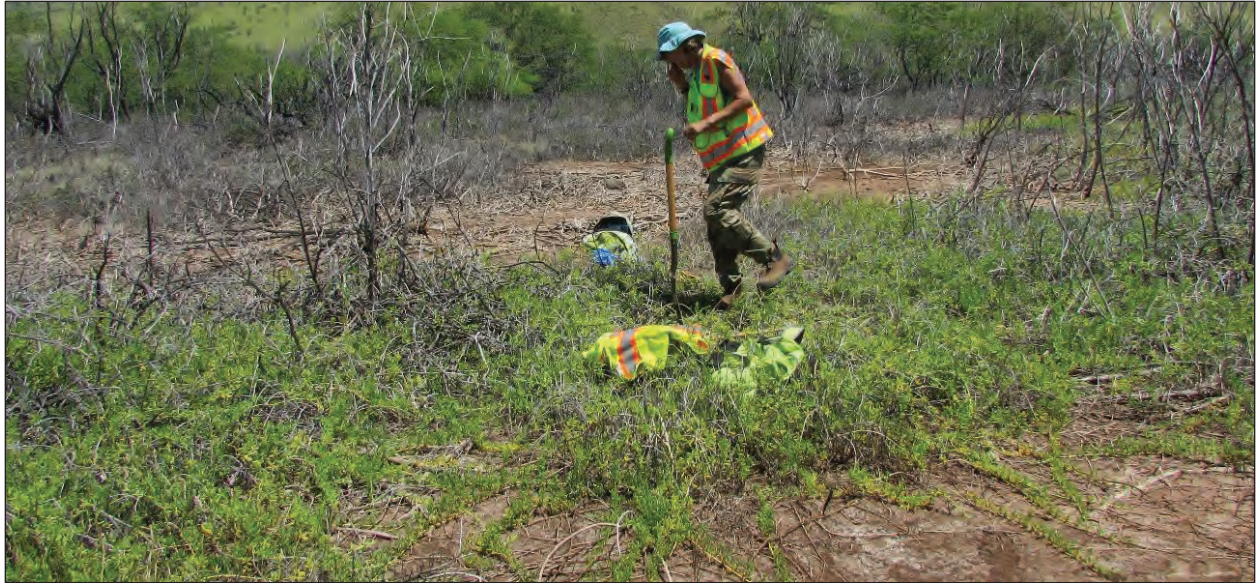
Photo 4. At SP2 Facing East; Area Dominated by Obligate Pickleweed (*Batis maritima*) Species

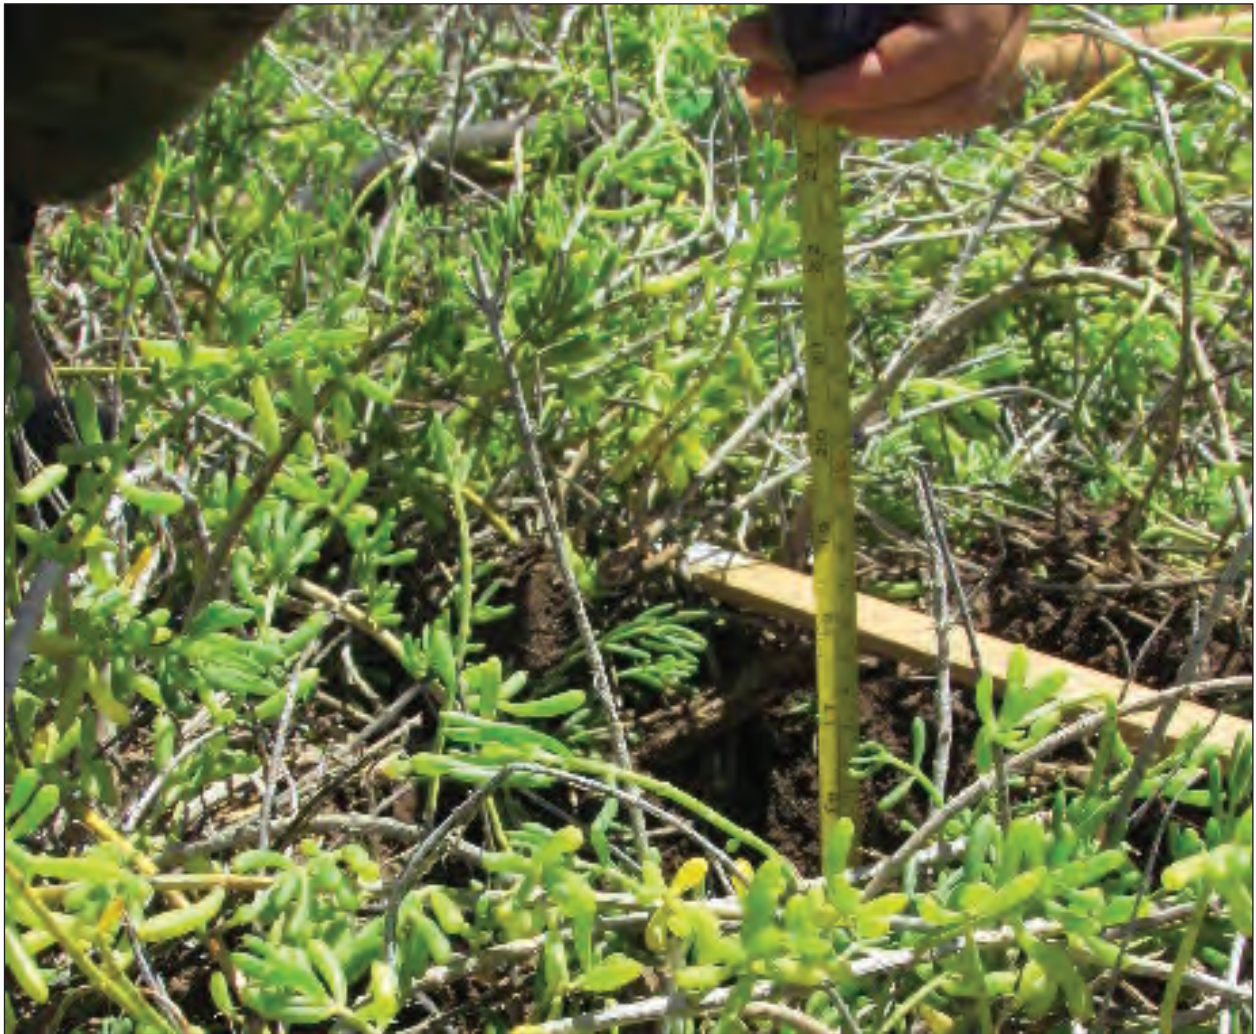
Photo 5. Soil Pit at SP2 with Obligate Pickleweed (*Batis maritima*) Species

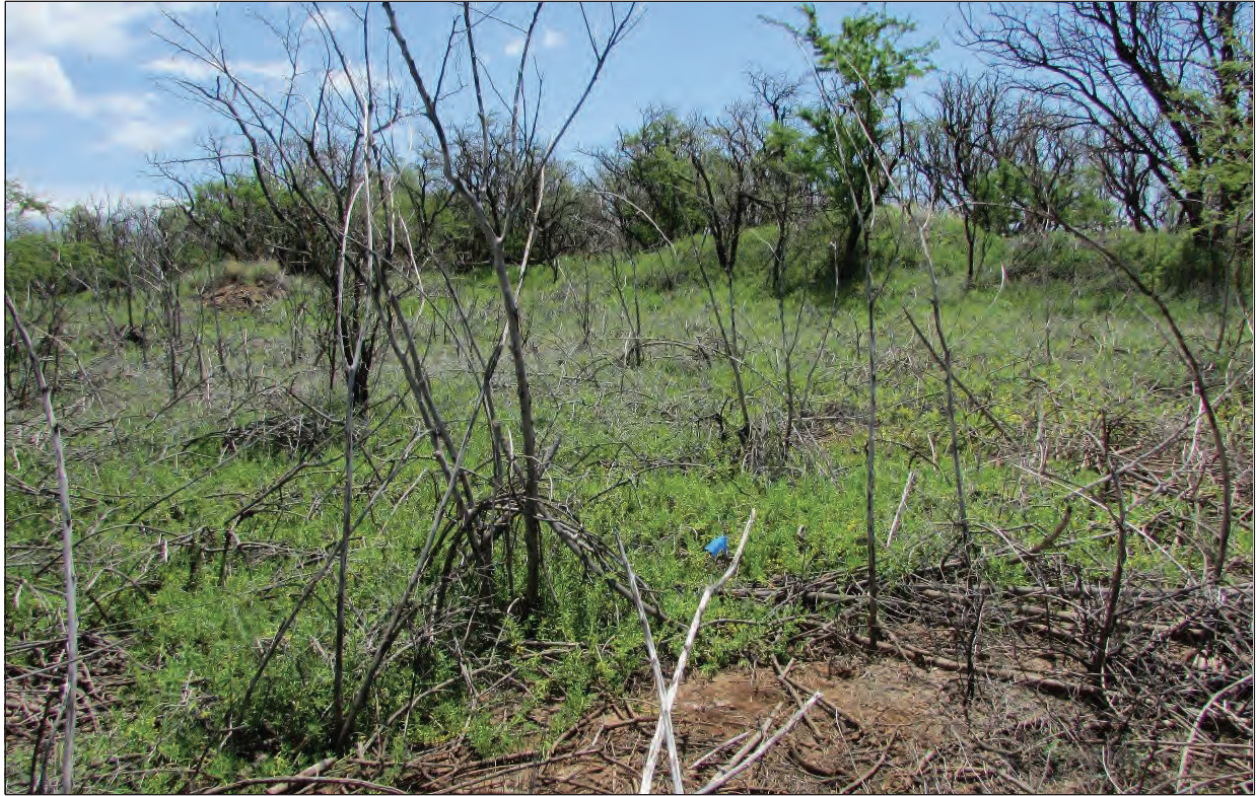
Photo 6. Representative Area between SP2 and SP3 Included in Wetland as Similar to SP2 in Observed Vegetation, Slope, and Hydrology Characteristics

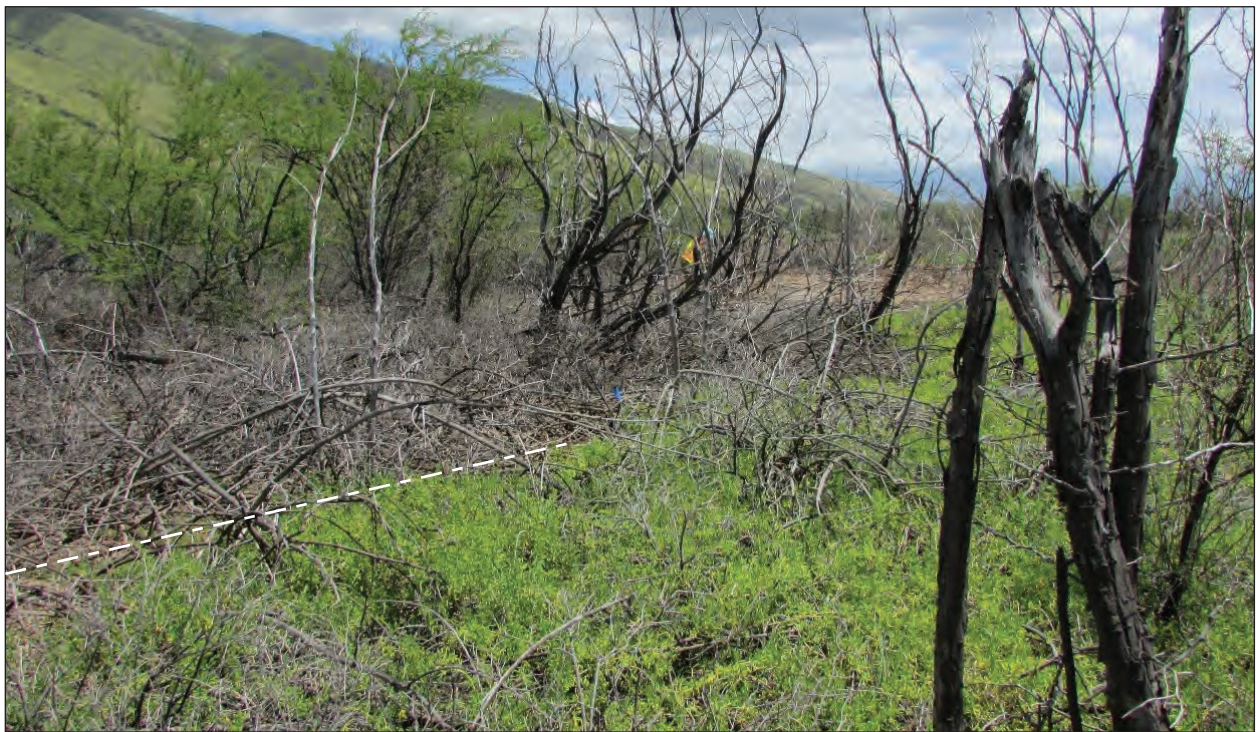
Photo 7. Area South of SP3 Showing Transition (White Dash Line) between Wetland—Right Side with Pickleweed (*Batis maritima*) [OBL] and Dead Kiawe (*Prosopis pallida*) (FACU) Trees and Upland—Upper Left Side with Live Kiawe Trees and No Pickleweed in Understory

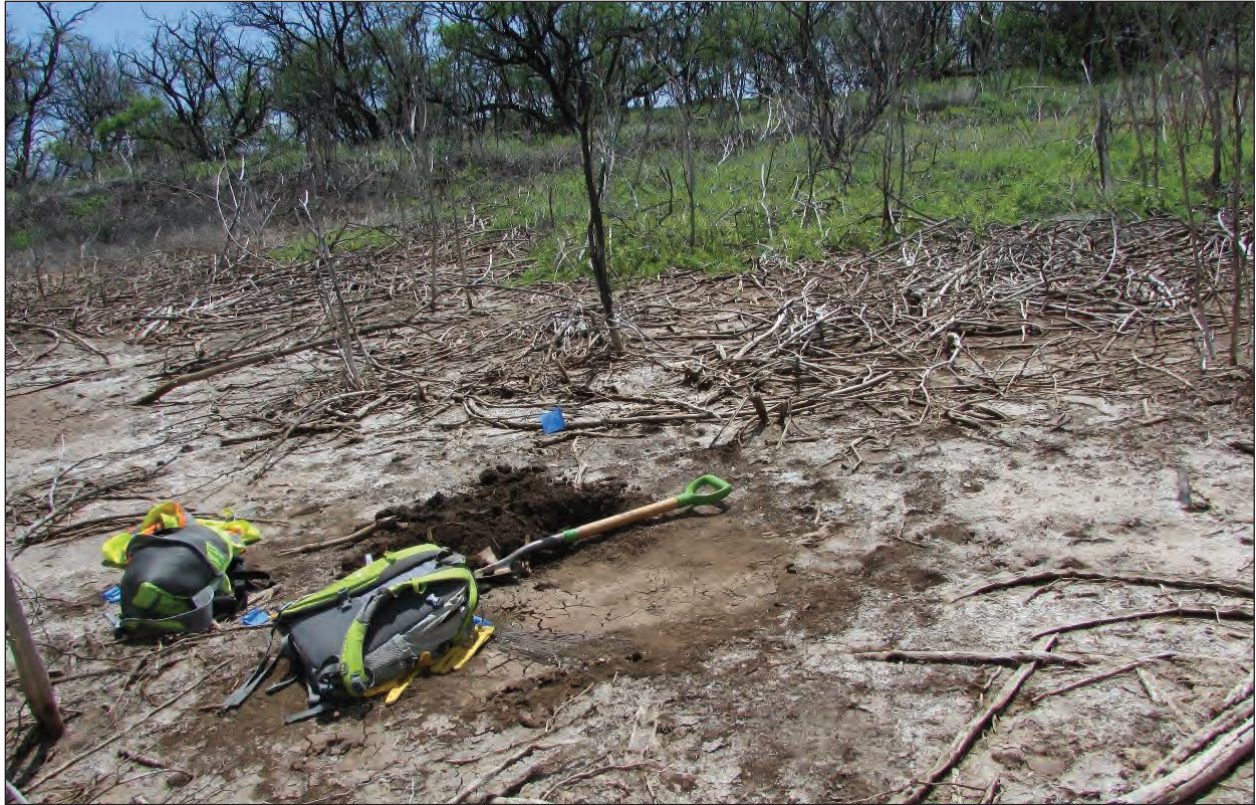
Photo 8. At SP3 - Salt Crusted Bare Ground Devoid of Vegetation

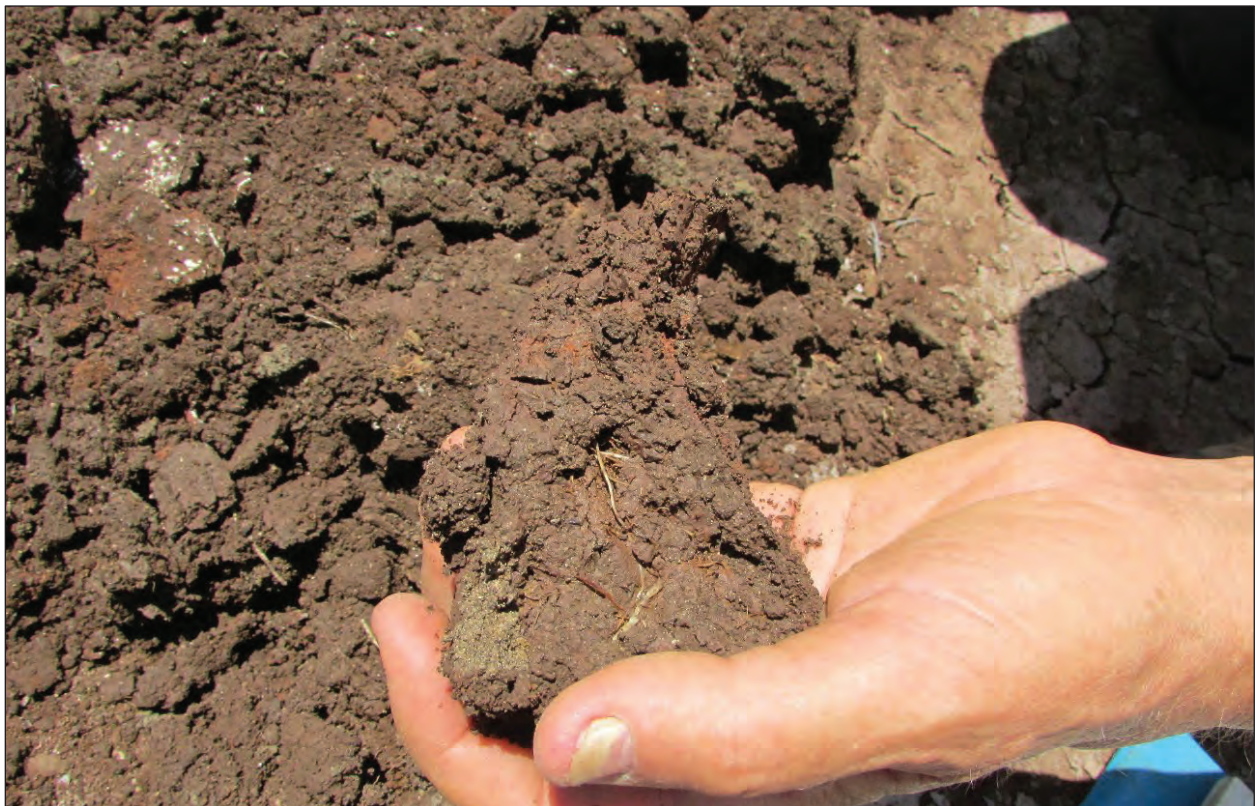
Photo 9. At SP3 - Oxidized Root Channels Observed in Hydric Soils

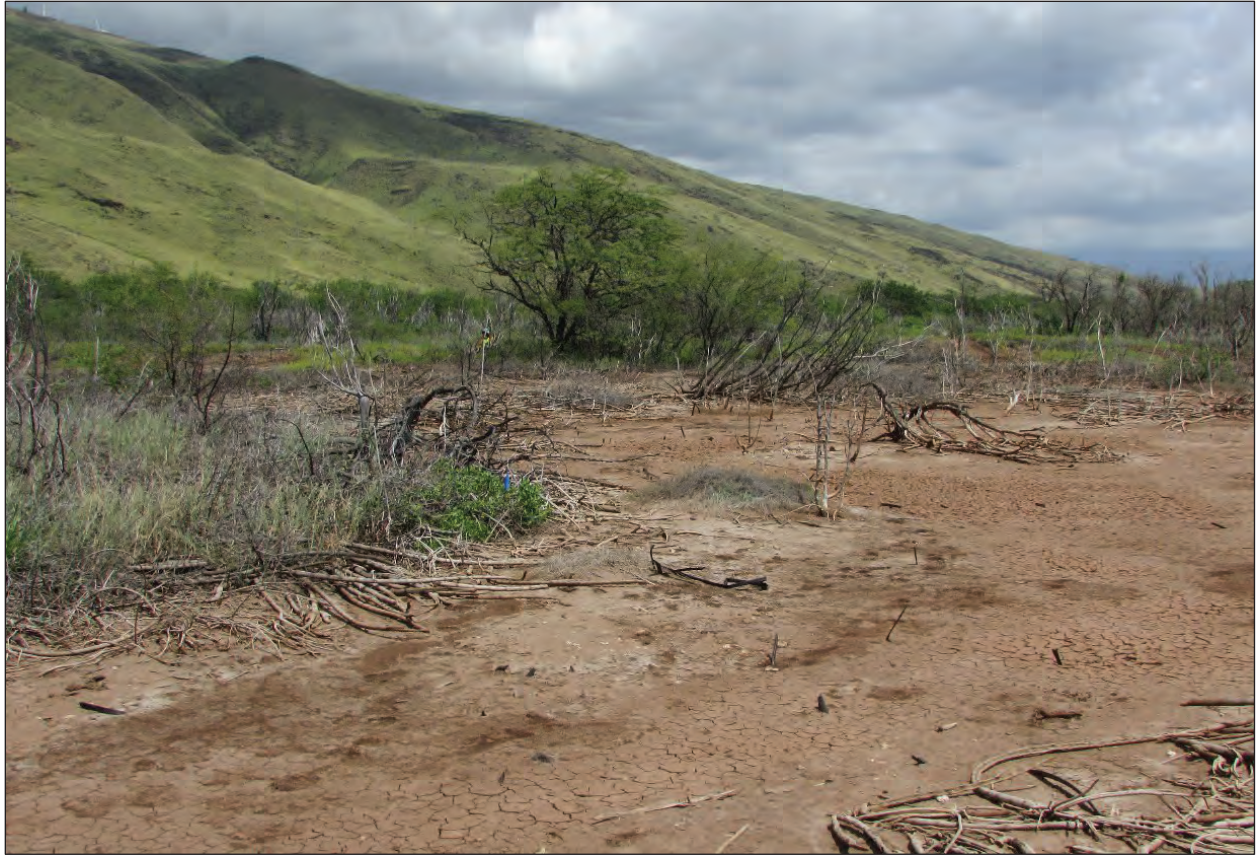
**Photo 10. Representative Area South of SP3 Showing Habitat Conditions Similar to that Observed at SP2 and Therefore Included as Wetland**

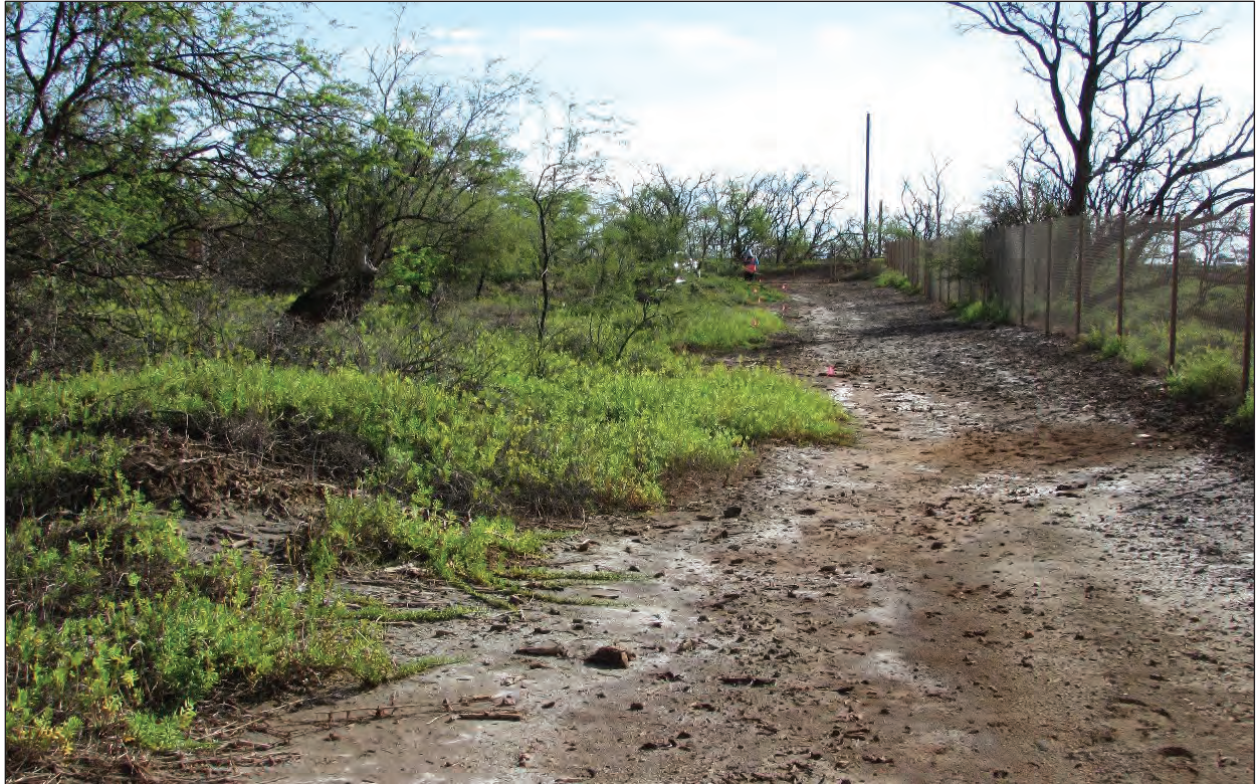
Much evidence of ponding.

Photo 11. At SP4 - Wetland Habitat with Kiawe (*Prosopis pallida*) Overstory and Ground Vegetation Dominated with Obligate Pickleweed (*Batis maritima*)

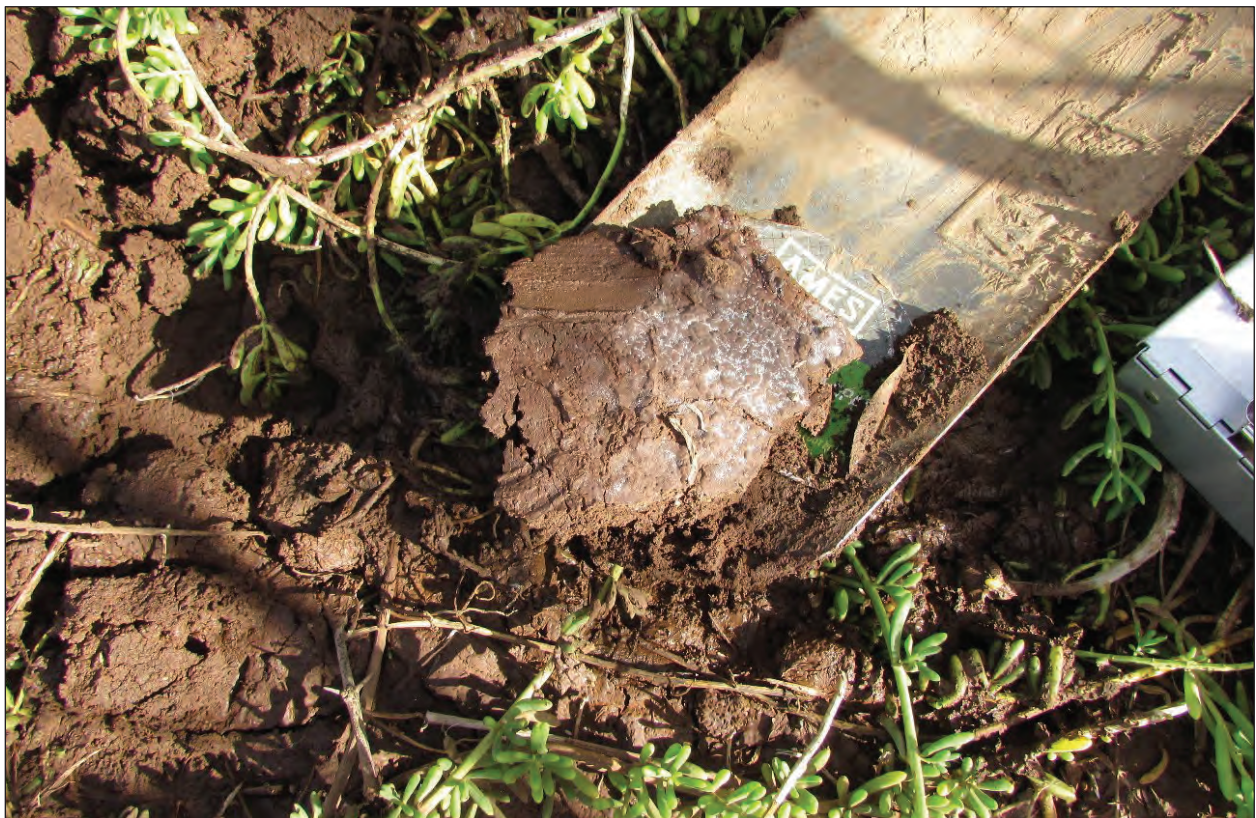
Photo 12. At SP4 - Saturated Hydric Soil Conditions

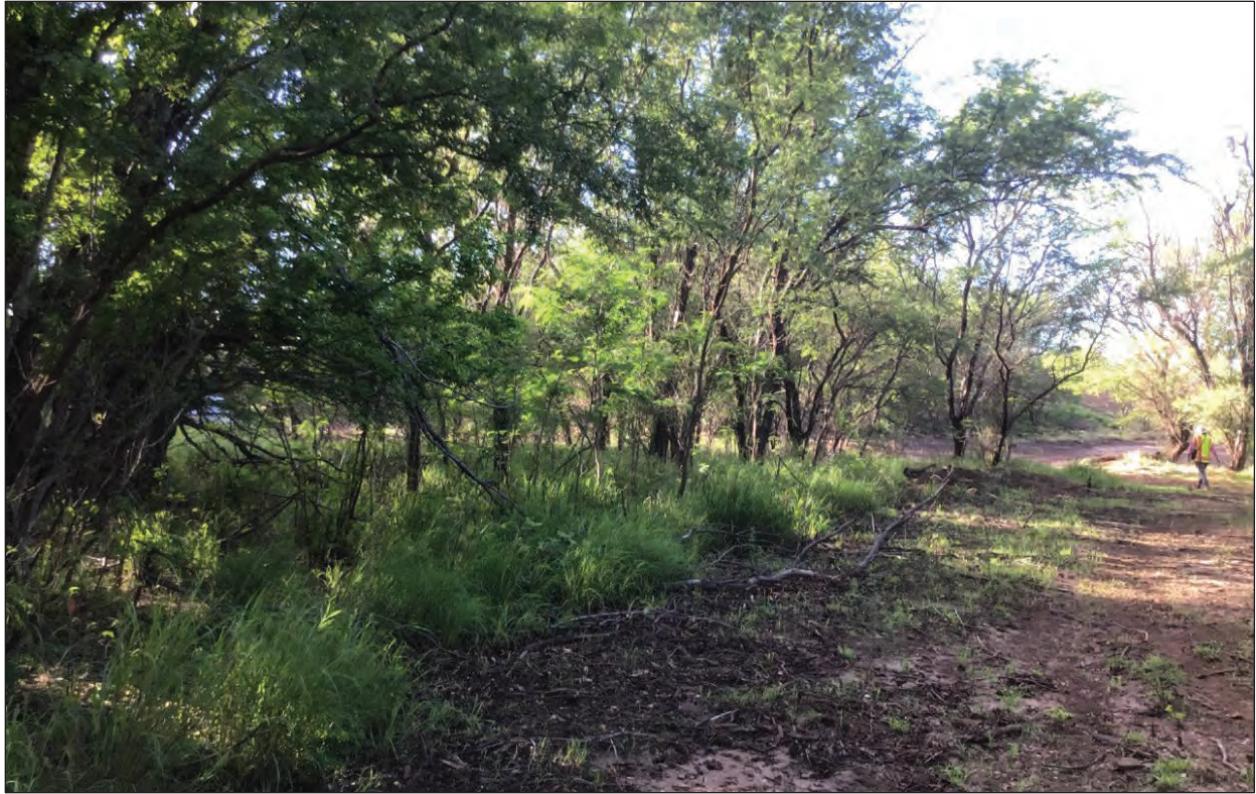
Photo 13. At SP5 - Slightly Elevated Area with Upland Habitat Conditions Similar to that at SP5. Live Kiawe (*Prosopis pallida*) with Predominantly Buffel Grass (*Cenchrus ciliaris*) in Understory

Name	Sampling Rationale	Hydrophytic Vegetation	Hydric Soil?	Wetland Hydrology?	Overall Wetland Assessment
SP5 (Photos 13-14)	Placed to investigate a large swath of elevated area in the northeastern part of Ukumehame Firing Range with predominantly buffel grass in understory.	No	No	No	This area does not meet the three parameter wetland criteria.
SP6 (Photos 17-18)	Placed to investigate large, sparsely vegetated area with moist platy soils and surface soil cracks.	Yes	Yes	Yes	This area (Wetland 5) meets the three parameter wetland criteria.
SP7 (Photos 19-20)	Placed to investigate large sparsely vegetated area with platy moist soil with dark black and bright red deposits/coloration on surface.	Yes	Yes	Yes	This area (Wetland 11) meets the three parameter wetland criteria.
SP8 (Photos 21-22)	Placed on slightly higher ground adjacent to wetland to investigate thicket of facultative <i>Pluchea</i> species under kiawe canopy.	No	No	No	This area does not meet the three parameter wetland criteria.

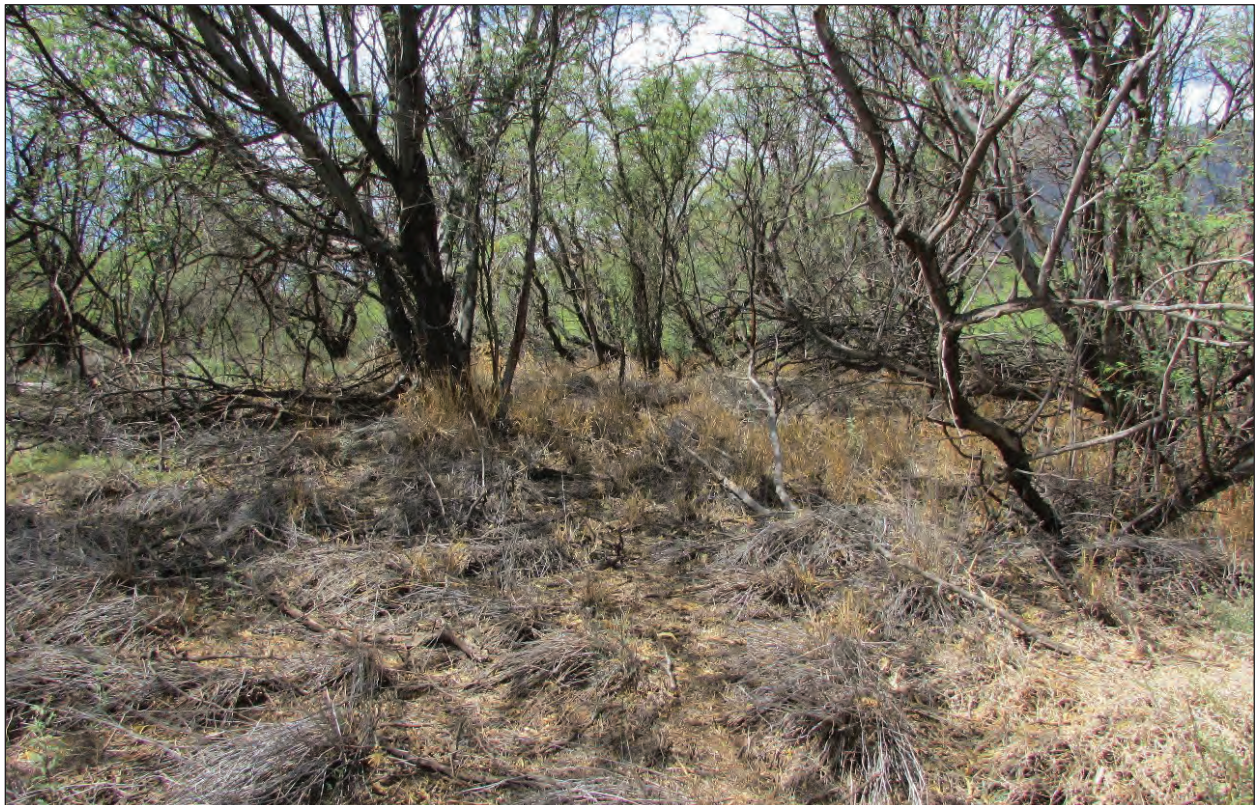
Photo 14. Southeast of SP5 - Habitat Conditions Representative of Similar Uplands Observed at SP5

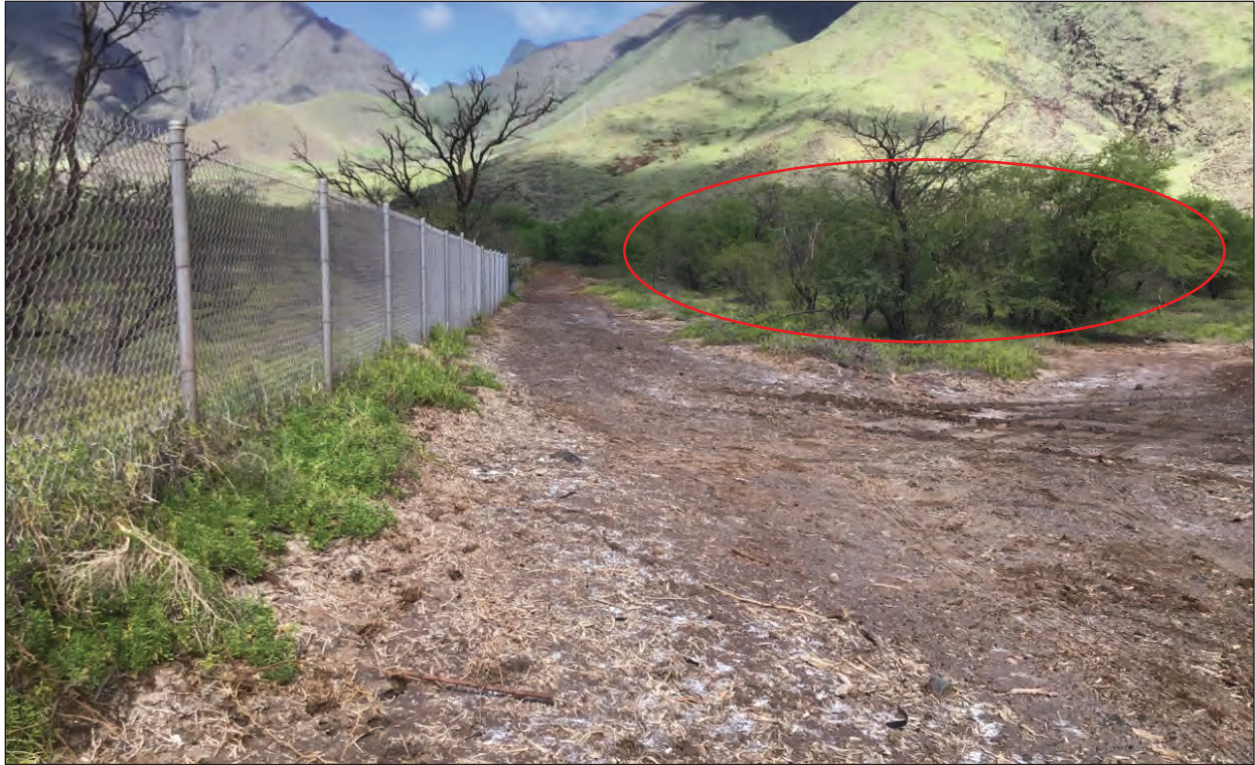
Photo 15. Looking East at Large Kiawe (*Prosopis pallida*) Buffel Grass (*Cenchrus ciliaris*) Area (Red Oval) Excluded as Upland

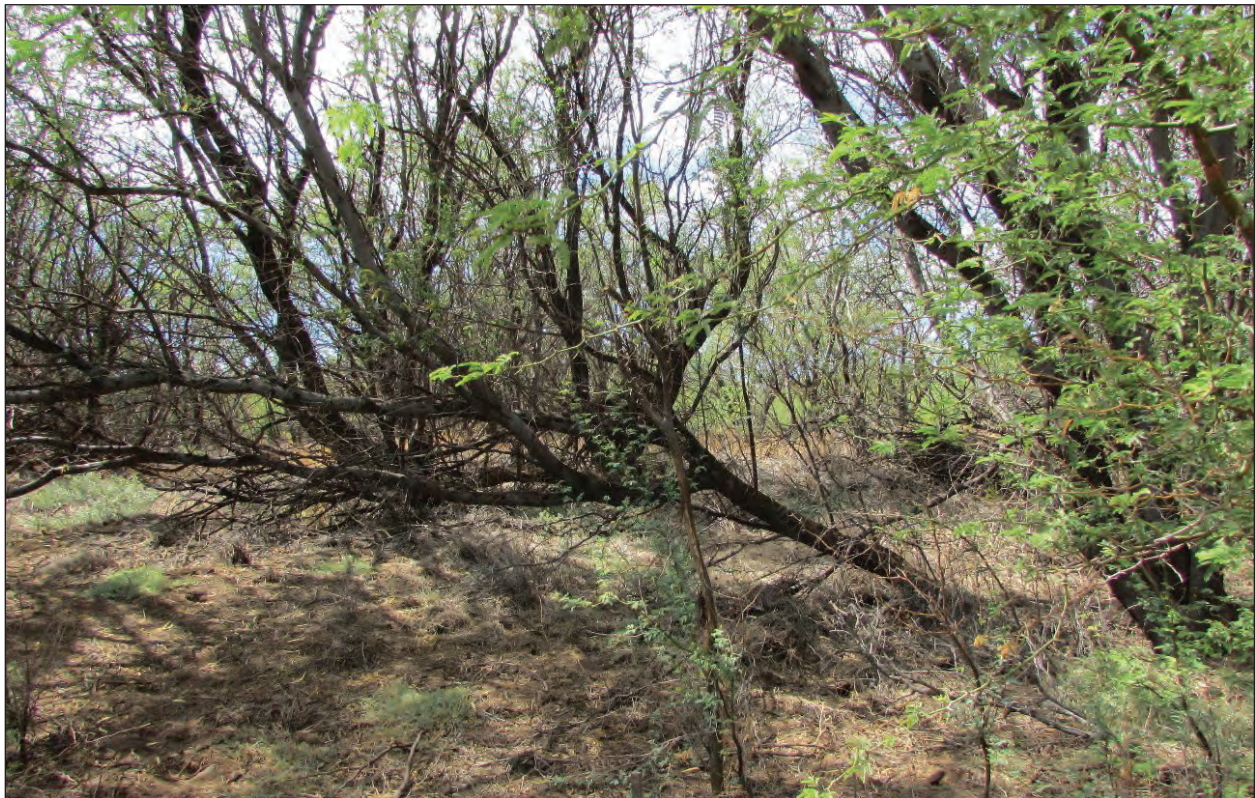
Photo 16. Close Up of Upland Representative Area in the Northeastern Part of Ukumehame Firing Range and Excluded as Upland

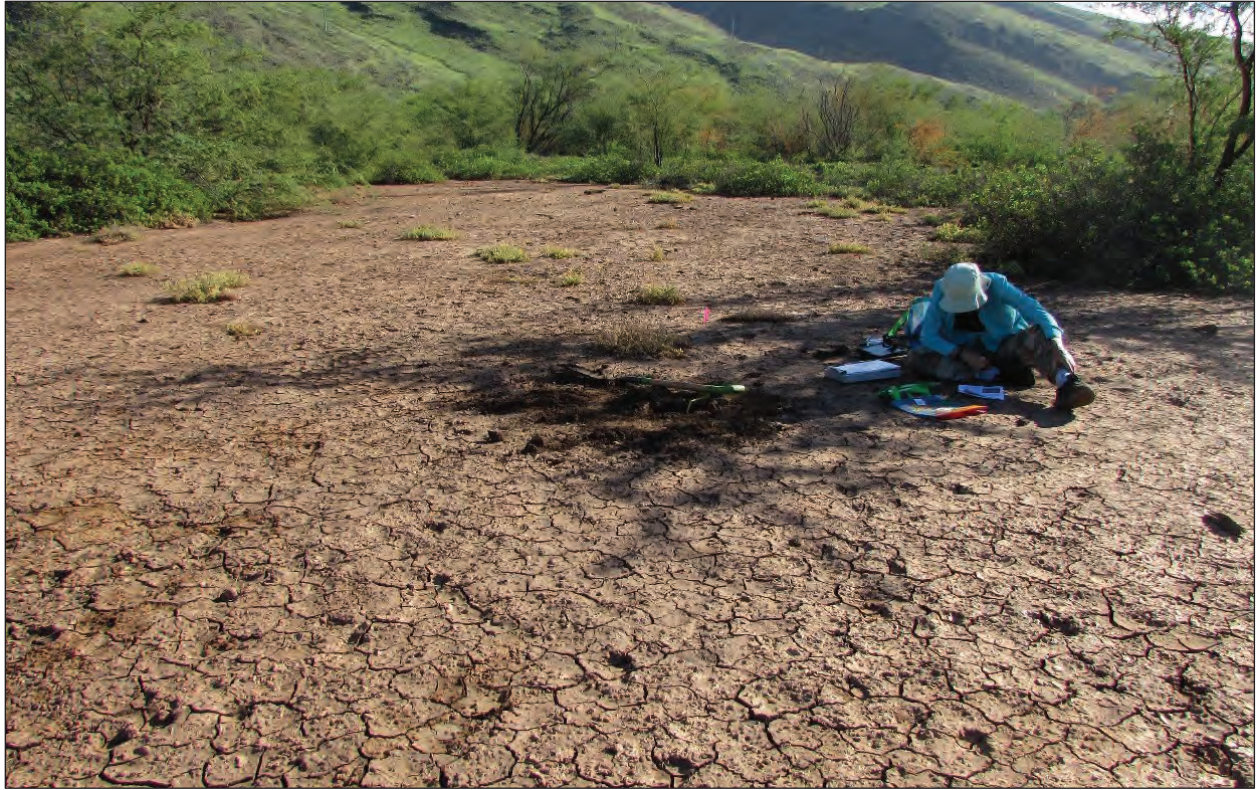
**Photo 17. At SP6—View to East; Large Sparsely Vegetated Wetland with Prominent Surface soil Cracks**

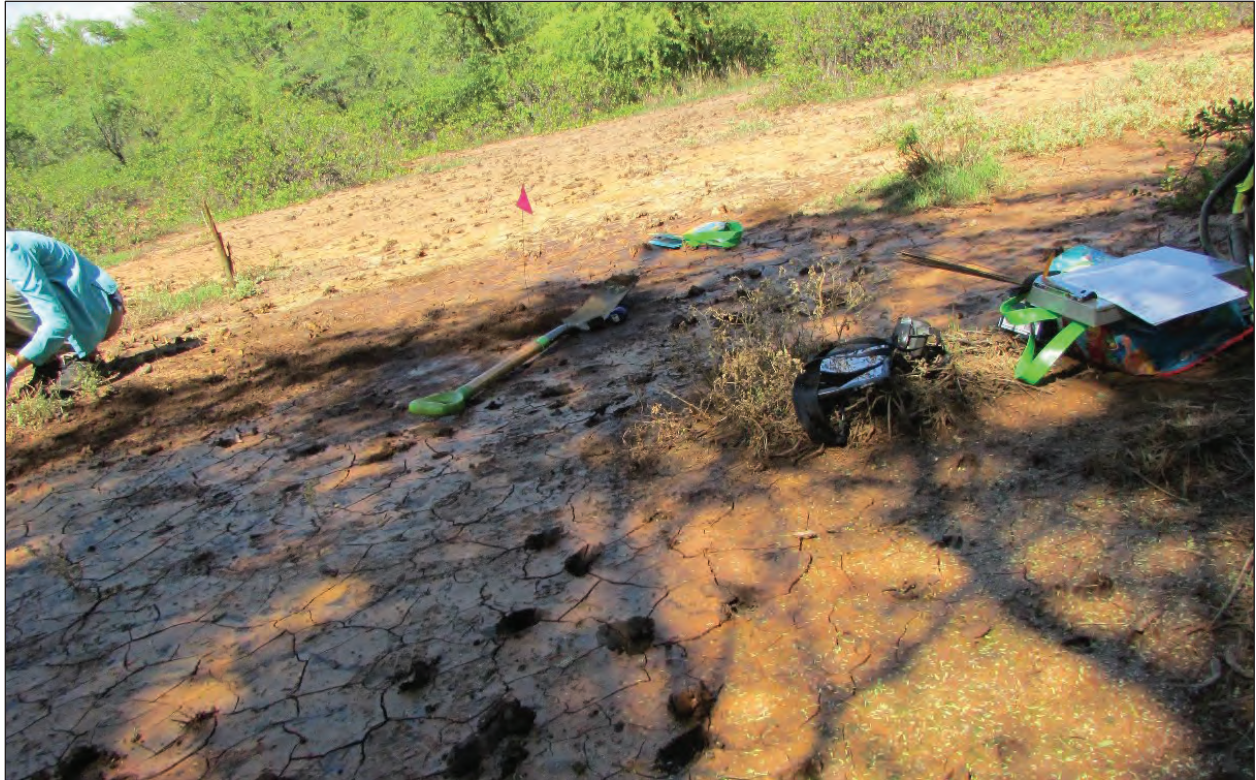
Photo 19. At SP7 - Placed in Sparsely Vegetated Area to Investigate Platy Moist Soils that Had Both Bright Red and Black Soil Surface Colors

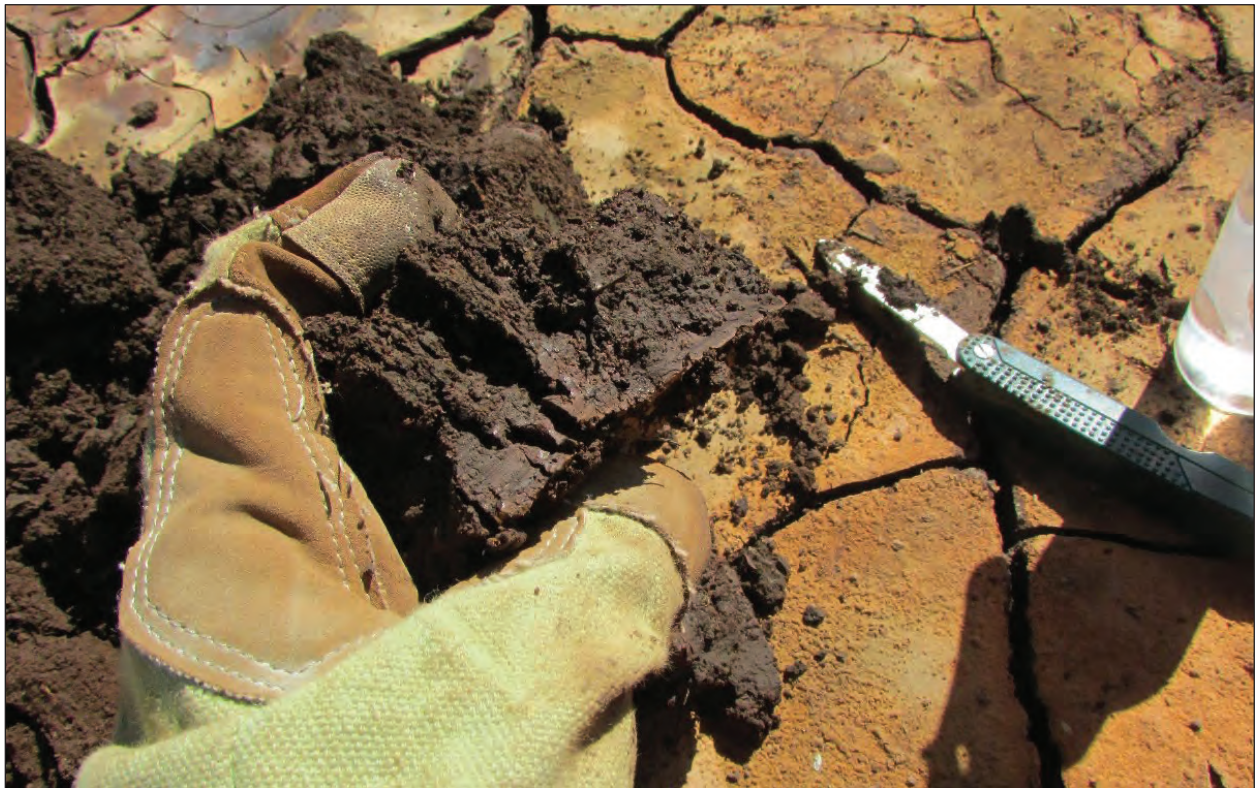
Photo 20. At SP7 - Soil Showed Redox Features of Iron and Manganese on Surface As Well As Mottles in the Matrix
