HONOAPI'ILANI HIGHWAY IMPROVEMENTS PROJECT,  
WEST MAUI: UKUMEHAME TO LAUNIUPOKO

# Appendix 3.9 – Water Resources, Wetlands, and Floodplains - Supplemental Information

**Honoapiilani Highway Improvement Project  
Preliminary Identification of Waters of the United States  
Technical Report**

**Project # 4692-02**

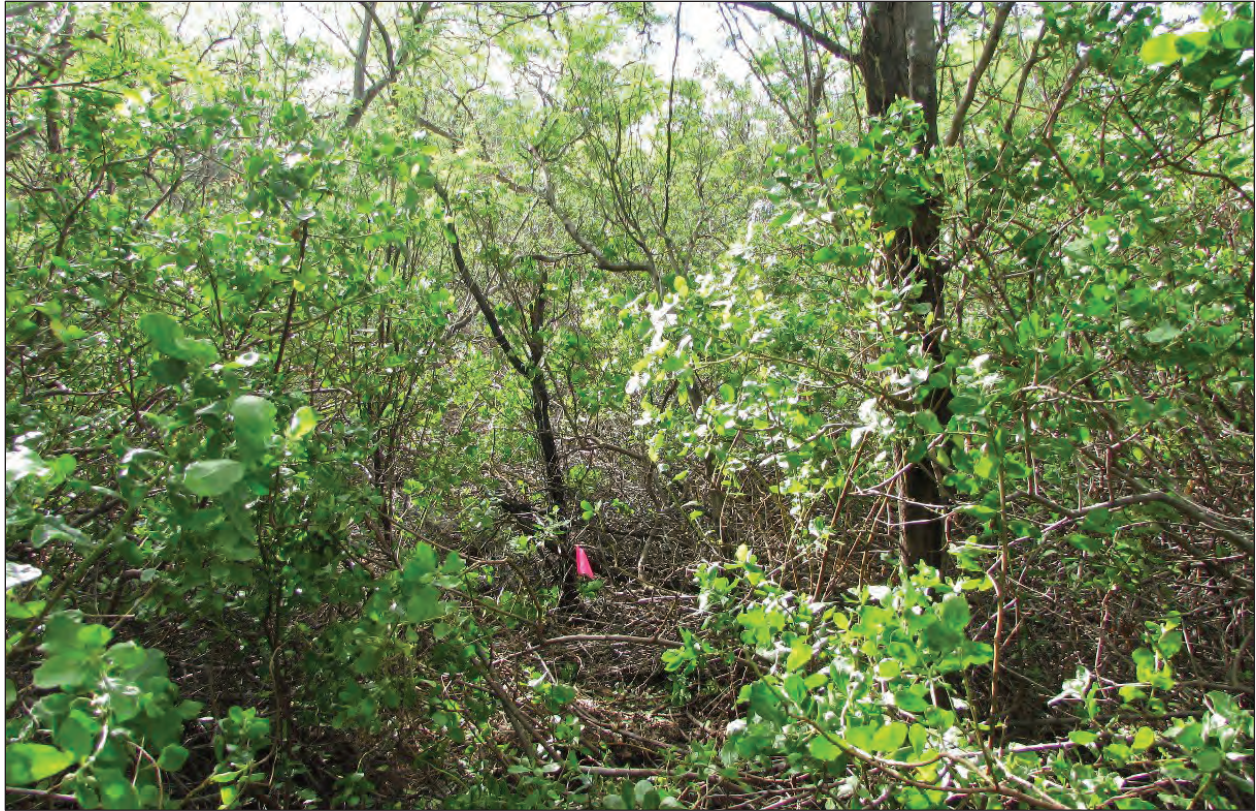
This area is on slightly (~one feet) higher elevation than the surrounded area that appeared to have recently ponded. No signs of ponding in this thicket.

Photo 21. At SP8 - Looking North into Thicket of *Pluchea* spp. with Kiawe (*Prosopis pallida*) As Canopy Species

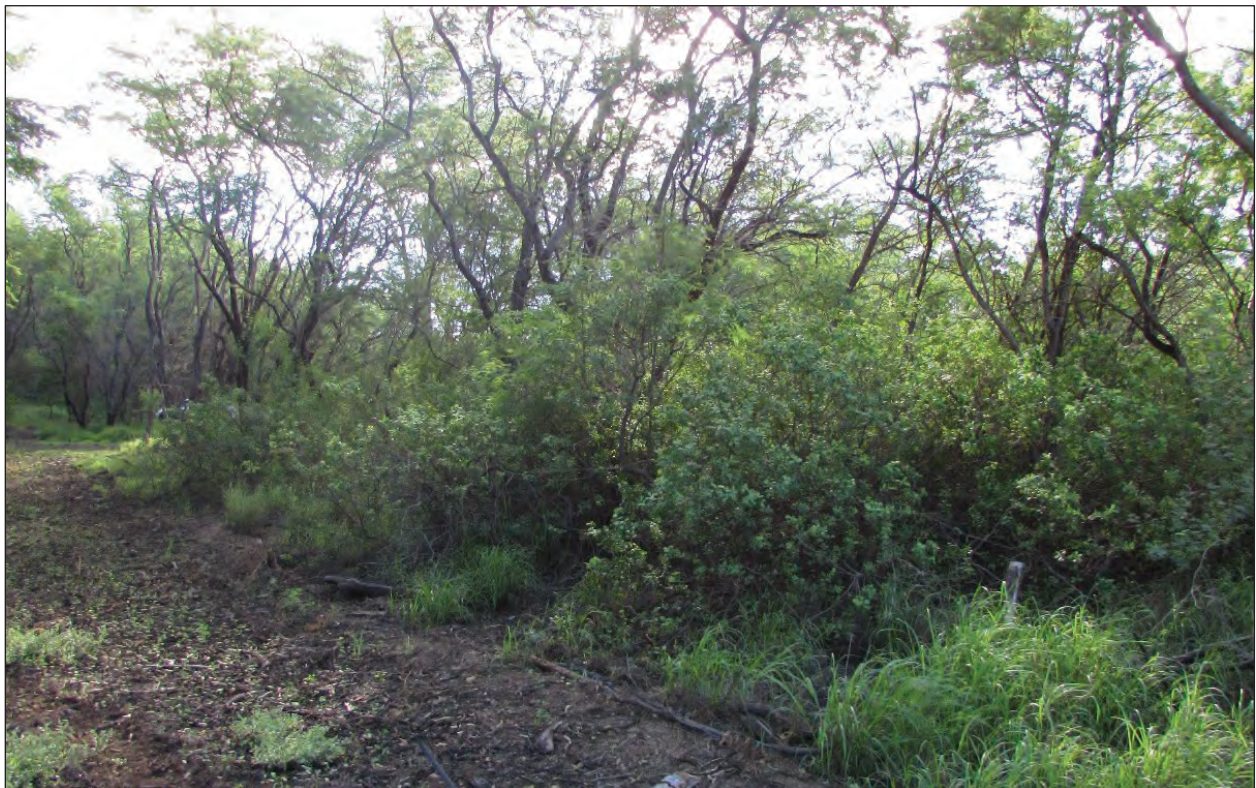
Photo 22. Area around SP8 - Mapped as Uplands Based on Similar Habitat Conditions Observed at SP8

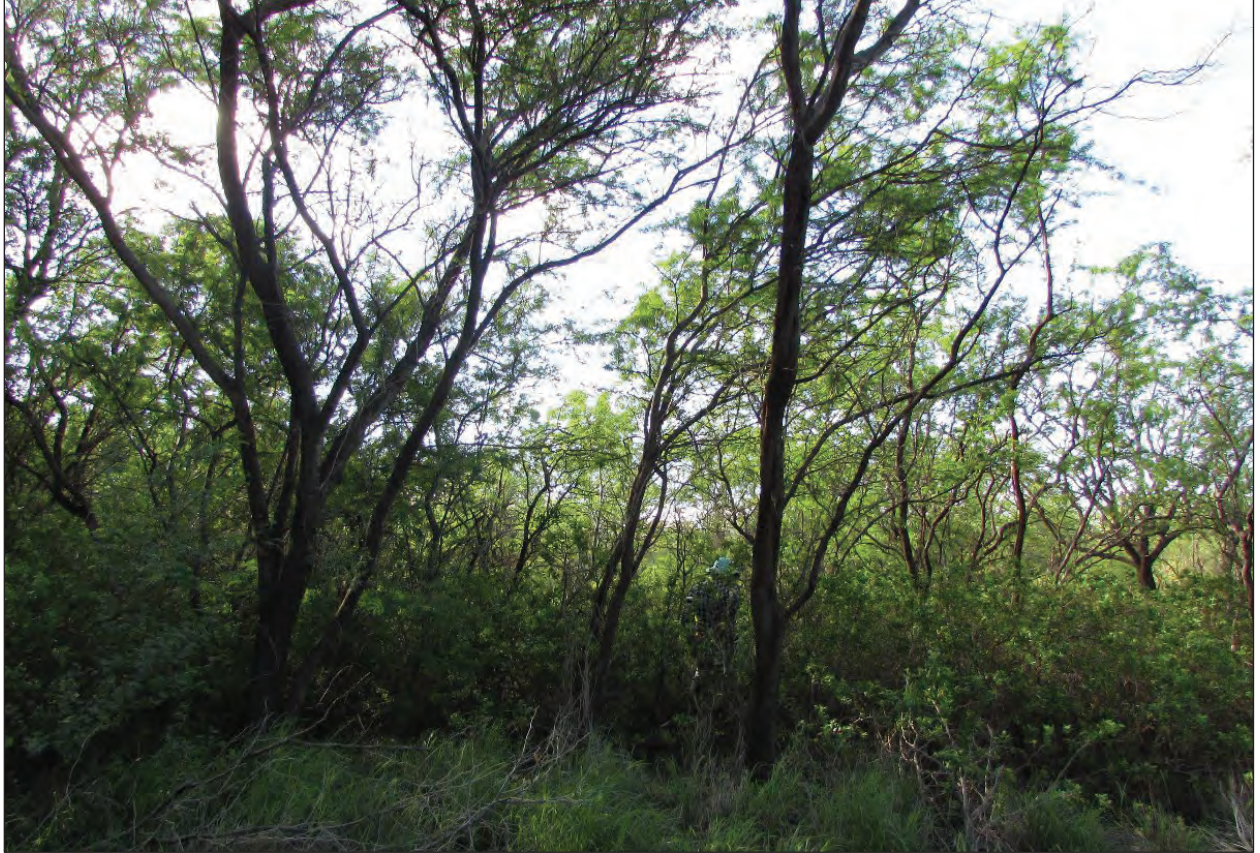
Photo 23. Upland Areas Identified Toward the Eastern End of Build Alternative 1 in Ukumehame Firing Range Based on Habitat, Slope, and Hydrology Similarities with SP8

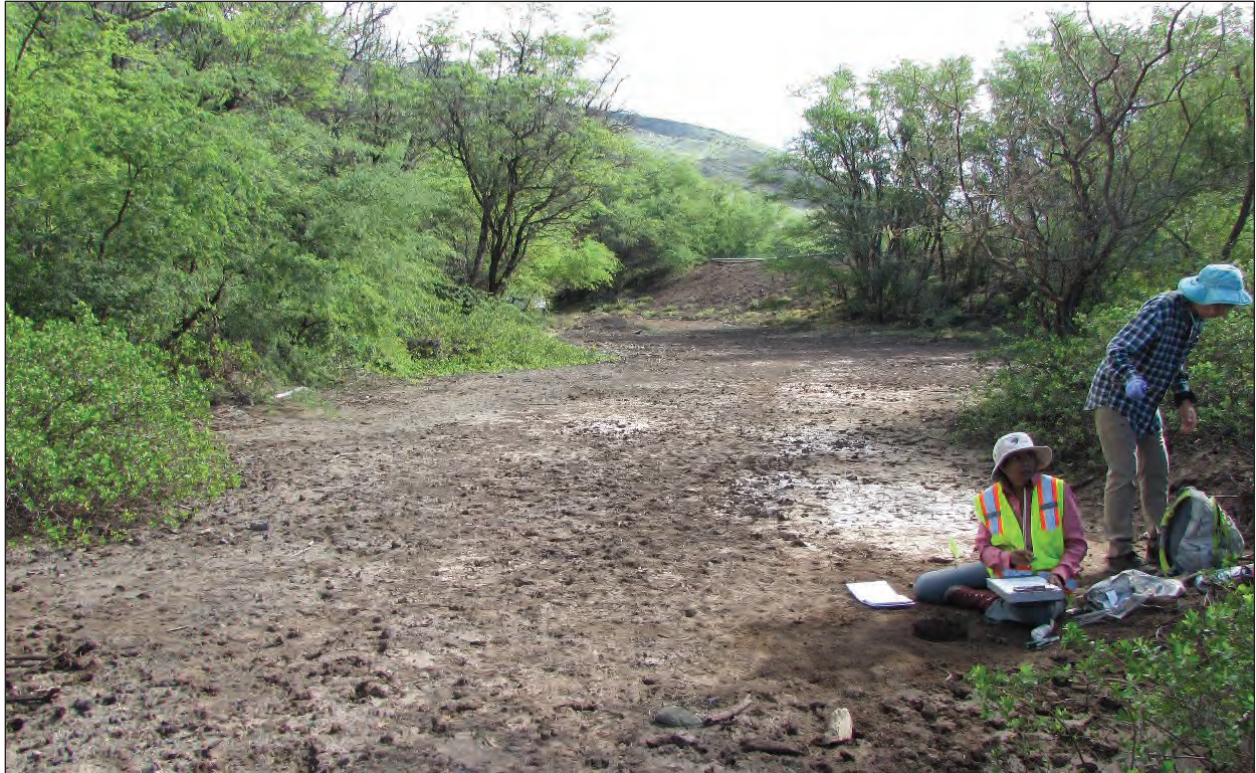
This sample point is next to vegetation but on bare dirt road that is a fire break on the firing range.

Photo 24. SP 9 in Ukumehame Firing Range, on Firebreak Dirt Road Separating an Upland Area to the Left and Wetland Area to the Right

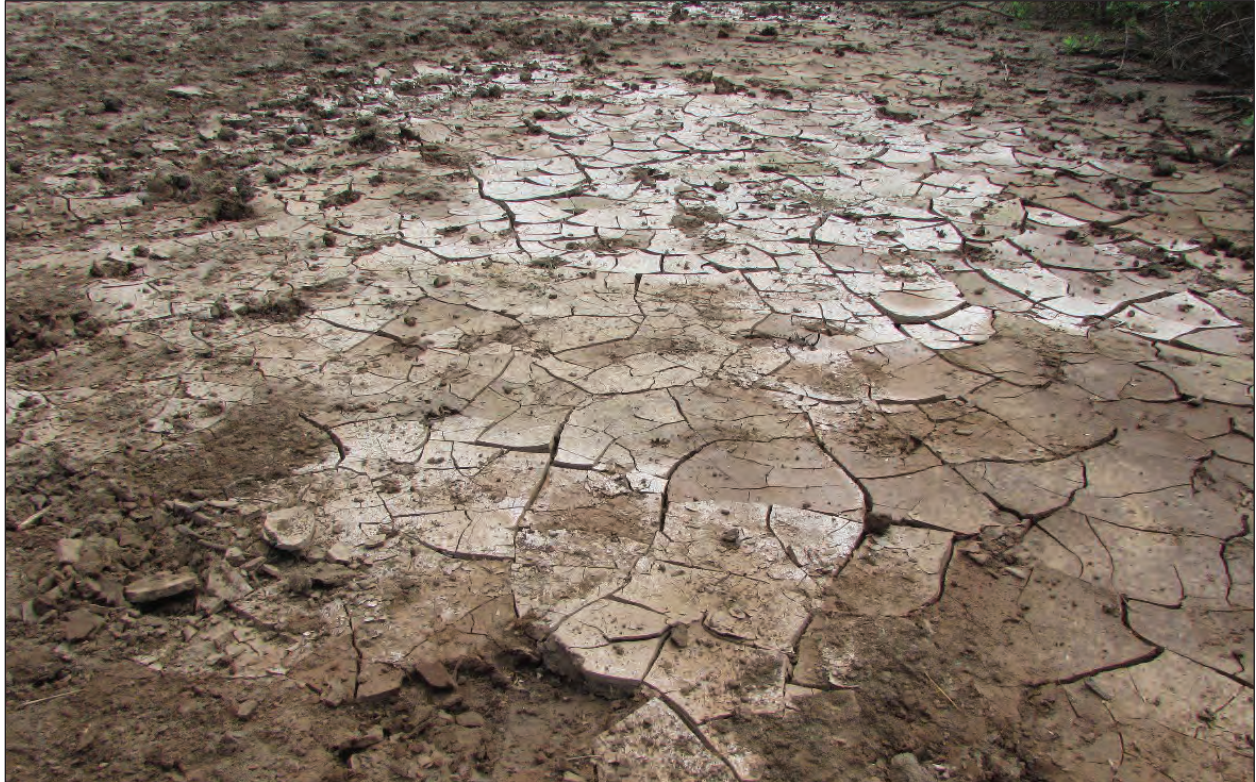
Photo 25. At SP9, Platy and Crack Surface Soils that were Not Hydric and Area Excluded as Wetland as It Did Not Meet the Three Parameter Wetland Criteria

SP9 (Photos 24-25)	Placed to investigate the unvegetated firebreak dirt road that runs between upland and wetland area.	No	No	No	This area does not meet the three parameter wetland criteria.
SP10 (Photos 26-27)	Placed to investigate the built-up (~ 6 feet) berm (#1 from east) artificially created in the Ukumehame Firing Range. Soils hydric from historic conditions before being placed as a berm.	No	Yes	No	This area does not meet the three parameter wetland criteria.
Sp11 (Photos 29-30)	Placed to investigate the low-lying areas between the built-up berms 1 and 2 at the that had predominantly saltbush in understory and surrounded by unvegetated areas with surface crack soils and salt crust.	Yes	Yes	Yes	This area (Wetland 7) meets three parameter wetland criteria.
SP12	Placed in pickleweed thicket between firing range berm and the County firing range parking lot.	Yes	Yes	Yes	This area (Wetland 7) meets three parameter wetland criteria.

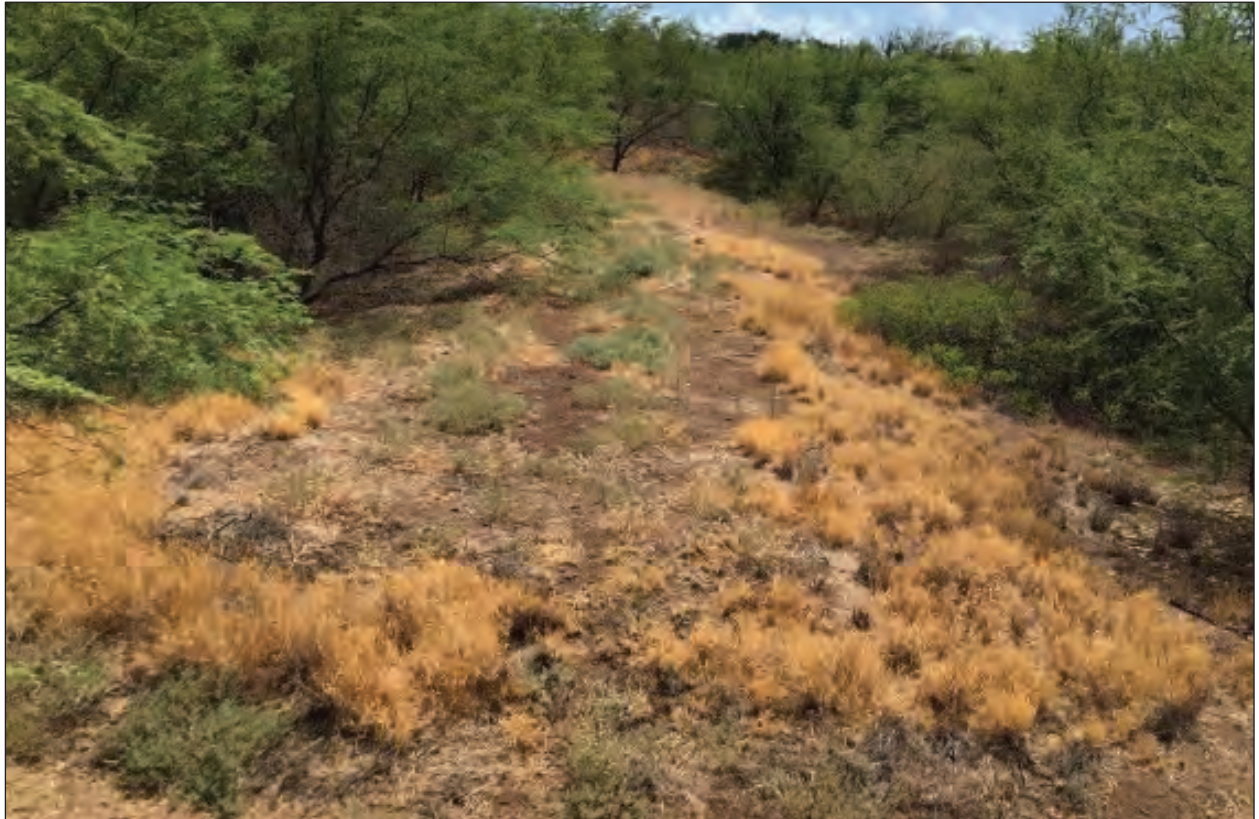
This sample point is on the built up berm in the firing range, approximately 6 feet higher than the surrounding area.

Photo 26. At SP10 - View to South, Artificially Built Up Berm in Ukumehame Firing Range

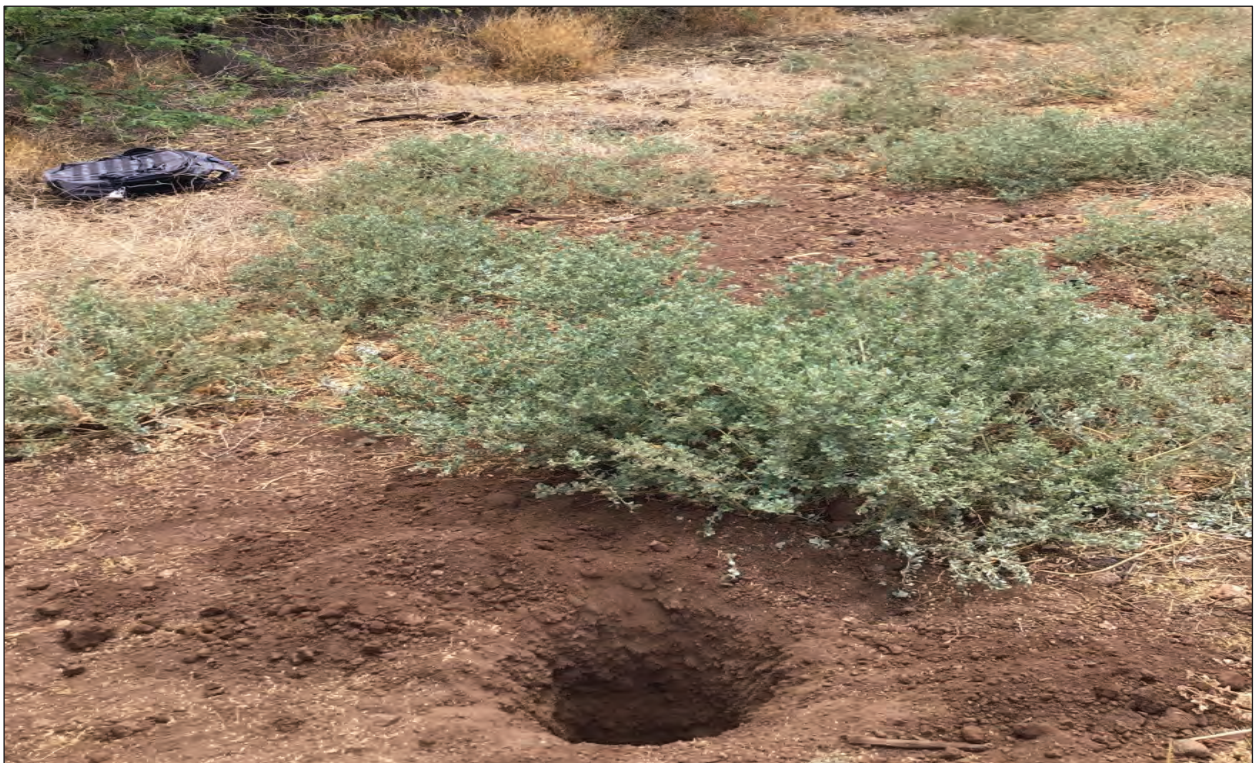
Photo 27. At SP10 - Close Up of Sample Pit with No Signs of Hydrology and FAC saltbush (*Atriplex semibaccata*) mixed with FACU Buffel Grass (*Cenchrus ciliaris*)

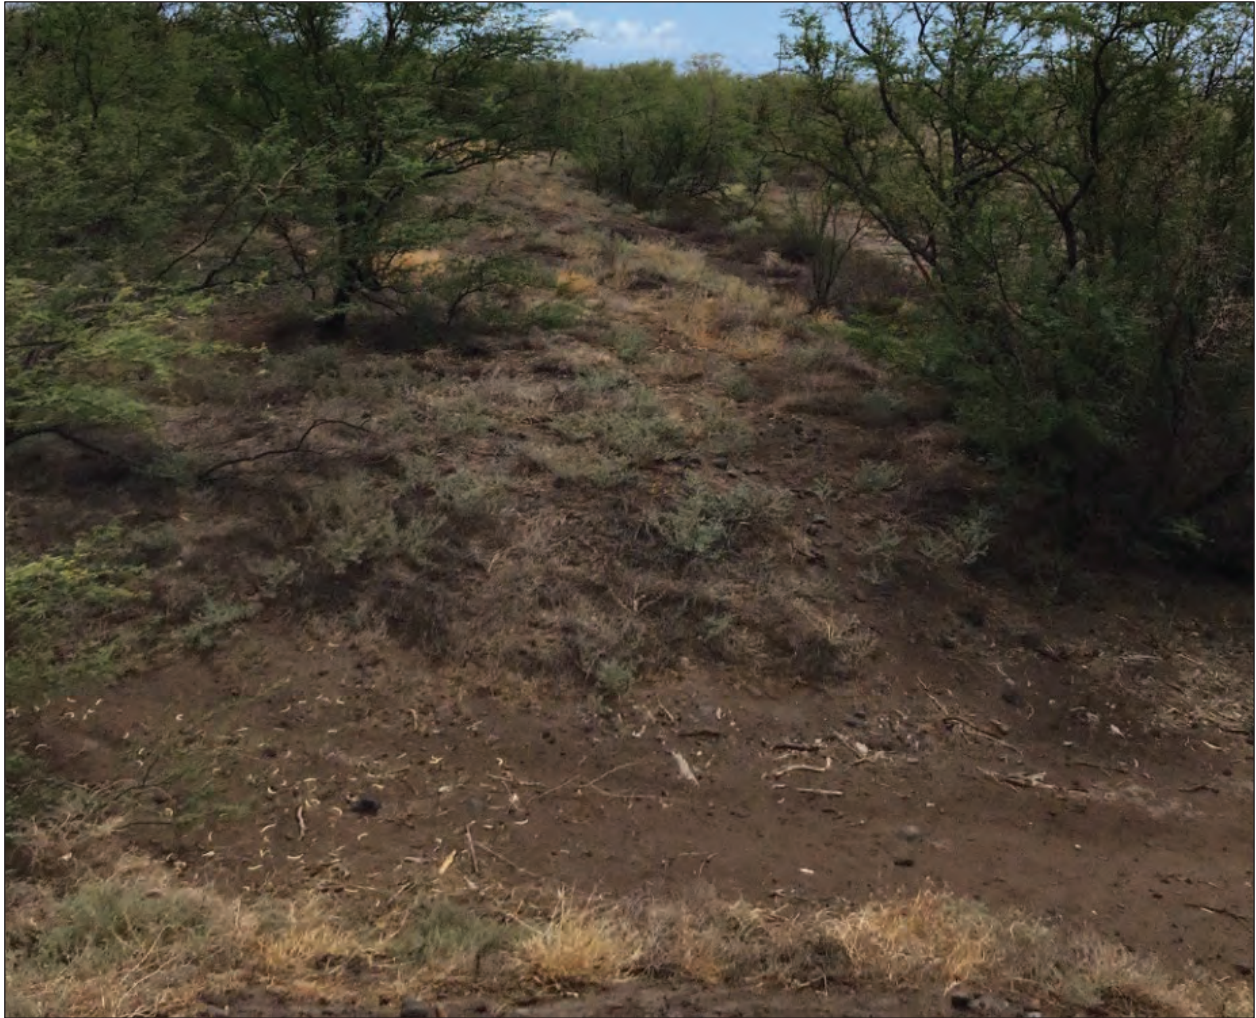
Photo 28. **View to South, Photo of Second Berm (From East)** that was Excluded as Upland Based on Similarities in Habitat, Slope, and Hydrology Observed at the SP10 Berm Site

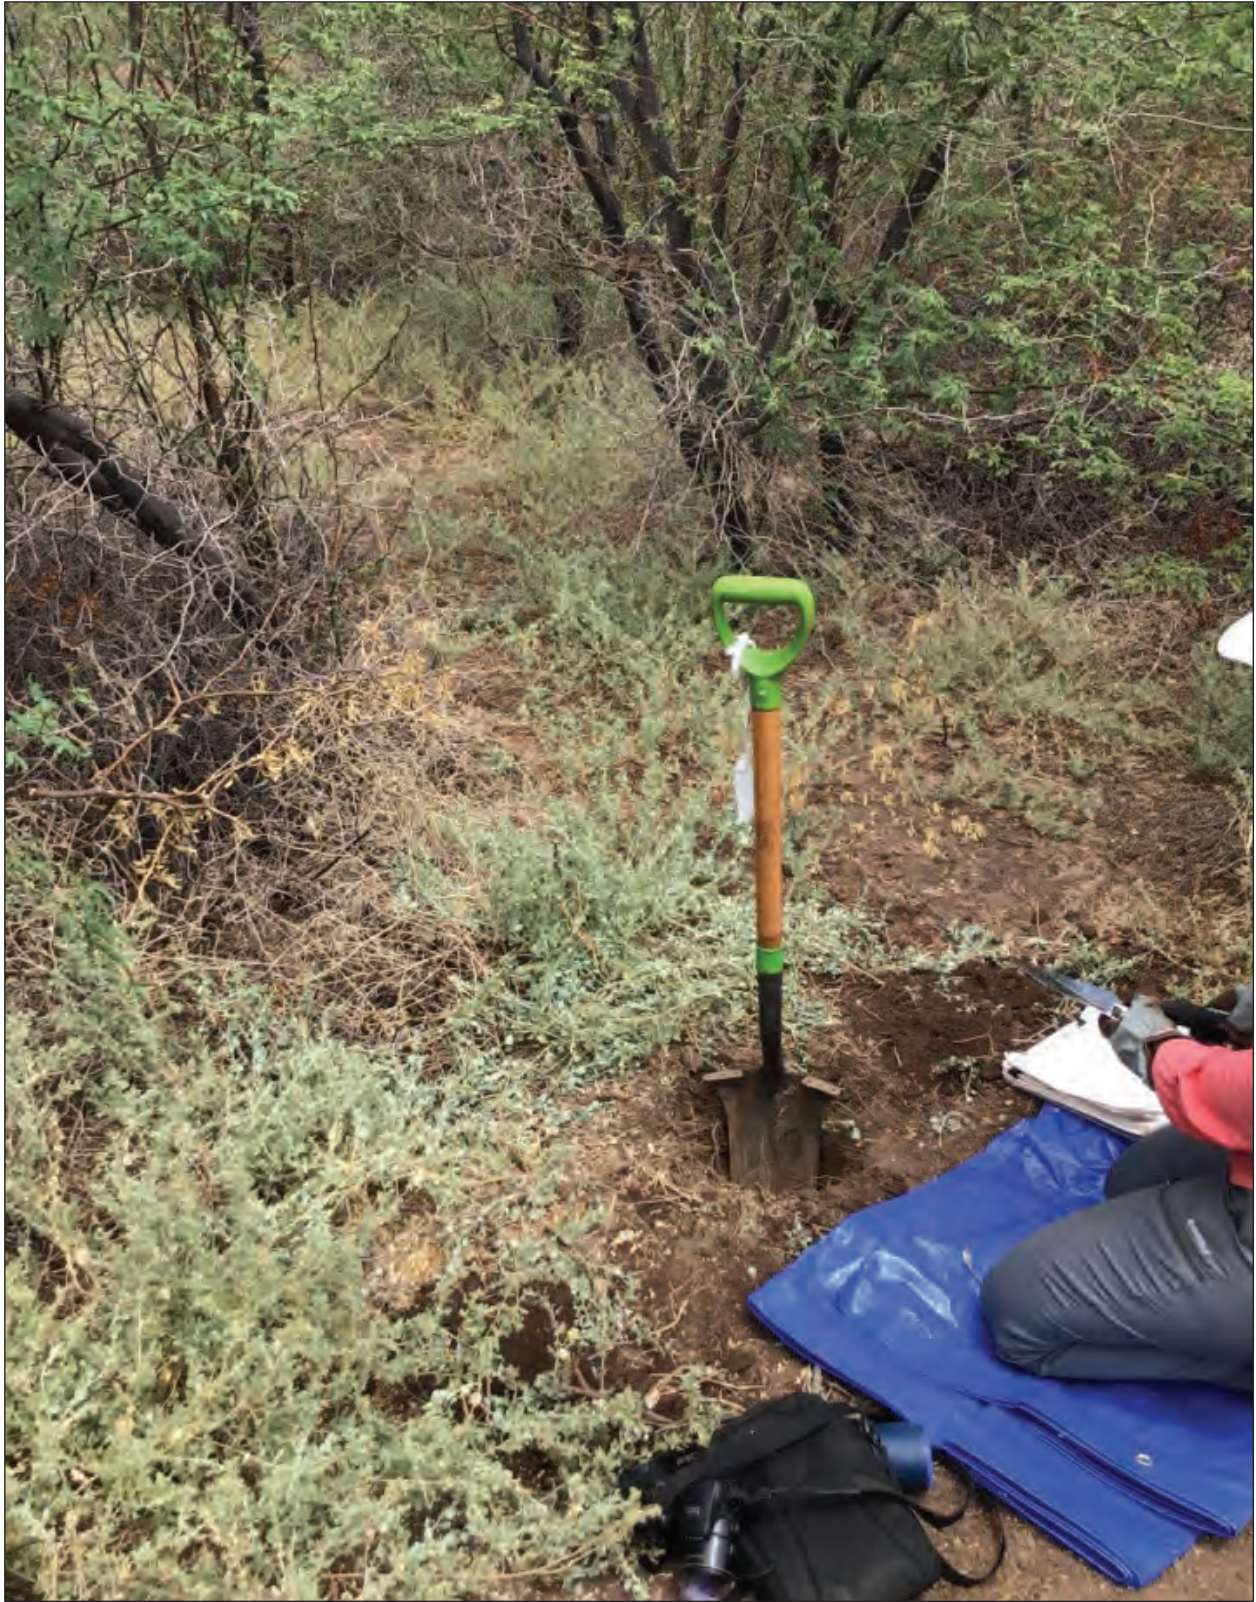
This sample point is representative of area between the berms. Ponding was observed here in January 2023.

Photo 29. At SP11 - Between Berms 1 and 2; Kiawe (*Prosopis pallida*), with Predominantly Facultative Saltbush (*Atriplex semibaccata*) in Understory

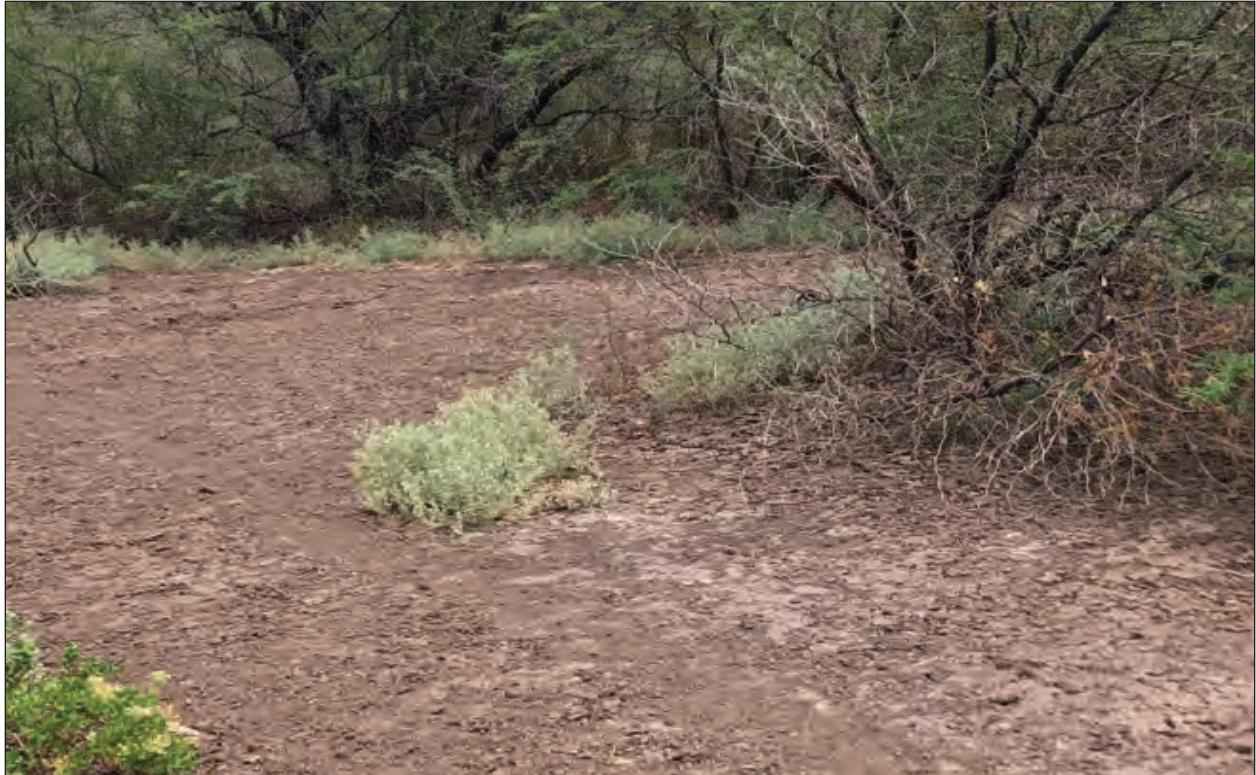
**Photo 30. Around SP11 - View to East. Wetland Habitat with Surface Crack Soils and Salt Crust**

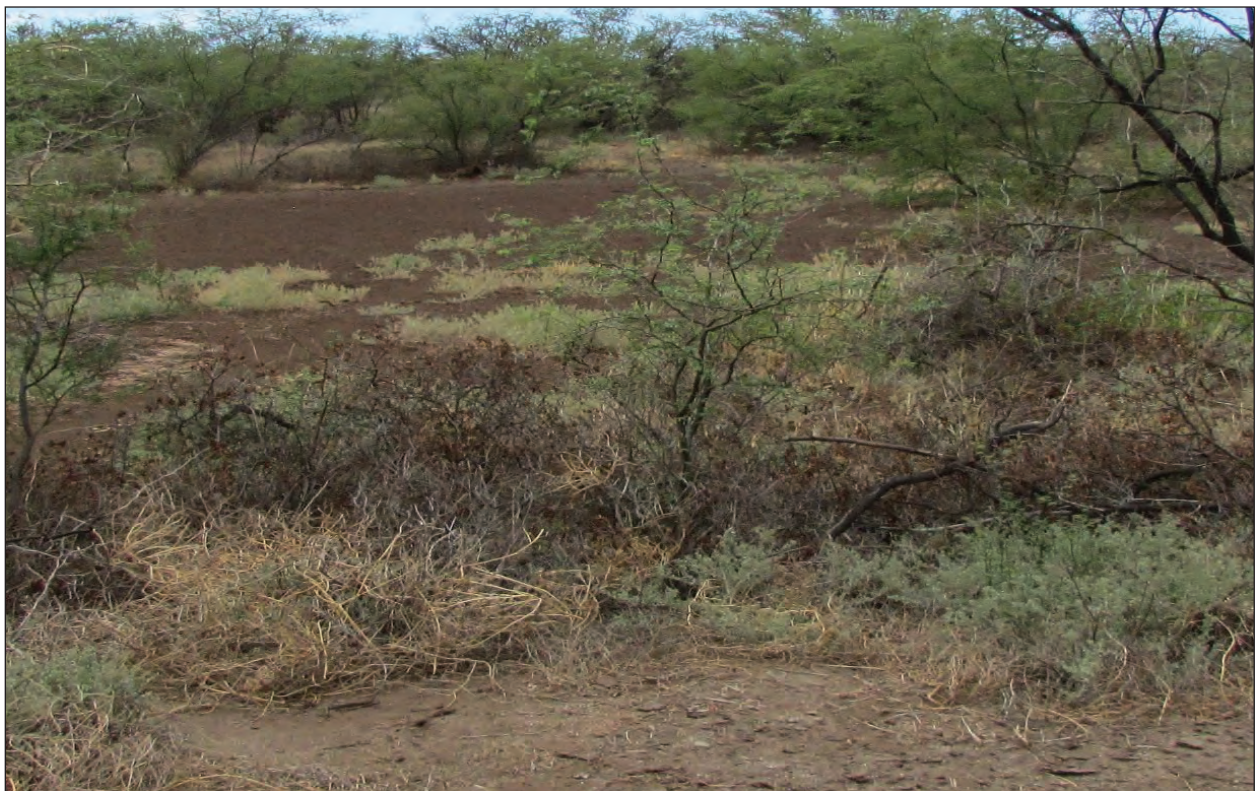
**Photo 31. View to West from Top of Berm 2 into the Low-Lying Area Between Berms 2 and 3; Area Included as Wetland Based on Similar Habitat, Slope, and Hydrology Observed at SP11 Between Berms 1 and 2**

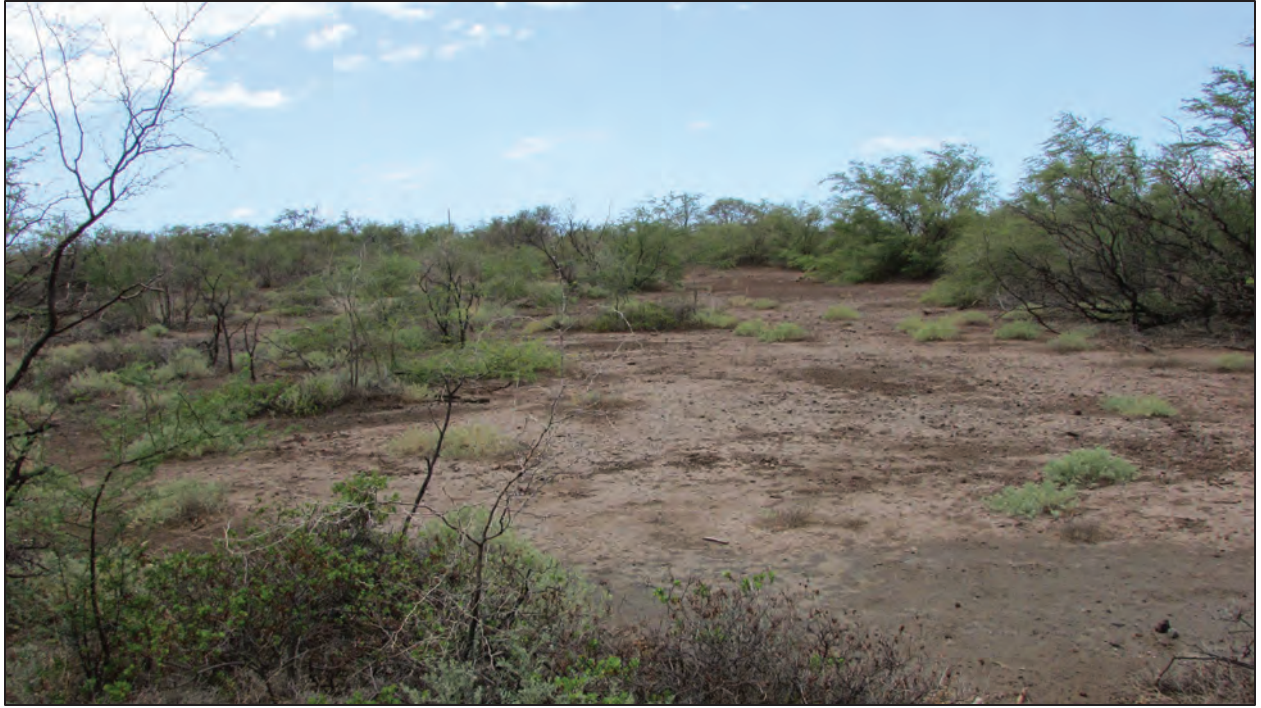
**Photo 32. View to West from Top Berm 3 into the Low-Lying Area Between Berms 3 and the Western Fence of Ukumehame Firing Range; Area Included as Wetland Based on Similar Habitat, Slope, and Hydrology Conditions Observed at SP11**

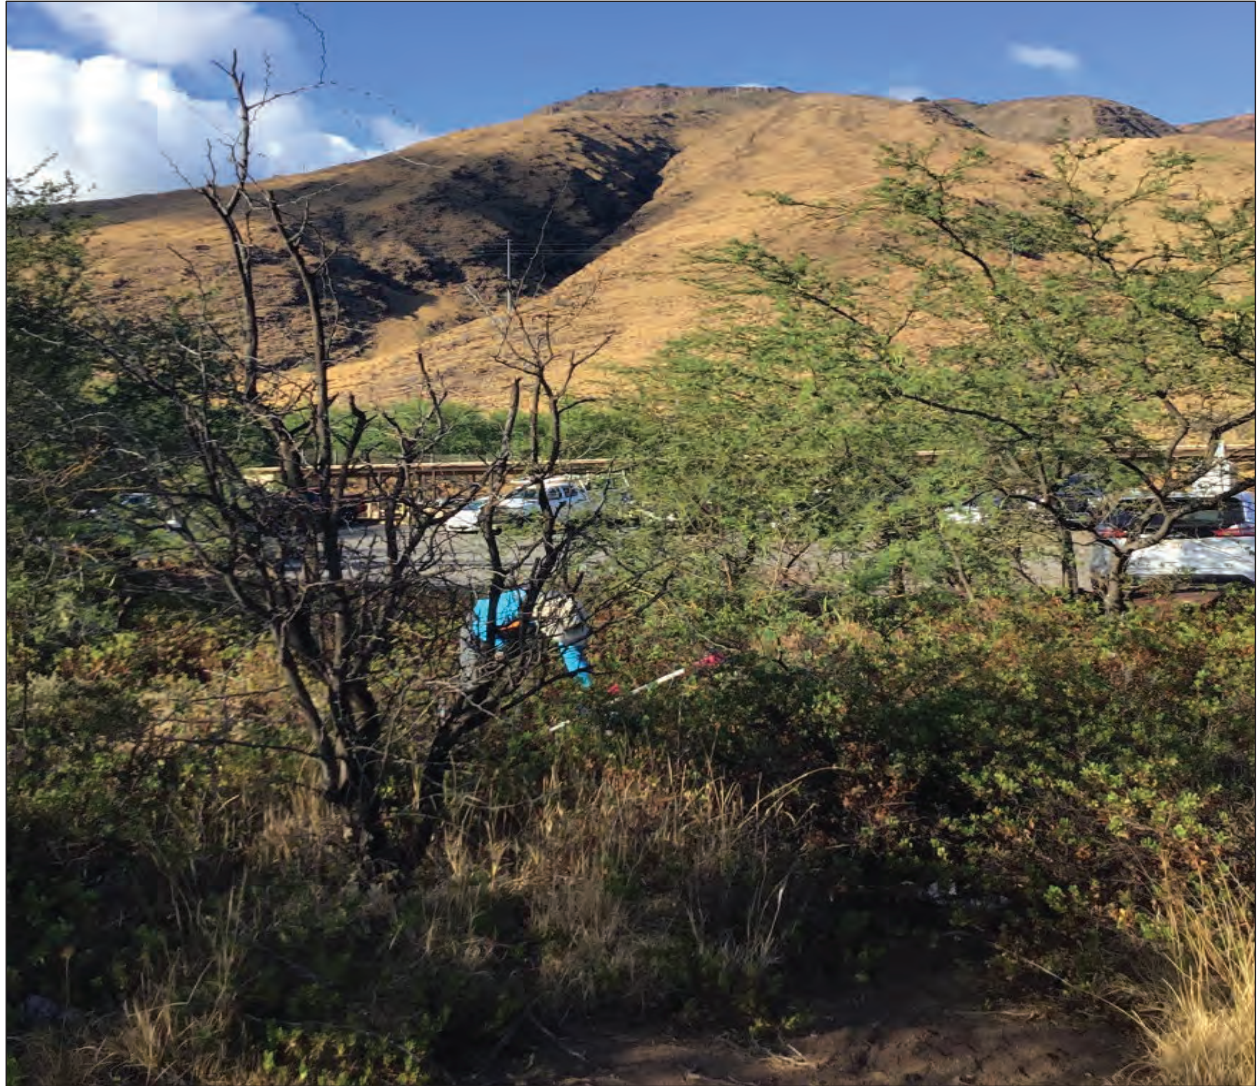
Photo 33. At SP13 – View to East; This Upland Area in the Disturbed Swath Next to the County Firing Range Parking Lot Defined the Edge of the Wetland to the West

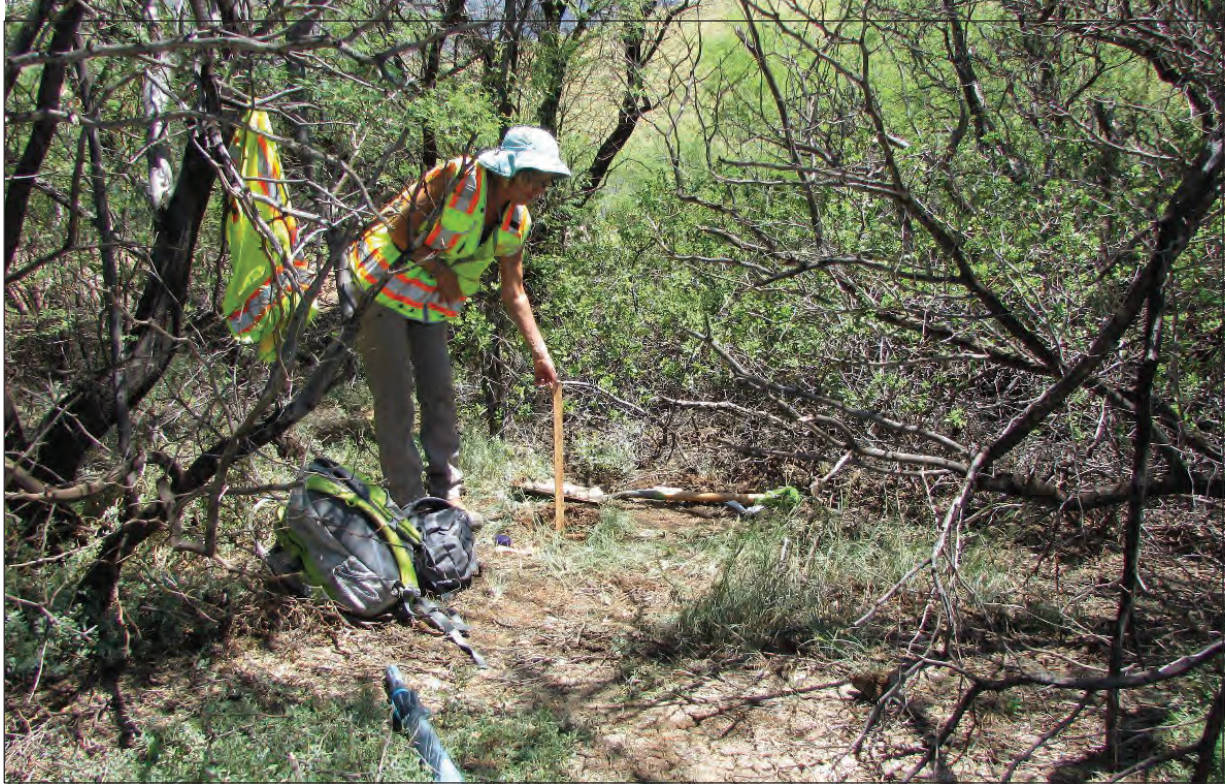
**Photo 34. At SP14 - Wetland Area with Salt Crust and Dominated with Facultative Species of *Pluchea* sp. and Saltbush (*Atriplex semibaccata*) in Understory**

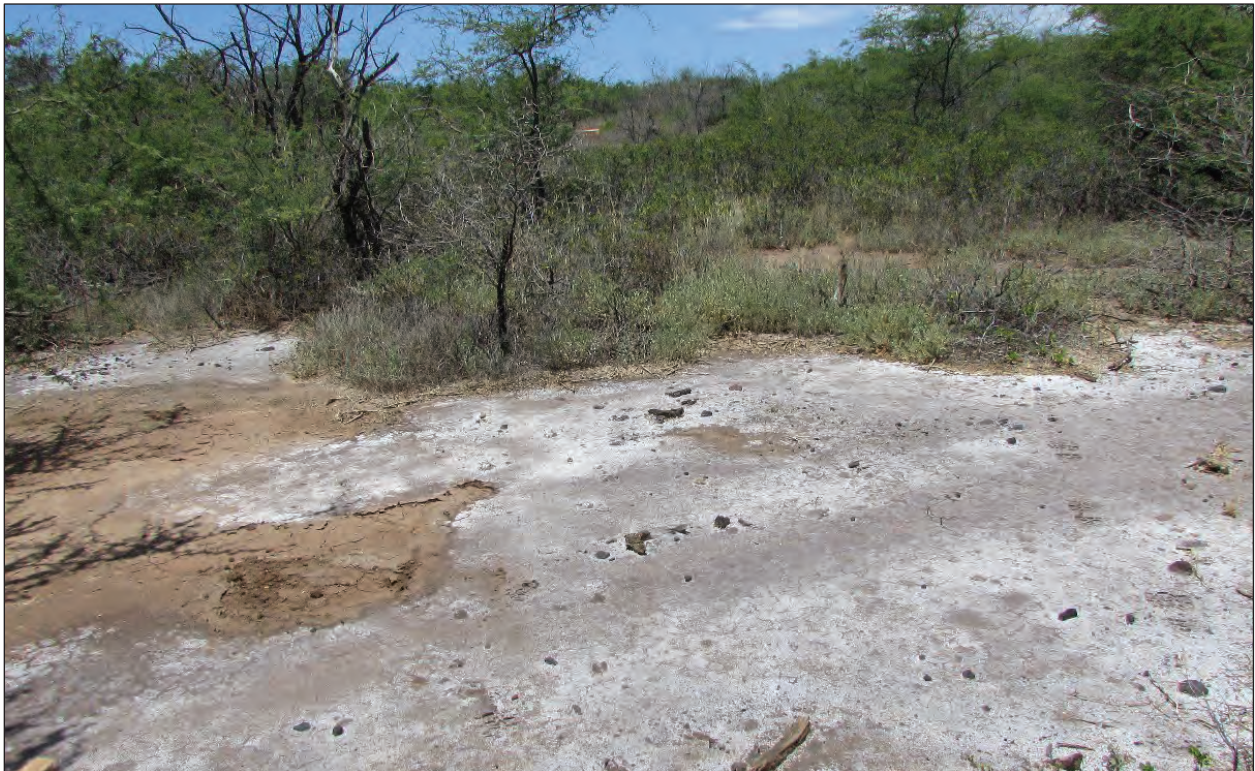
**Photo 35. Salt Crust on Soil in Unvegetated Area Next to SP14 (Seen Here in the Background)**

Name	Sampling Rationale	Hydrophytic Vegetation	Hydric Soil?	Wetland Hydrology?	Overall Wetland Assessment
SP14 (Photo 34-35)	Placed to investigate typical representative habitat seen in the general area south of Ukumehame Firing Range: Areas with salt crust on soil and patches of FACU kiawe trees with predominantly facultative <i>Pluchea</i> sp. and saltbush in the understory.	Yes	Yes	Yes	This area (Wetland 10) meets three parameter wetland criteria.
SP15 (Photos 39-40)	Placed to investigate a large “island” area within the wetland that appeared to be slightly (~ on feet) higher with thickets of buffel grass in understory and did not show signs of being flooded.	No	No	No	This area did not meet the three parameter wetland criteria.
SP16 (Photo 43)	Placed to investigate the HDOT artificially created sedimentation basin	No	No	Yes	This area does not meet the three parameter wetland criteria.
SP17 (Photo 44)	Placed to investigate a patch of pickleweed east of the spillway bordering eastern side of the sedimentation basin	No	No	No	This area does not meet the three parameter wetland criteria.

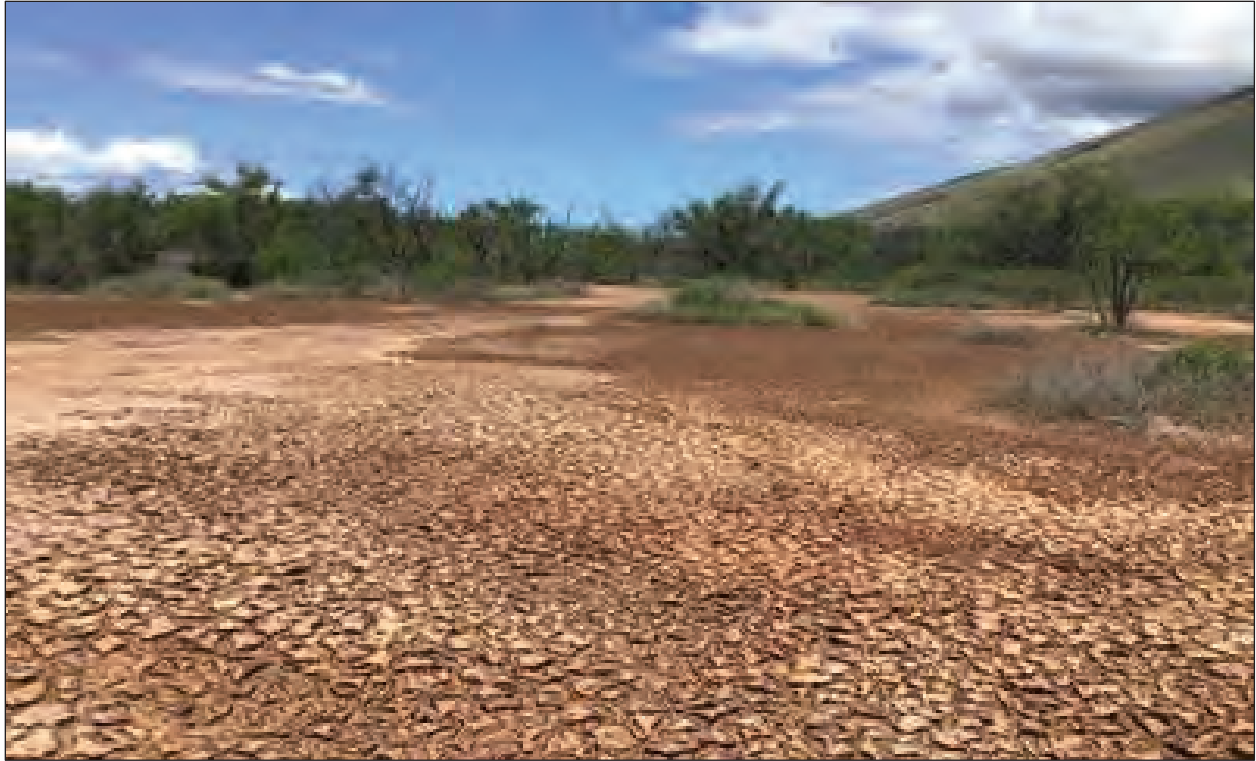
**Photo 36. View to South - Representative Wetland Habitat Mapped to South of the Upland Area (As Identified by SP15)**

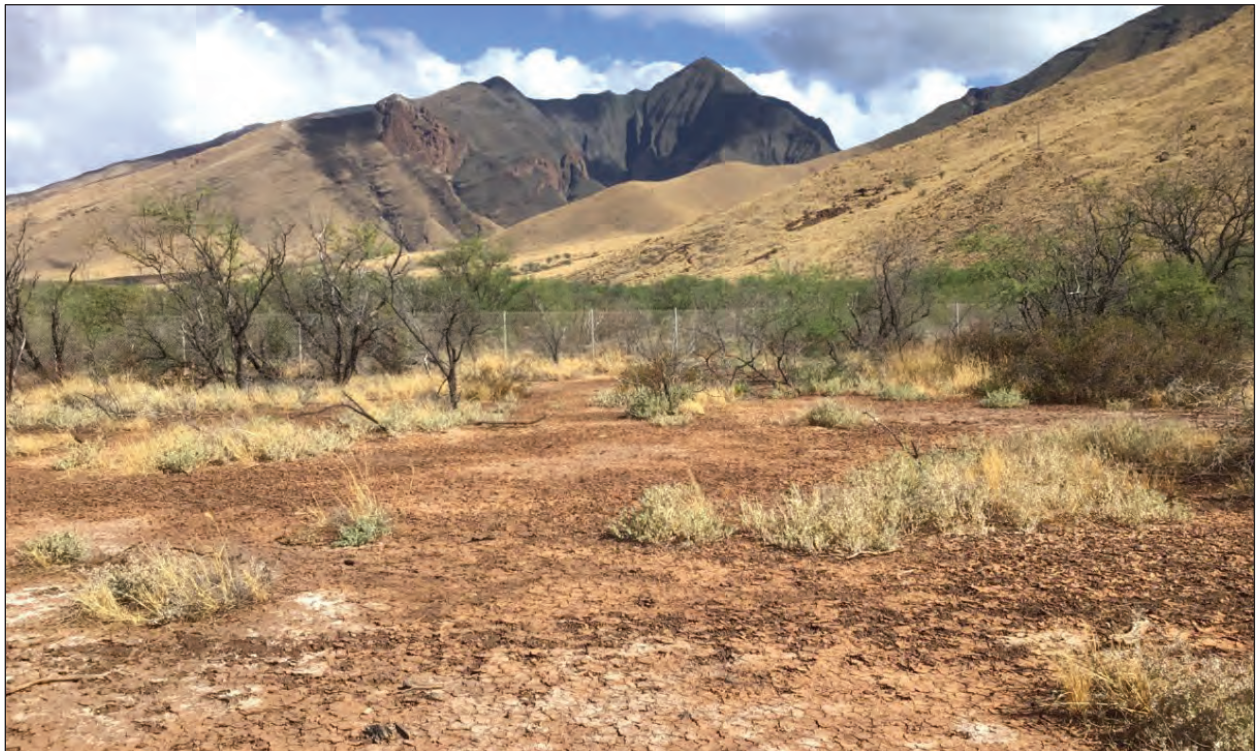
**Photo 37. View to North - Representative Wetland Habitat Mapped to the West of Upland Area (as Identified by SP15)**

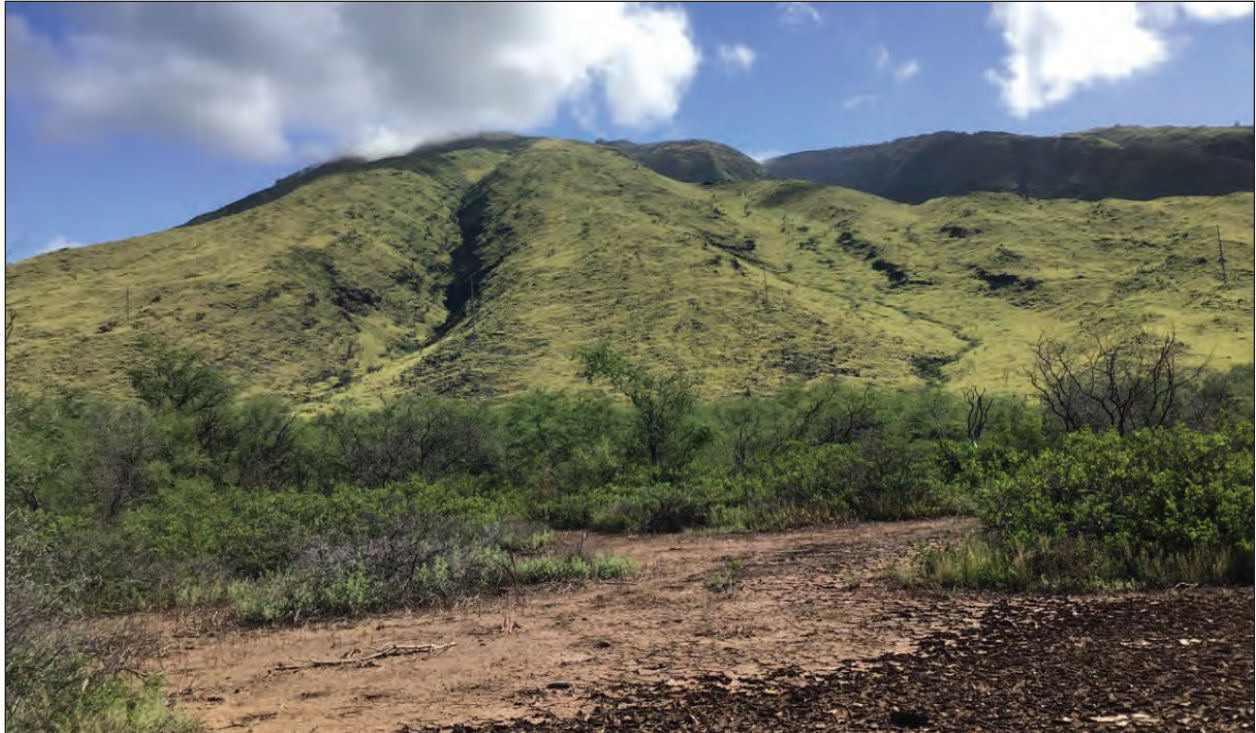
**Photo 38. View to East - Representative Wetland Habitat Mapped to the East of the Upland Area (as Identified by SP15)**

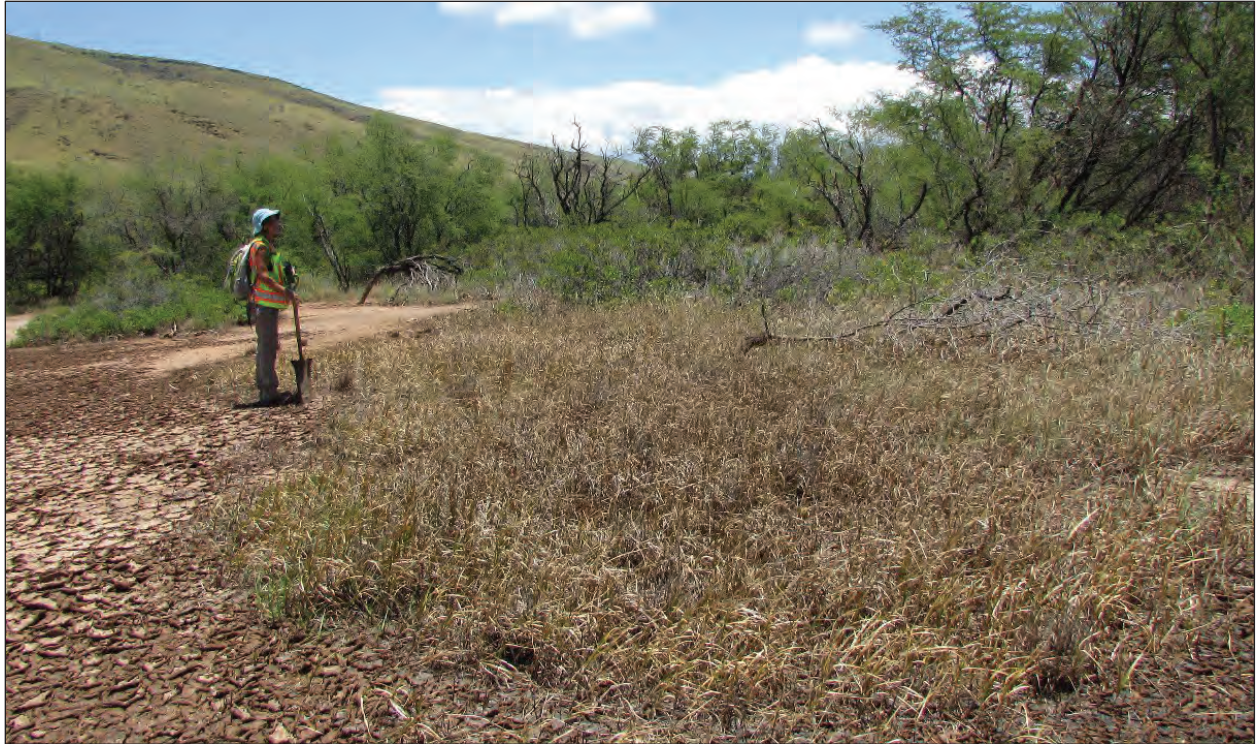
Sample point is in a kiawe (*P. pallida*) thicket that is slightly (~on feet) higher in elevation. Does not appear to have ponded like the surrounding area.

Photo 39. Border of Wetland (to the Left) and Upland Area to the Right as Identified by SP15

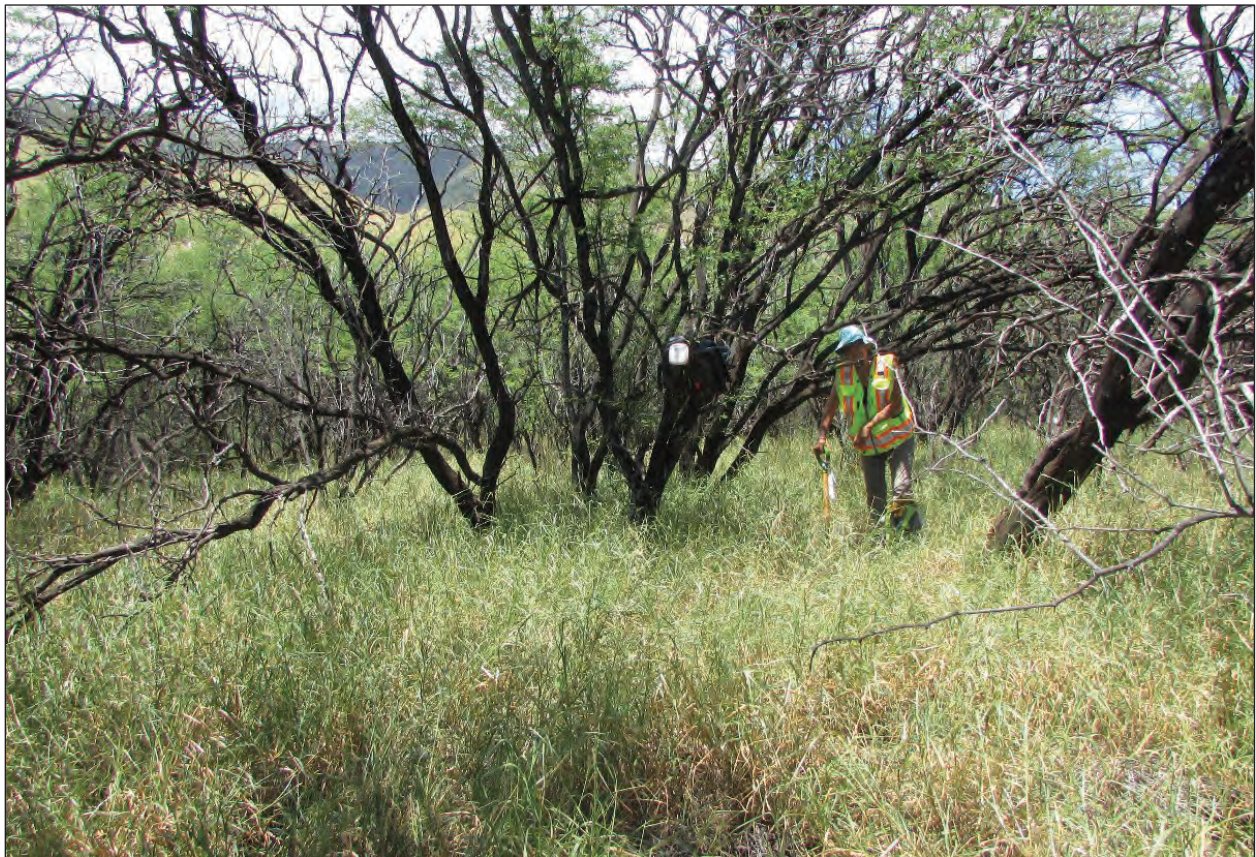
Photo 40. At SP15 - Upland Area Dominated FACU Kiawe (*Prosopis pallida*) and UPL Buffel Grass (*Cenchrus ciliaris*) in the Understory
