HONOAPI'ILANI HIGHWAY IMPROVEMENTS PROJECT,  
WEST MAUI: UKUMEHAME TO LAUNIUPOKO

# Appendix 3.9 – Water Resources, Wetlands, and Floodplains - Supplemental Information

**Honoapiilani Highway Improvement Project  
Preliminary Identification of Waters of the United States  
Technical Report**

**Project # 4692-02**

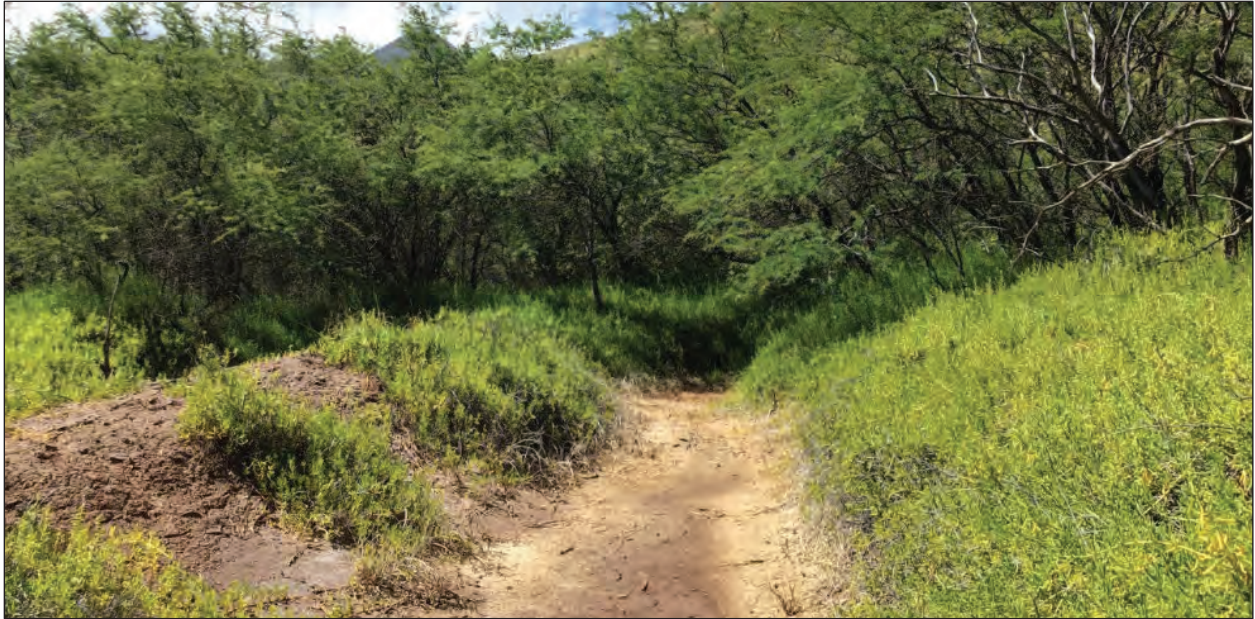
Photo 41. Area Northeast of the Road Leading to the Maui County Firing Range; Included as Wetland **Based on Similarity with Habitat Characteristics to SP2, SP4, and SP12**

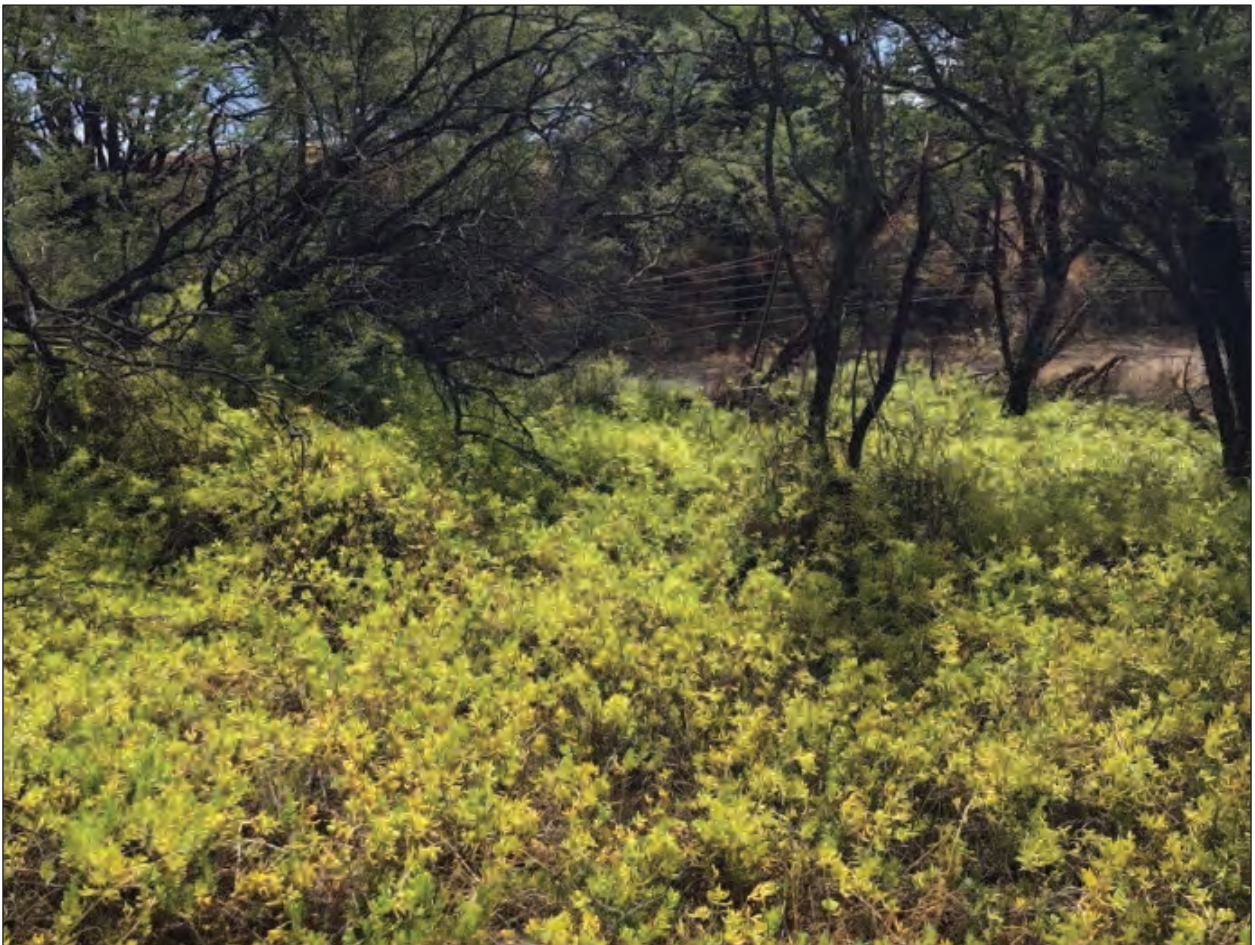
Photo 42. Area Northwest of Road Leading to the Maui County Firing Range; Included as Wetland as Similar in Habitat Characteristics to SP2, SP4, and SP12

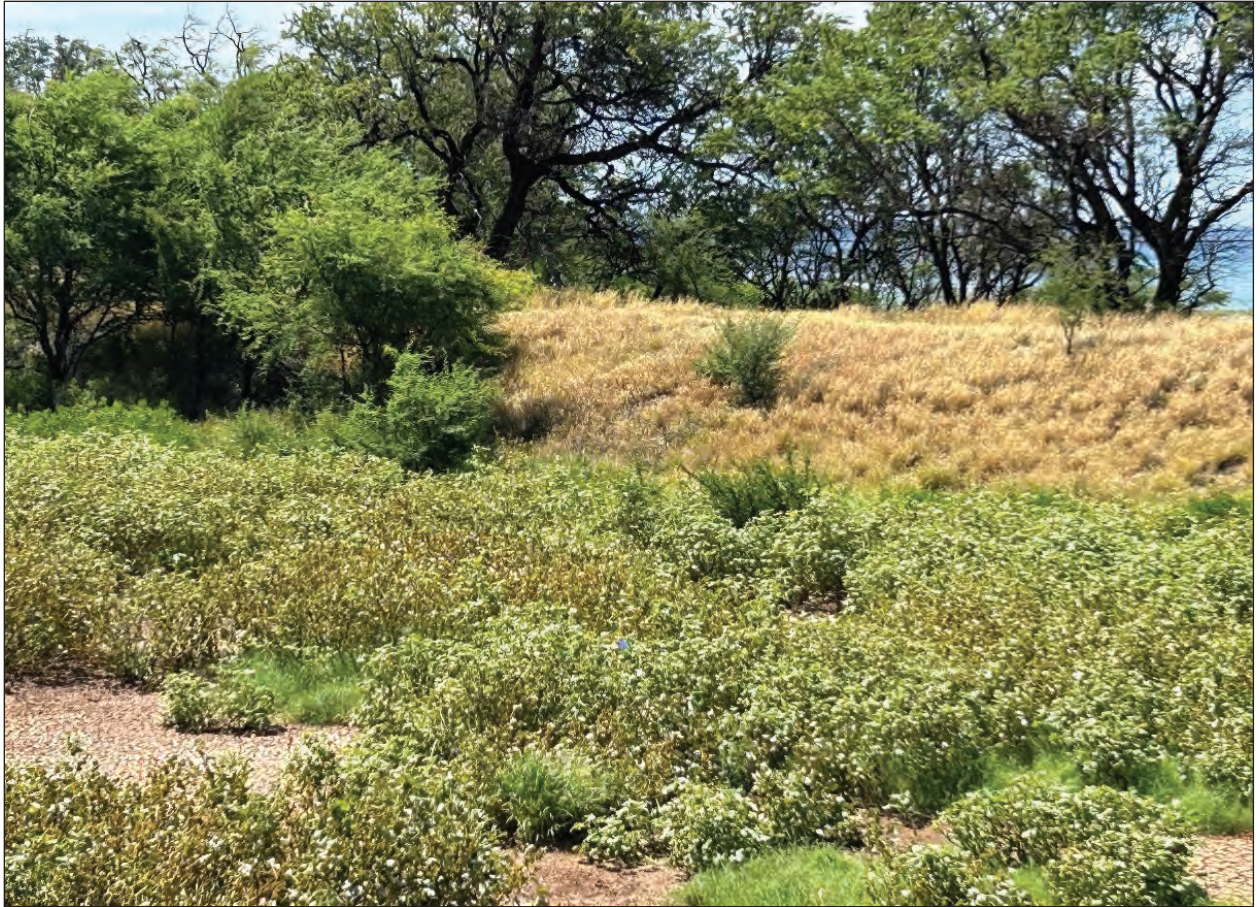
The sedimentation basin is fed by two streams that enter from the southern border.

Photo 43. The Sedimentation Basin where SP16 was Placed; Looking West

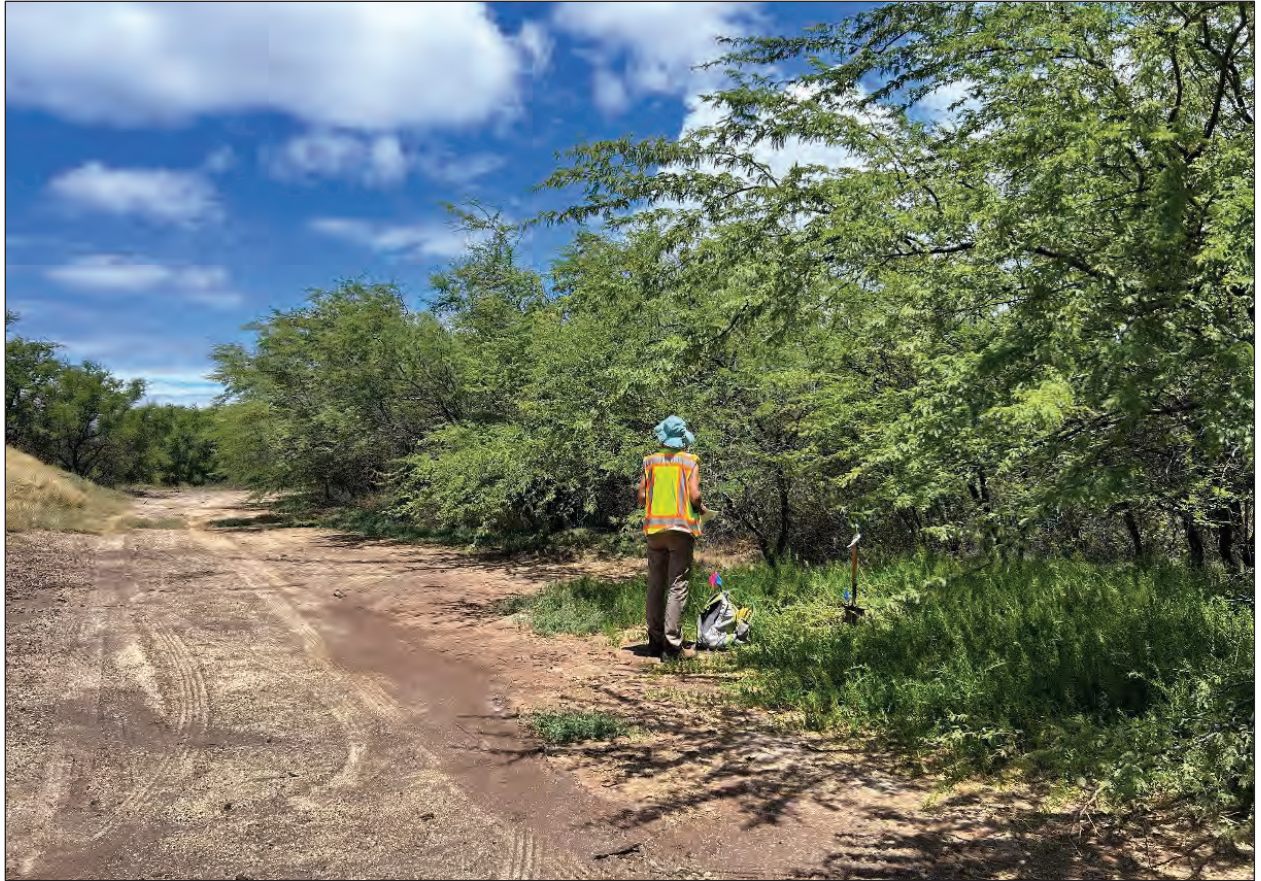
Photo 44. SP17 Next to Road to the East of the Spill Way on the Eastern Side of the Sedimentation Basin

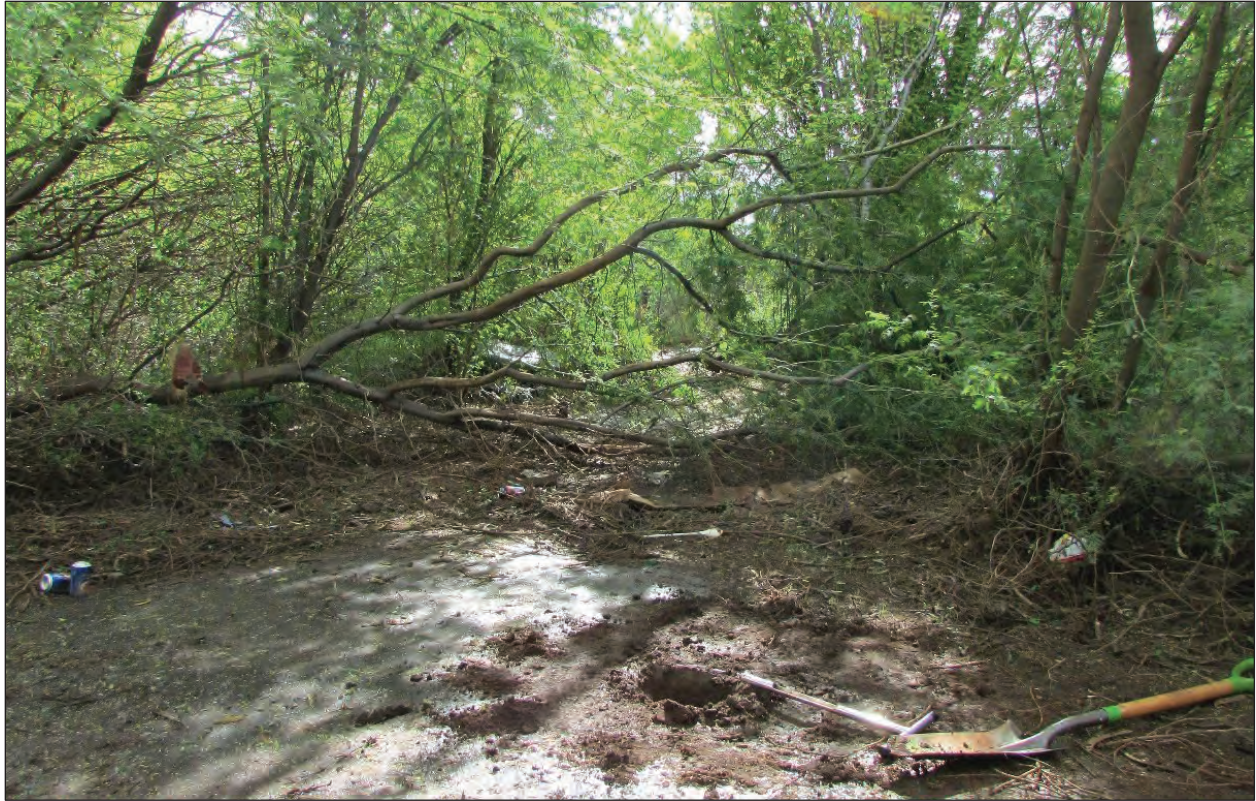
Photo 45. SP19 Placed in the Low Point of the Area Identified as a National Wetland Inventory Feature (PEM1C) in the Northernmost Part of the Study Area

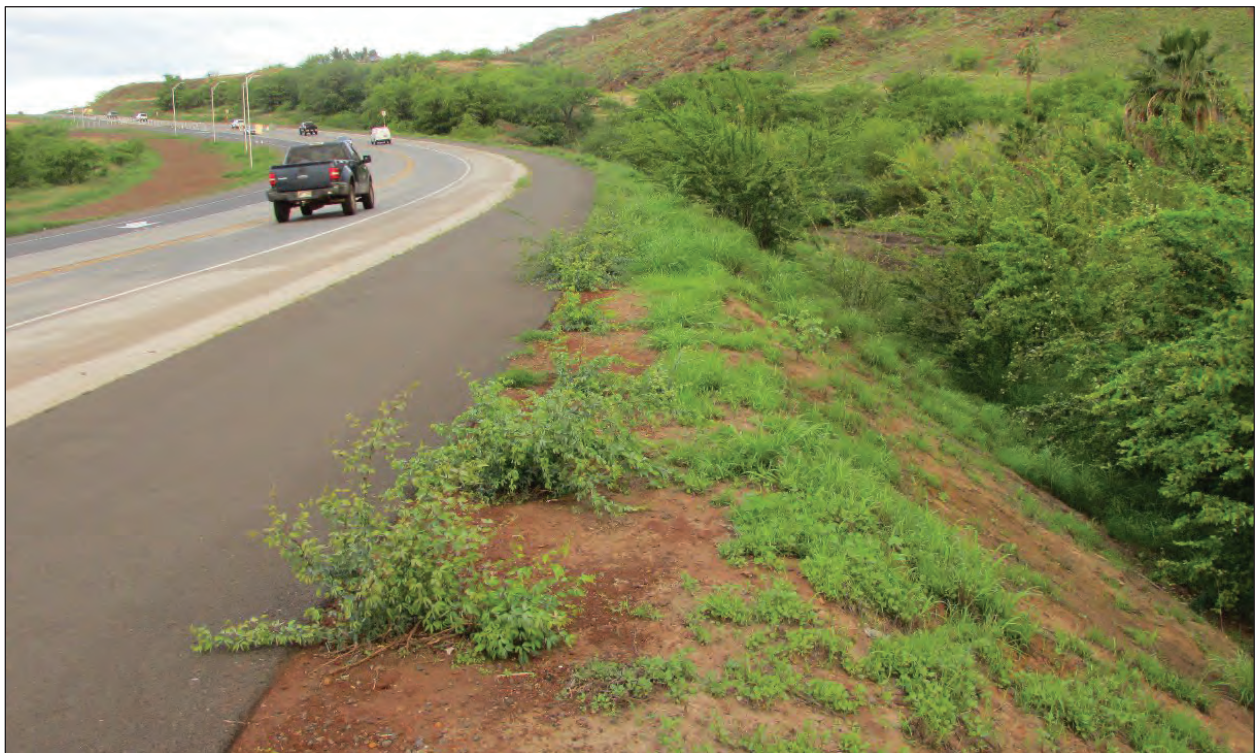
Photo 46. Lahaina Bypass End of Study Area – The General Vicinity of SP19 that Overlaps the National Wetland Inventory Feature

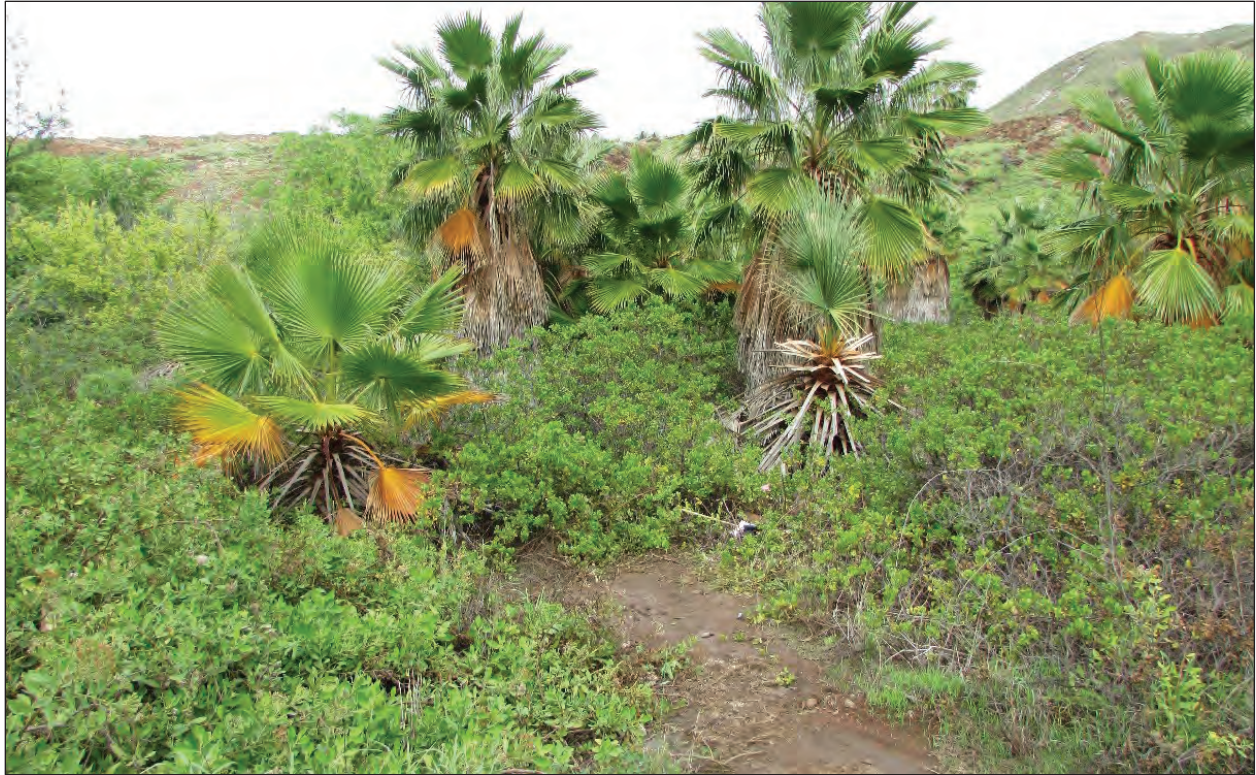
Photo 47. SP19 Representative of National Wetland Inventory Feature (PEM1C) Seen Here Dominated by Facultative Species of *Pluchea* spp. and Mexican Fan Palms (*Washingtonia robusta*); Looking East

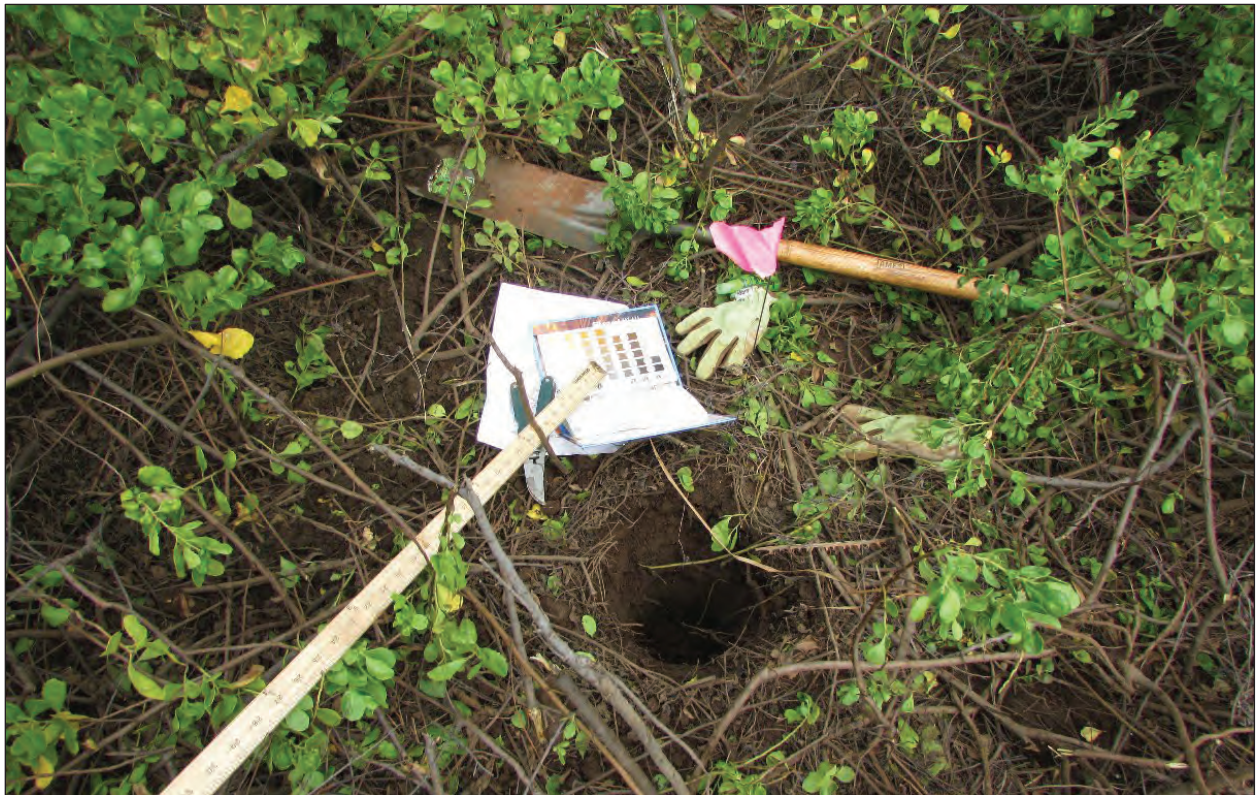
Photo 48. SP19 Soil Pit that Did Not Show Any Evidence of Hydric Soil Indicators

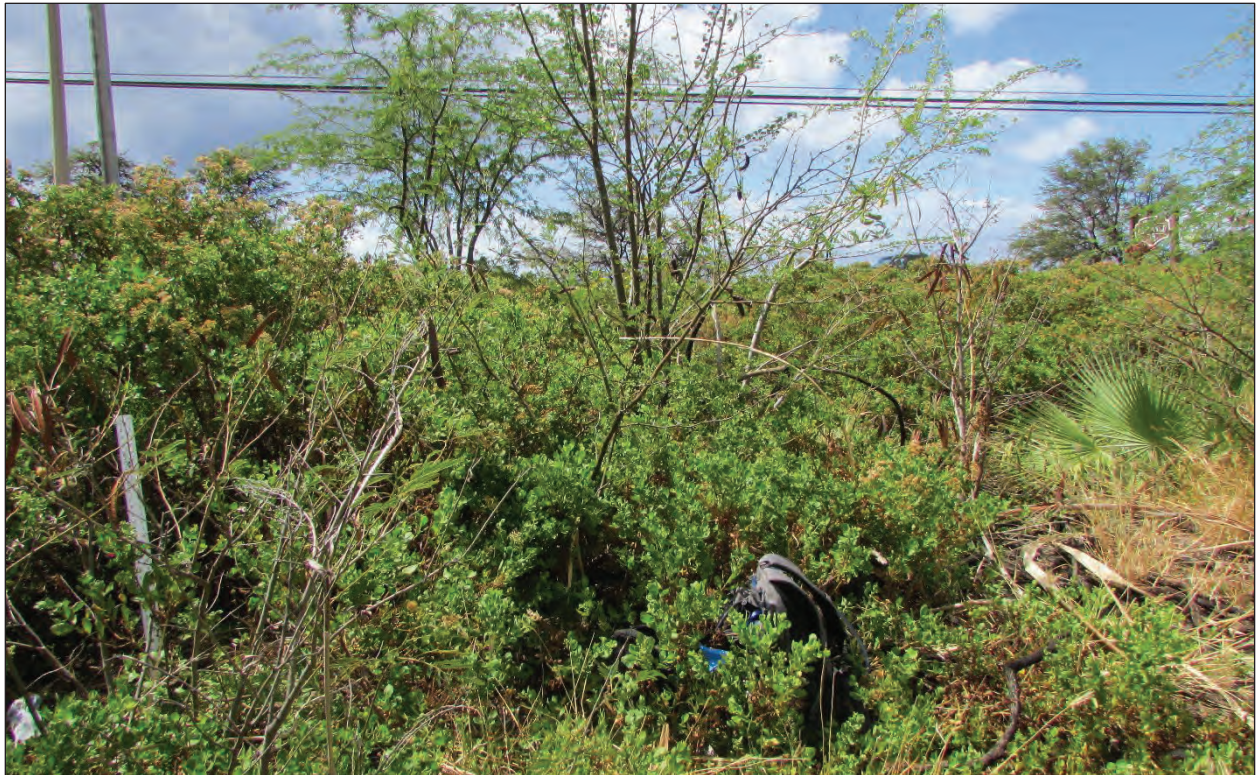
Photo 49. Placed to Investigate Edge of the Ditch

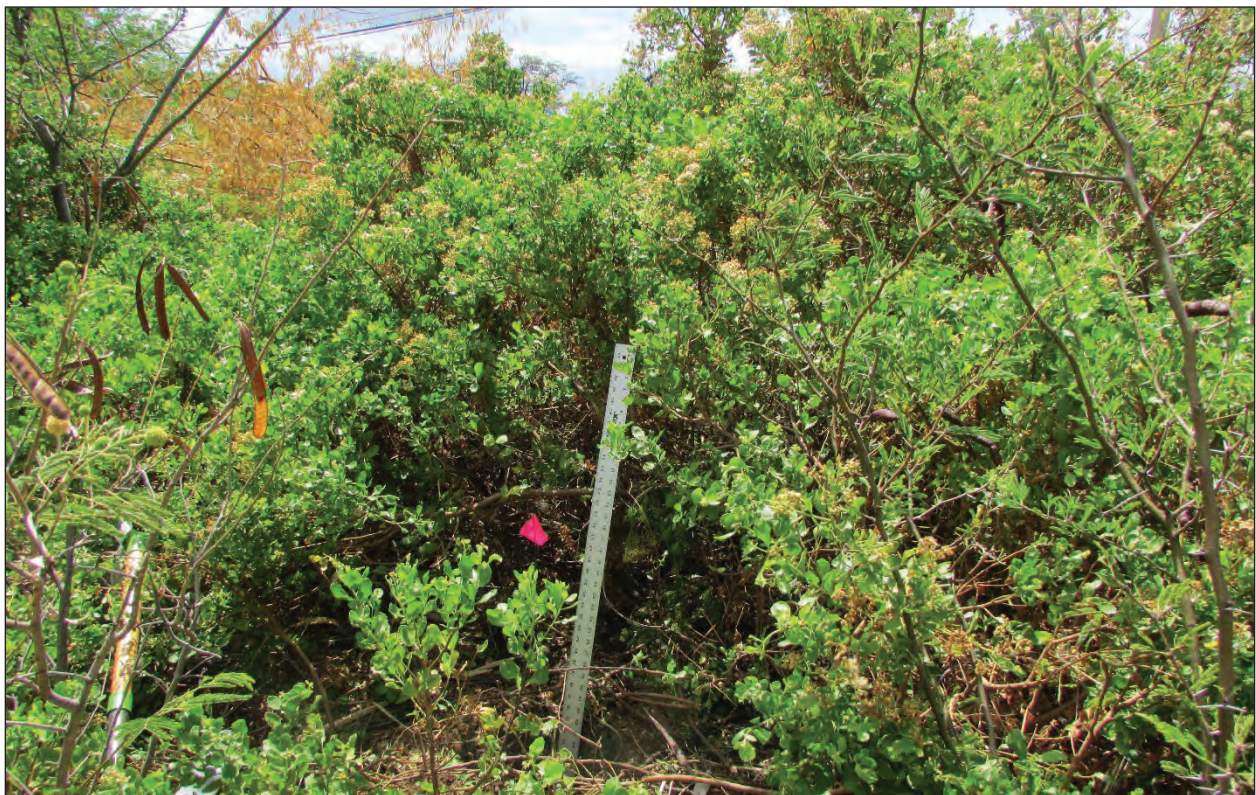
Photo 50. Dominated by Facultative *Pluchea* sp. but Did Not Meet Three Parameter Wetland Criteria

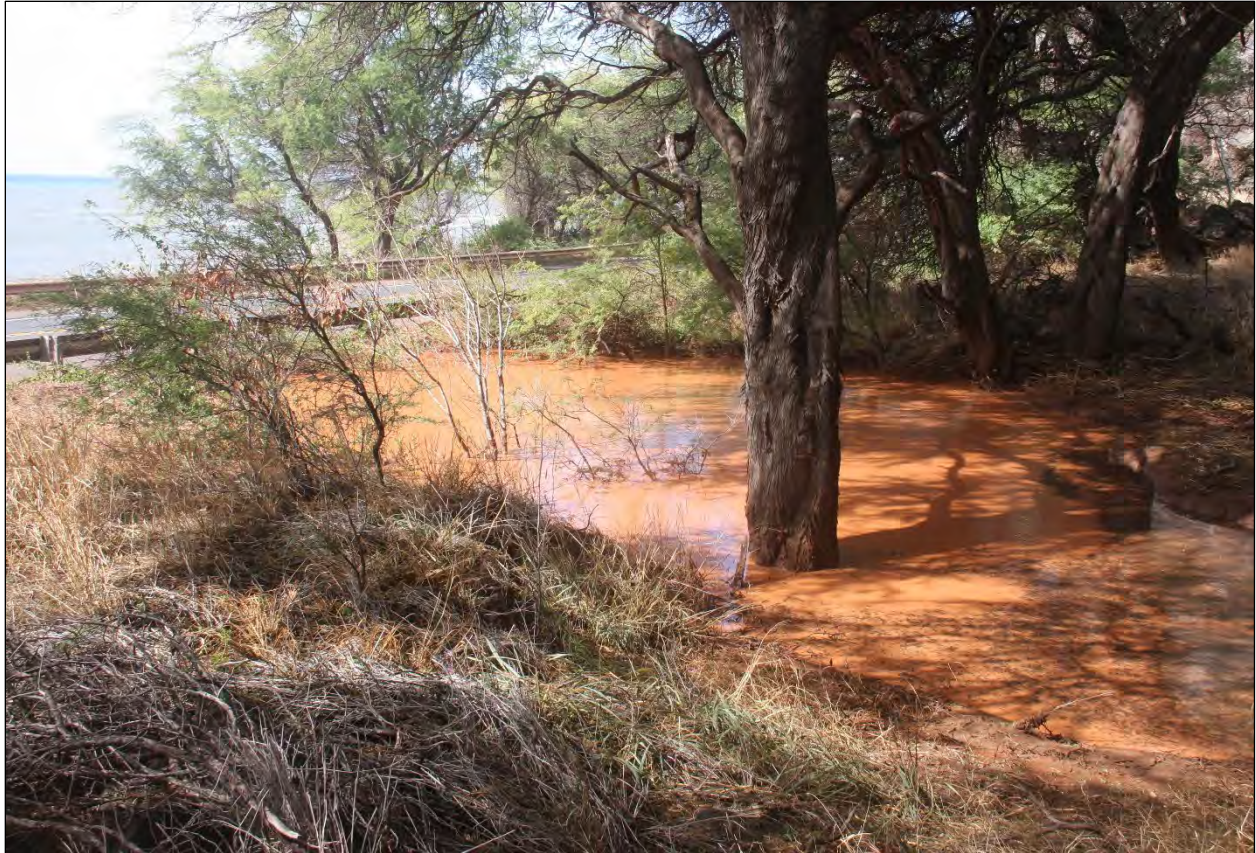
Photo 51. Ponded and Backed Up Stream on December 20, 2022 Following Heavy Rains

Manawaipueo Stream is a seasonal drainage. On December 20, 2022, and on January 3, January 2023, there was standing water in the gulch overlapping the study area (Appendix D, Figures 51; DLNR 2022). Later, on March

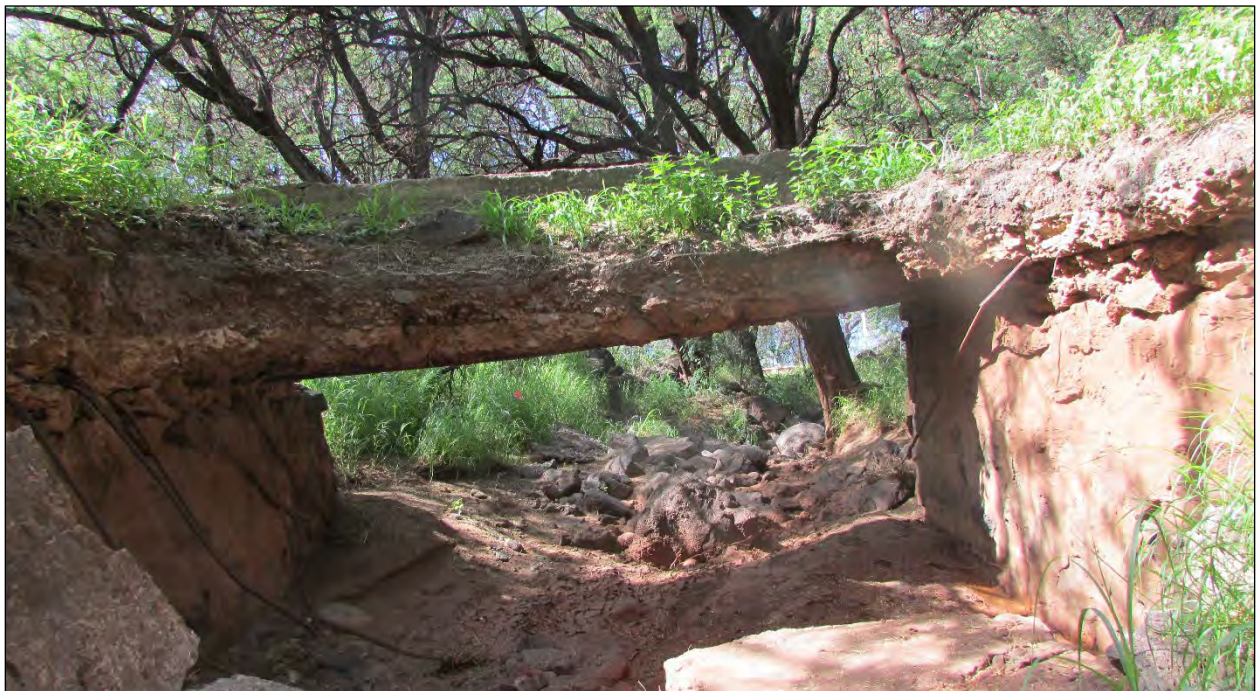
Photo 52. Remnant of an Old Concrete Bridge at the Upper (Eastern) End of the Stream in the Study Area. [Water and sediment staining used to identify the OHWM level here.]

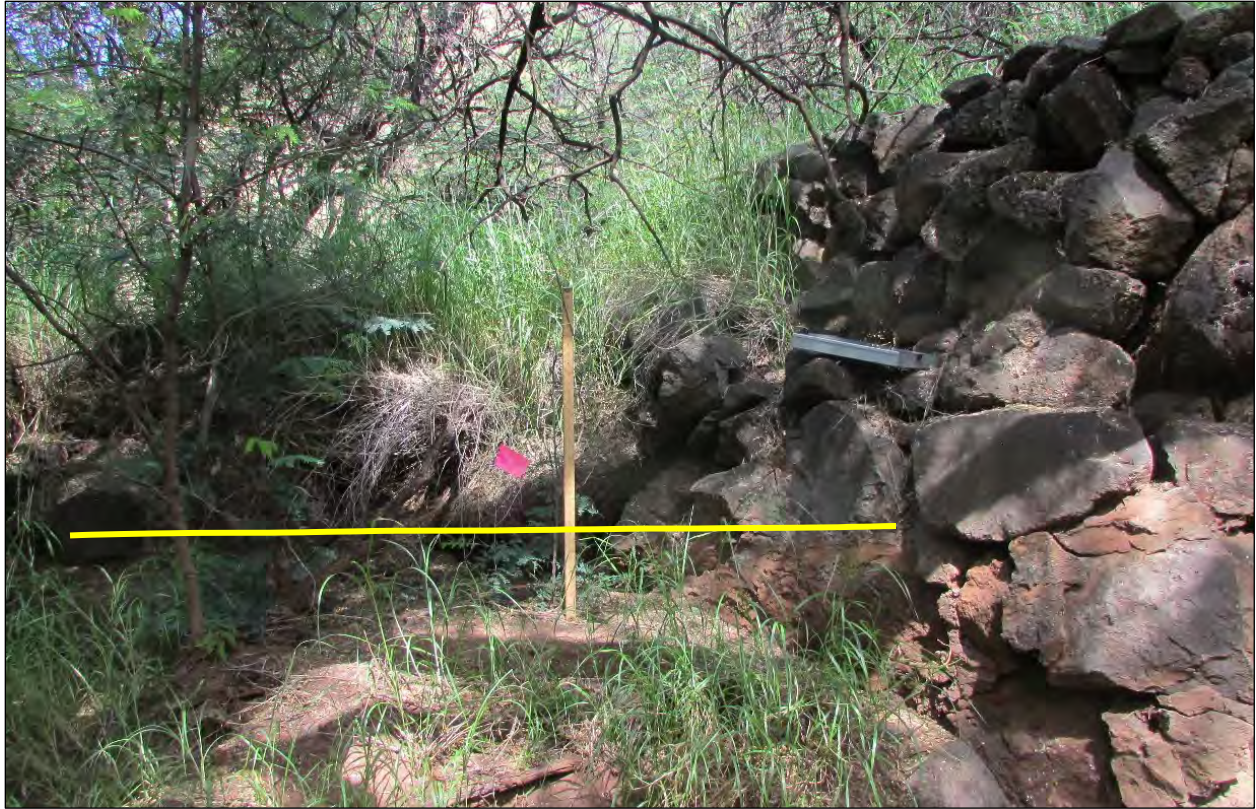
Photo 53. Location of Transect 1; Sediment/Water Staining on the Rocks at the OHWM and Wracking of Debris Above the OHWM were Used to Mark the OHWM Level Here

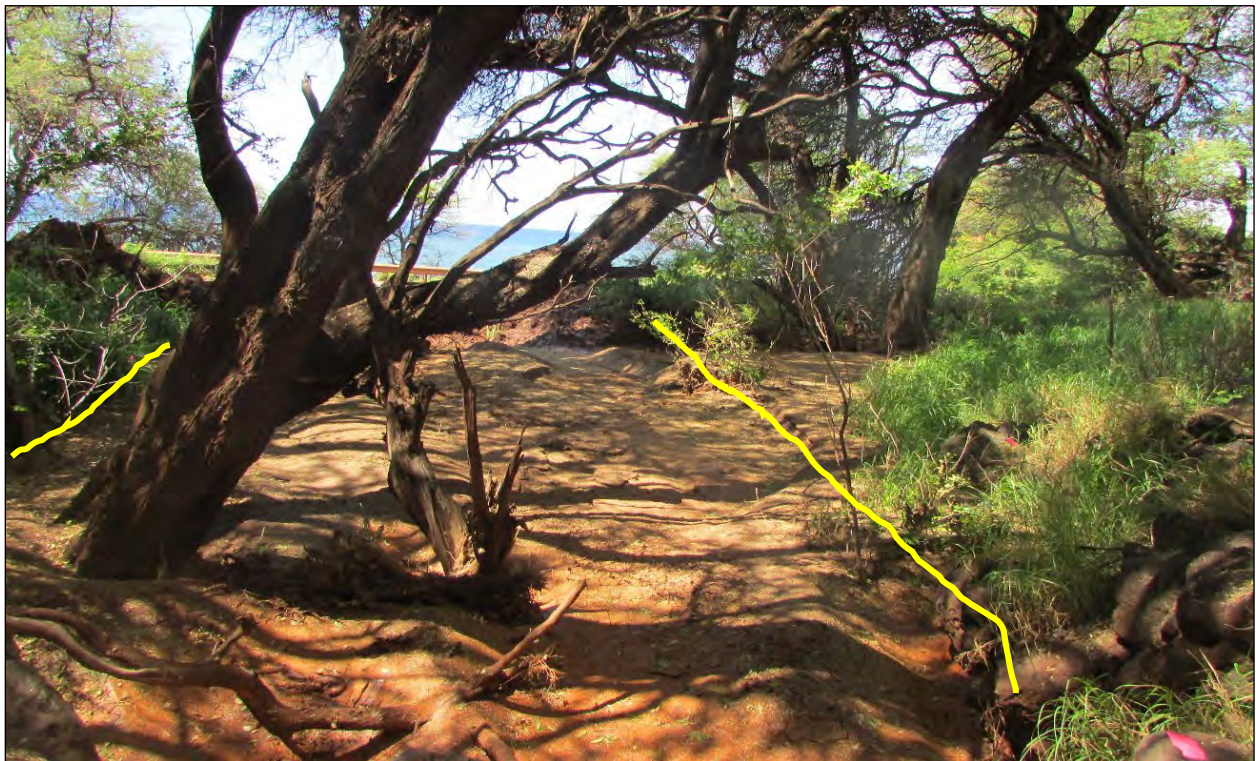
Photo 54. Location of Transect 2; Placed Where Indicators Such as Vegetation Destruction were Selected to Mark the OHWM Level

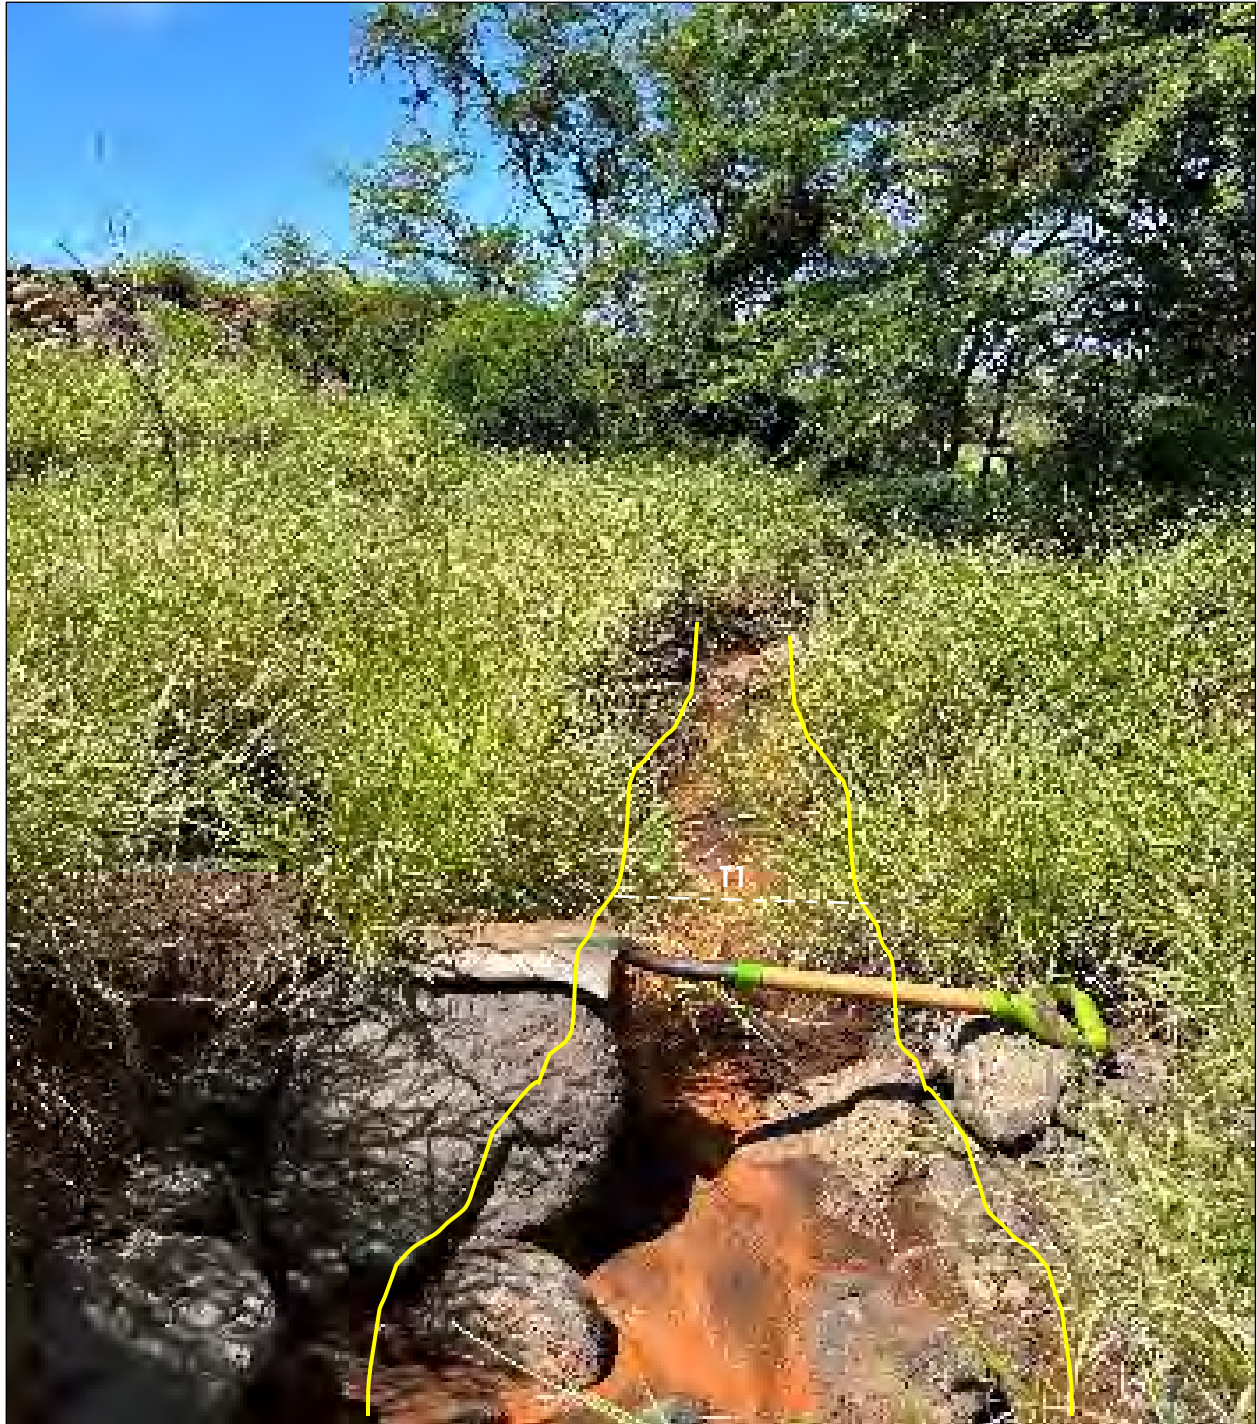
Figure 55. Papalaua Gulch – Location of Transect 1 on Southern Unnamed Stream; Stream Flow Here is in the East West Direction Before it Turns North Along the Raised Berm of the Sedimentation Basin

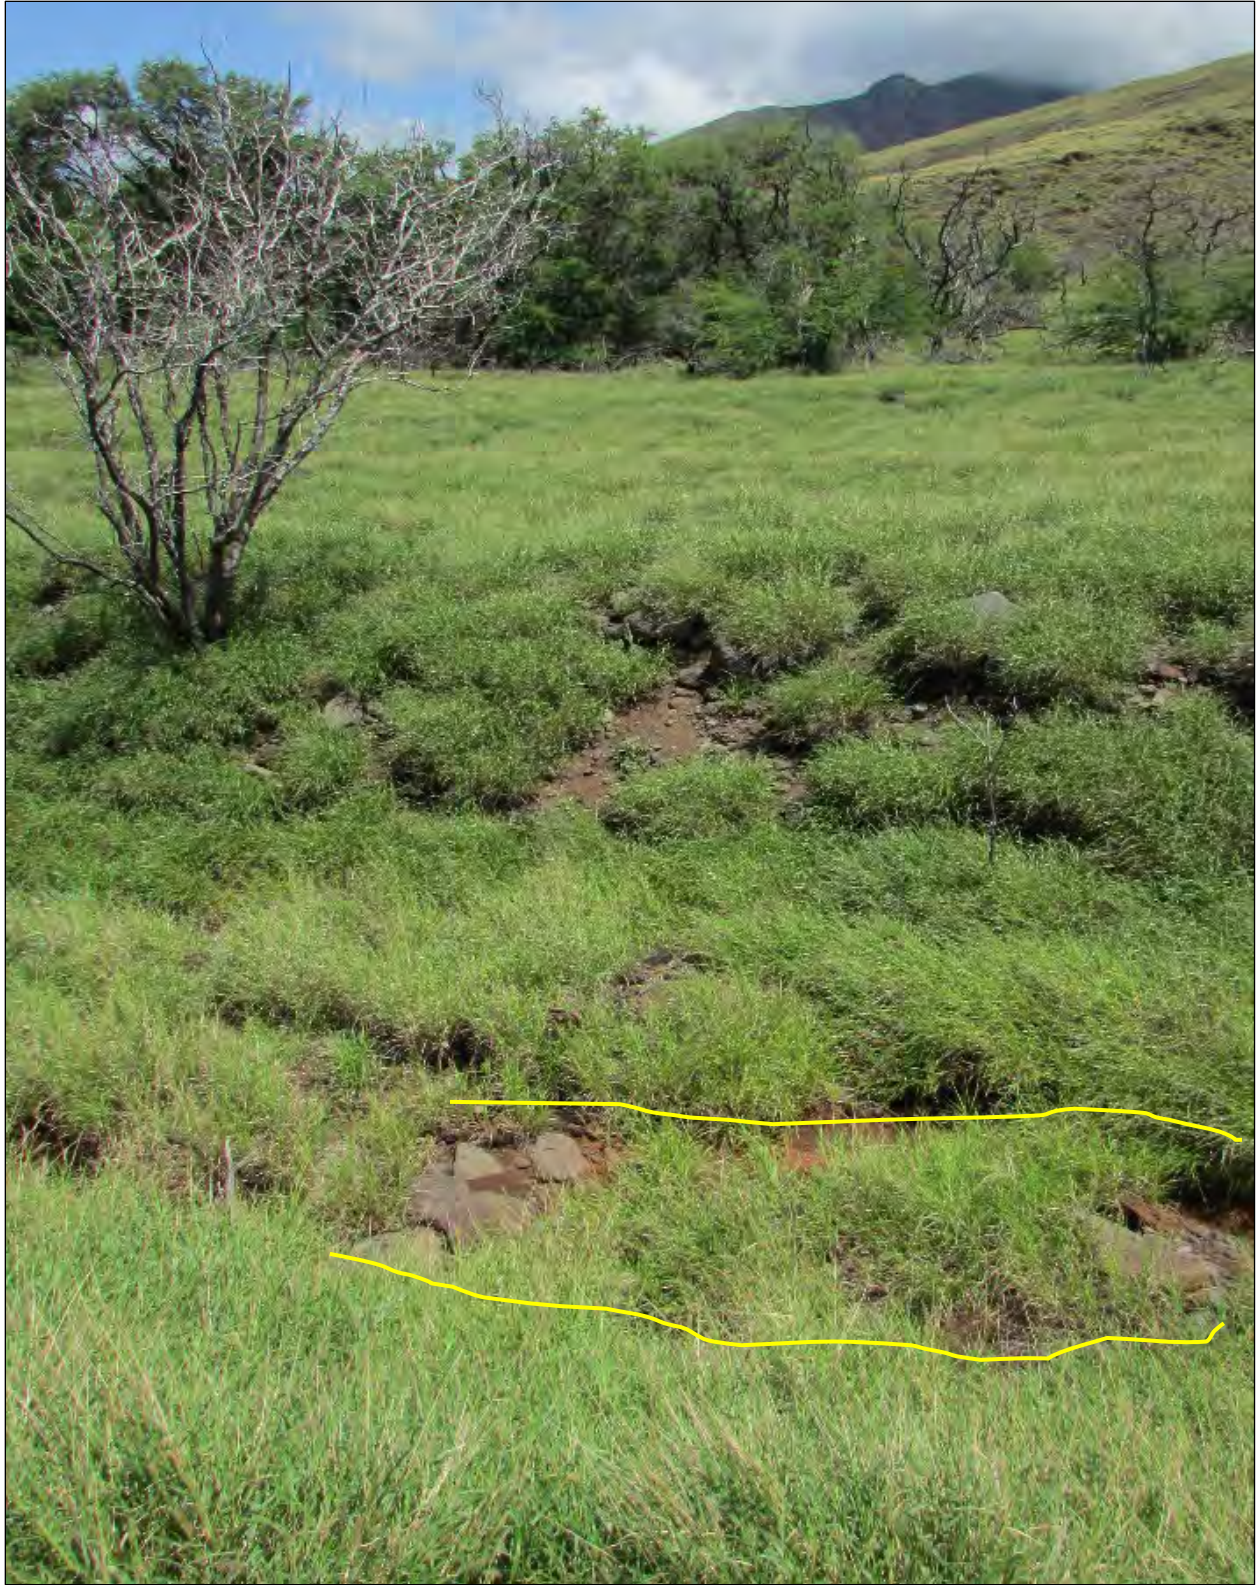
Figure 56. Papalaua Gulch Southern Unnamed Stream; Stream Flow Here is in the North South Direction Parallel to the Raised Berm of the Sedimentation Basin (Break in Bank was Much Above the OHWM Elevation as Indicated by Sediment Sorting)

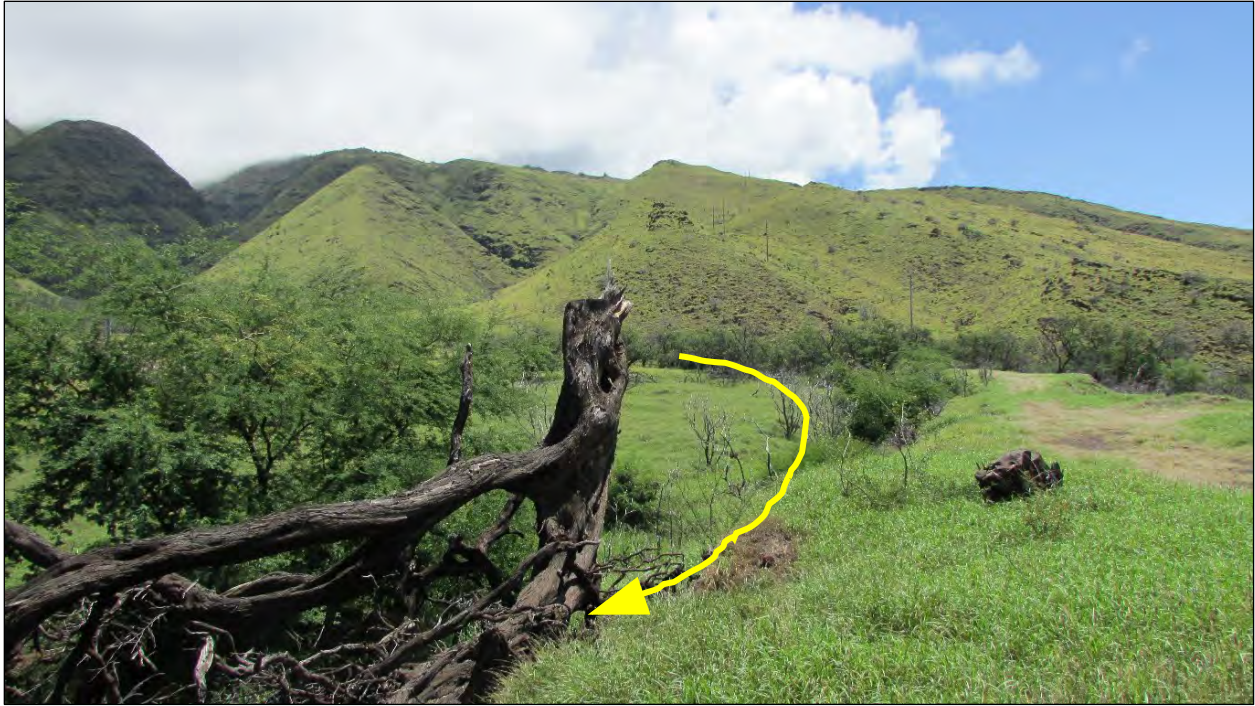
Figure 57. General Direction of Flow of the Papalaua Gulch Unnamed Southern Stream

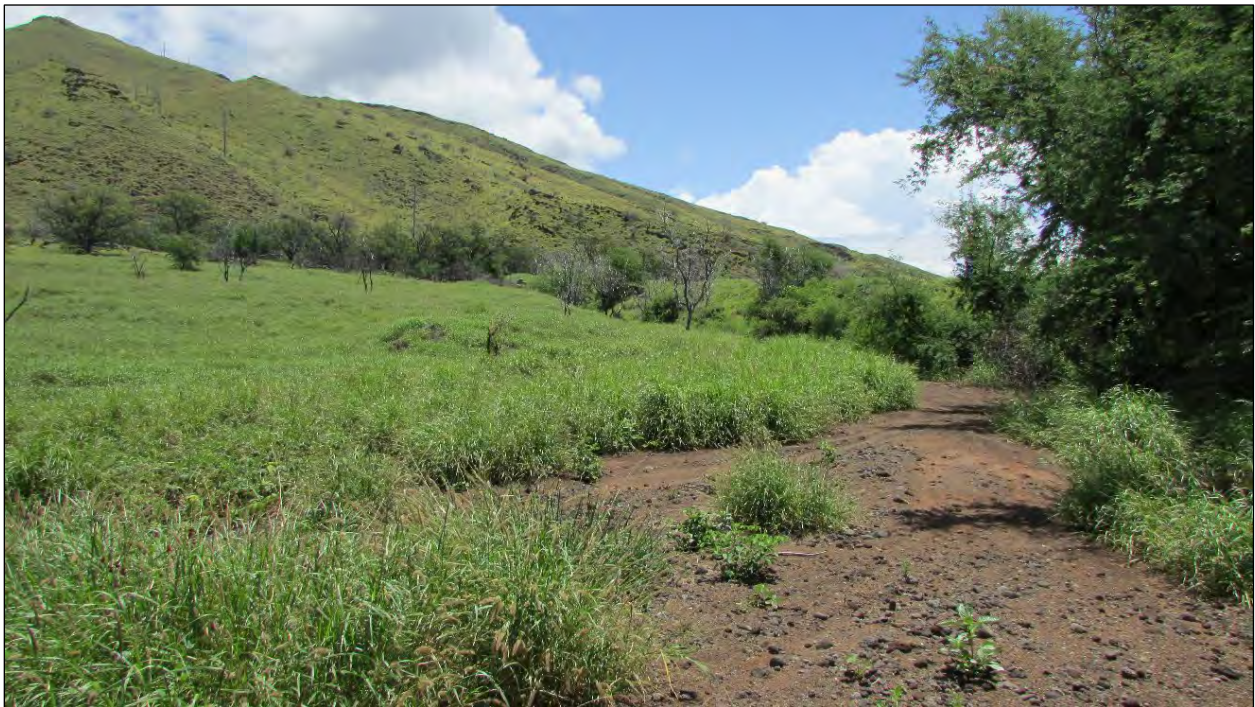
Figure 58. Alluvial/Sediment Fan Created by the Papalaua Gulch Unnamed Southern Stream

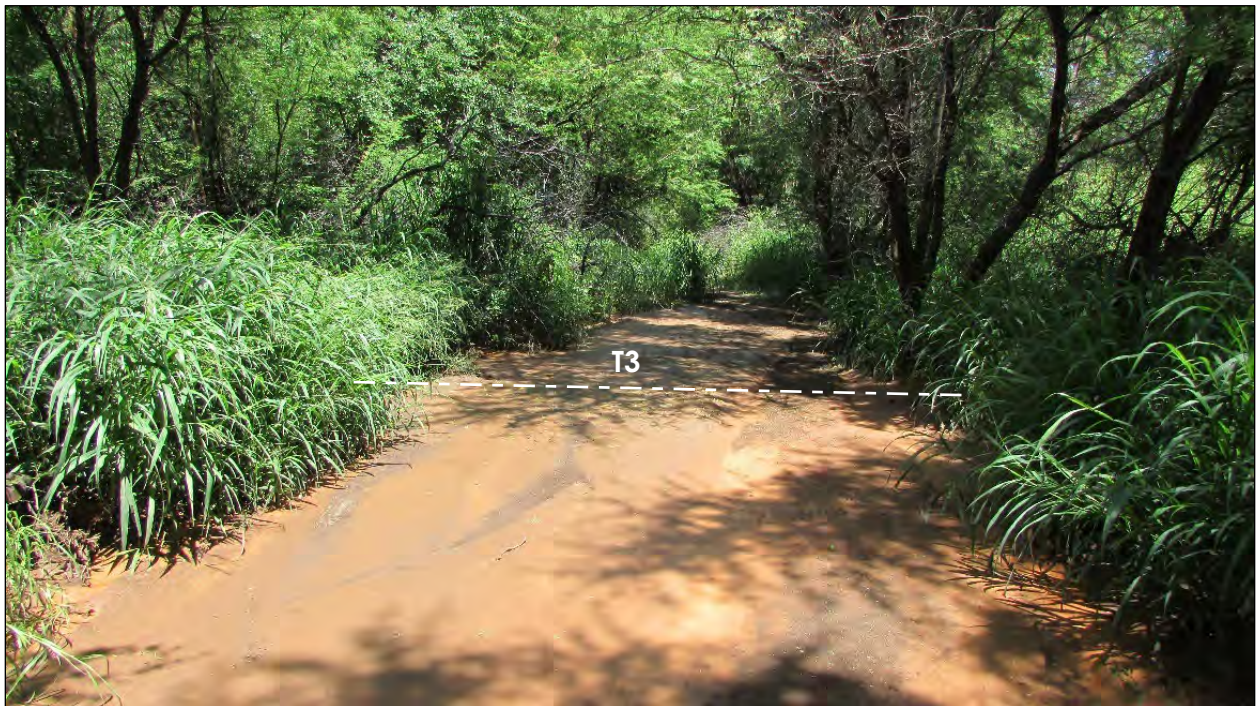
Figure 60. Papalaua Gulch – Location of Transect 3; Unvegetated Alluvial Fan Leading to the Sediment Basin (Looking south, the Northward Flow Runs Parallel to the Western Berm of the Sedimentation Basin [not seen here])

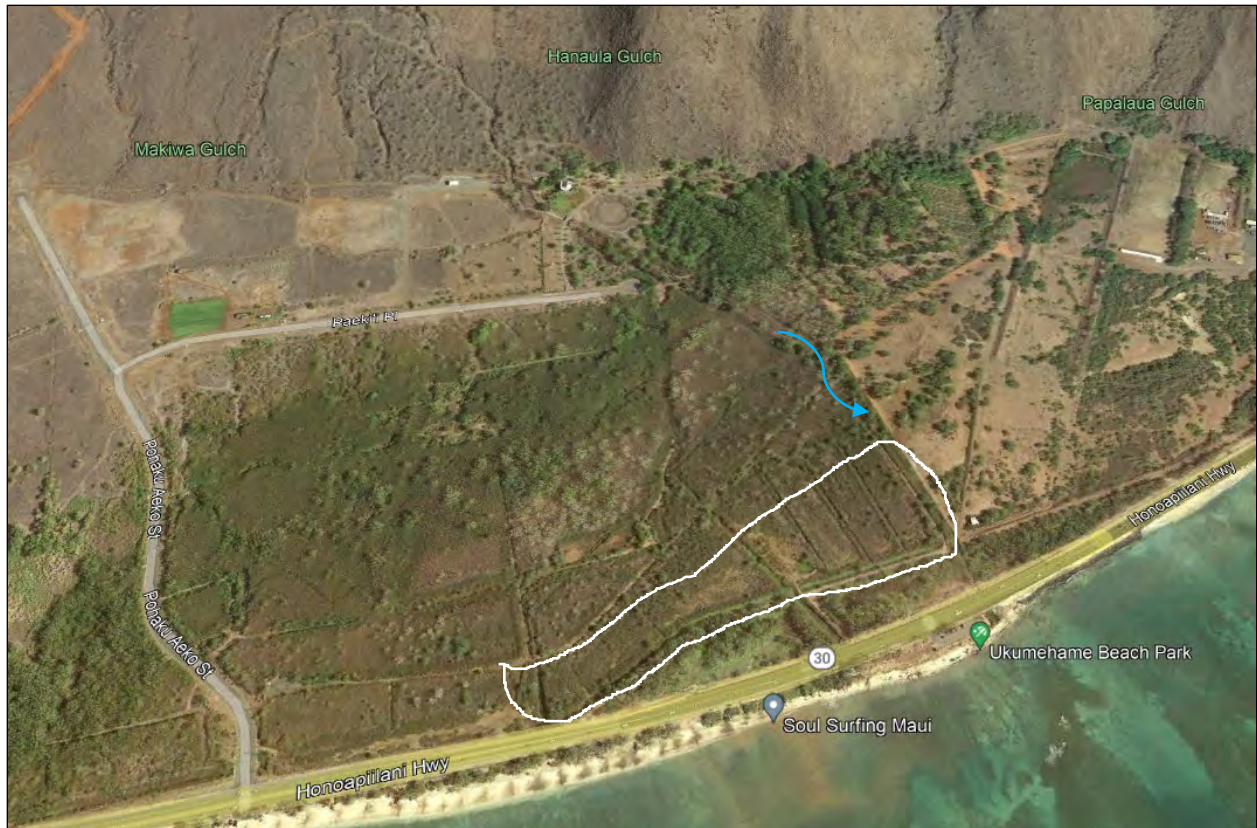
Photo 61. Google Earth Imagery - Hanaula Gulch (Blue Arrow) and Associated Ditches. D1 to D7 (While Outline) [Landscape View of Hanaula Stream Flow into the Ditch (Blue Arrow) that Runs Parallel to the Northern Boundary of Ukumehame Firing Range]

Immediately to the north of the Ukumehame Firing Range, there are a series of ditches (Figure 7, Ditches 1 to 7), remnant from when these lands were under sugar plantation, that are interconnected (Figure 7, Appendix D, Photos 61-64). Hanaula Gulch supports the hydrology of this ditch system and the associated wetlands described above in Section 3.3. Hanaula is a seasonal drainage (DLNR 2022) and during the winter rains or following a heavy rain event, this 20-foot wide gulch with high banks, that runs parallel to the northern fence line of the Ukumehame Firing Range (Appendix D, Photo 62) carries water through a culvert under the existing Honoapiilani Road into the Pacific Ocean (Figure 7). At the western end, this ditch is connected to another ditch (D7) via a three-foot plastic culvert and stretches for about 0.25 miles in a north-south direction (perpendicular to the stream flow) (Appendix D, Photo 63). Six additional ditches run parallel to each other and are connected to this long ditch (D7) that runs in the north-south direction. Ditches 1 to 5 were relatively narrow, about six feet across. At the time of the survey there was little to no water in these ditches, but the
