HONOAPI'ILANI HIGHWAY IMPROVEMENTS PROJECT,  
WEST MAUI: UKUMEHAME TO LAUNIUPOKO

# Appendix 3.9 – Water Resources, Wetlands, and Floodplains - Supplemental Information

**Honoapiilani Highway Improvement Project  
Preliminary Identification of Waters of the United States  
Technical Report**

**Project # 4692-02**

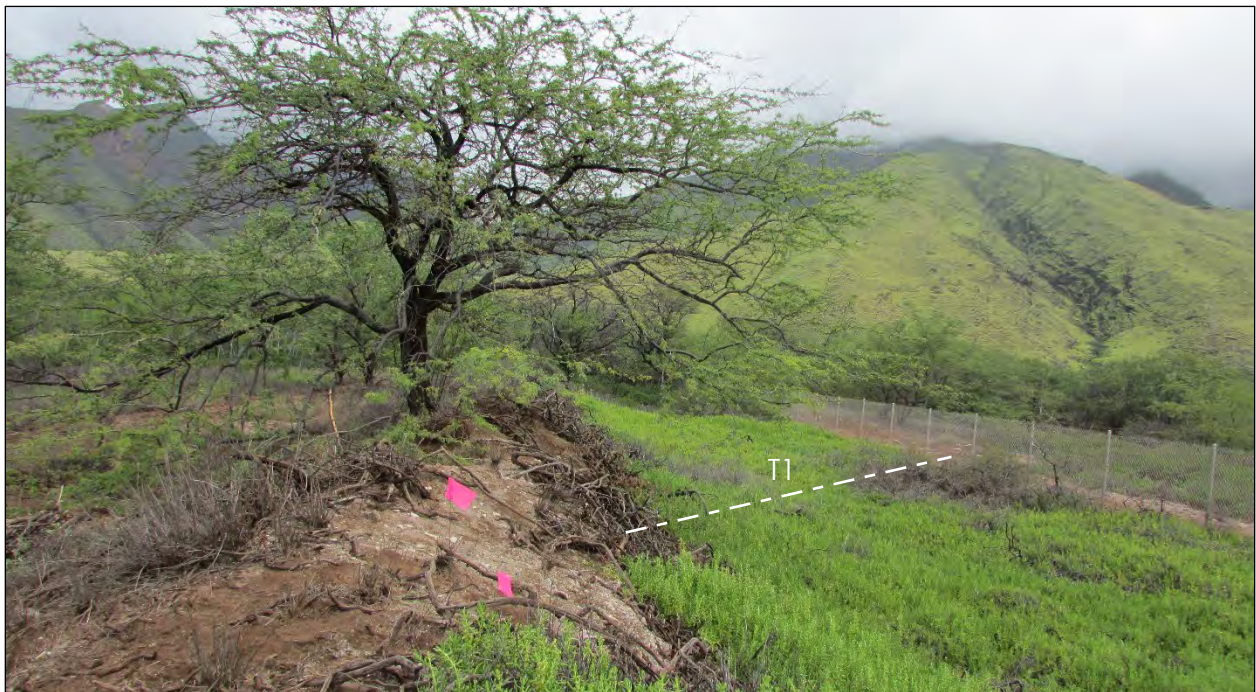
Photo 62. Hanaula Gulch and Ditch Next to Ukumehame Firing Range Fence in the Study Area. Location of Transect 1 to Identify the OHWM Line

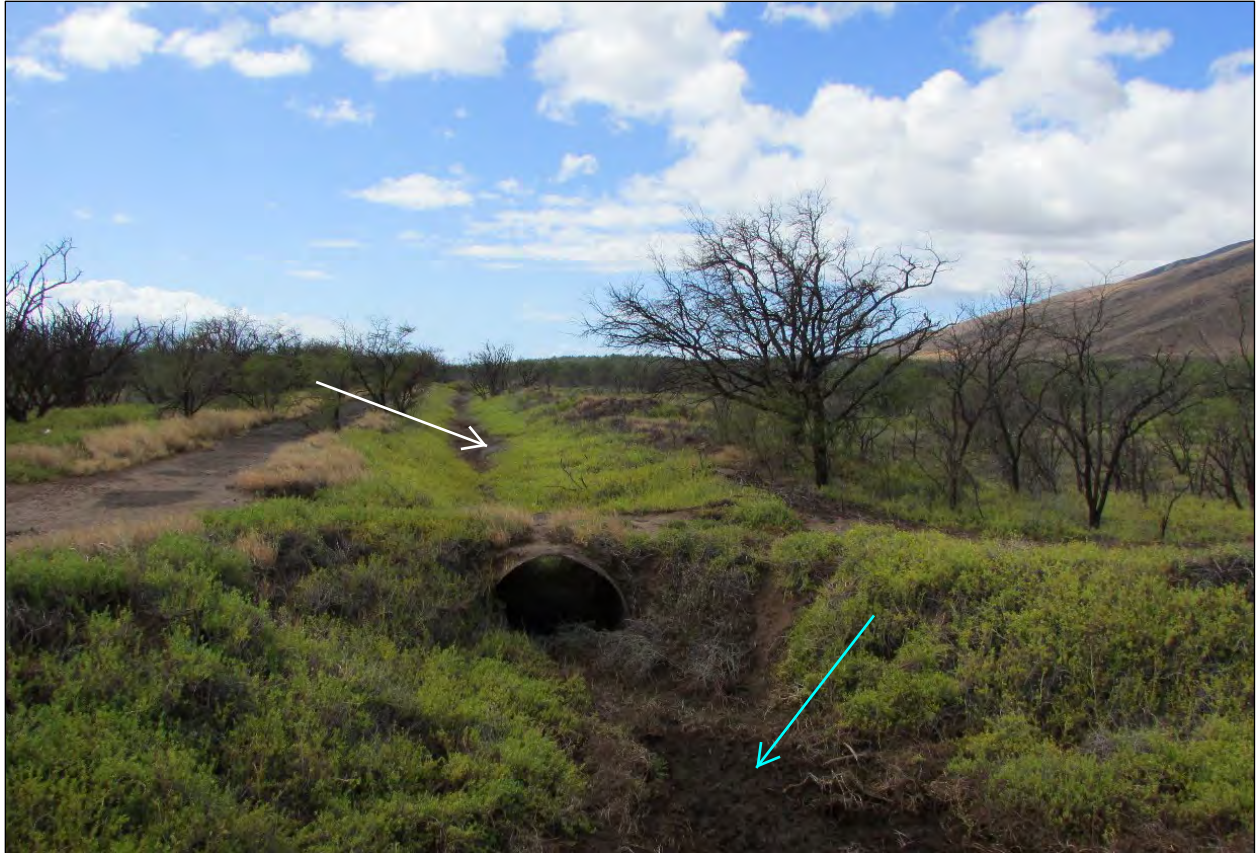
Photo 63. Culvert Connecting the North-South Ditch 7 (White Arrow) to the Hanaula Gulch (Blue Arrow)

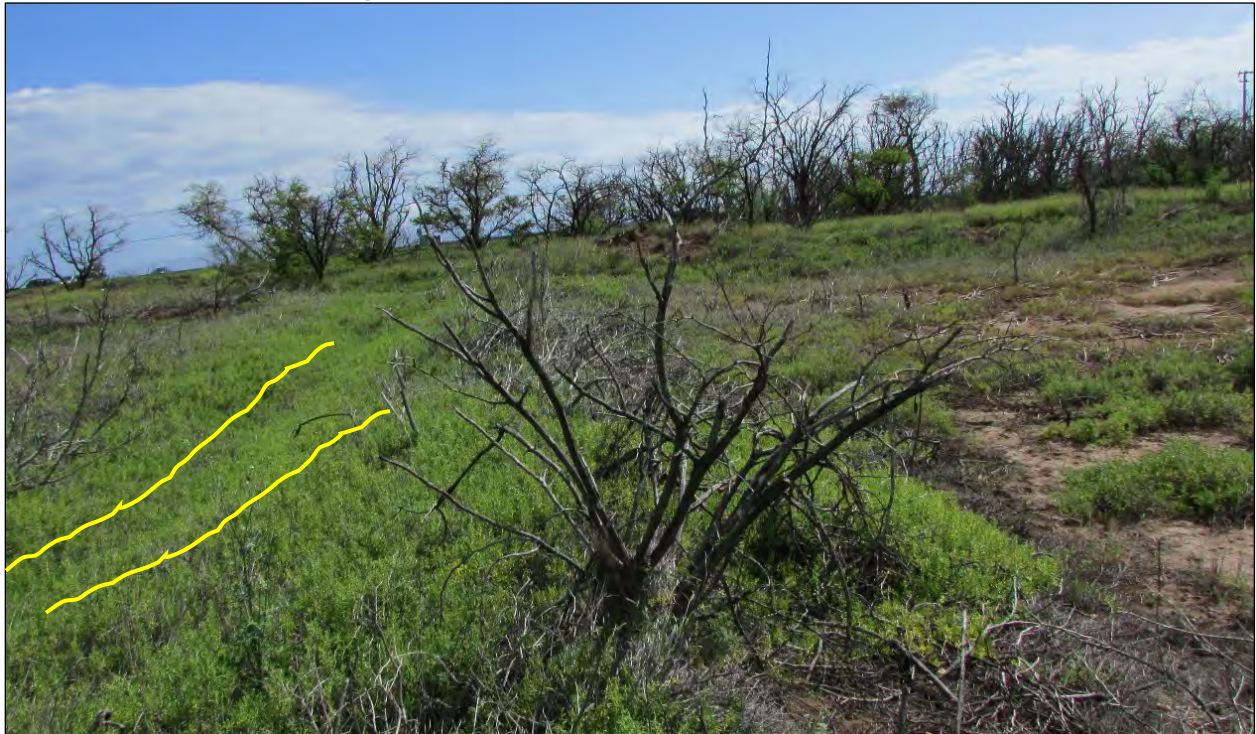
Photo 64. Dense Growth of Pickleweed Made it Challenging to Identify the OHWM Level. [Break in slope was a weak indicator of the OHWM in many places.]

Dense growth of pickleweed in the ditches made it challenging to identify the OHWM level. Some ditches that recently carried water had a clean line of dead vegetation in the center of the bed. In some other ditches where the pickleweed was not very dense, prominent mud cracks were visible. These indicators were used to place the OHWM elevation at the ditches.

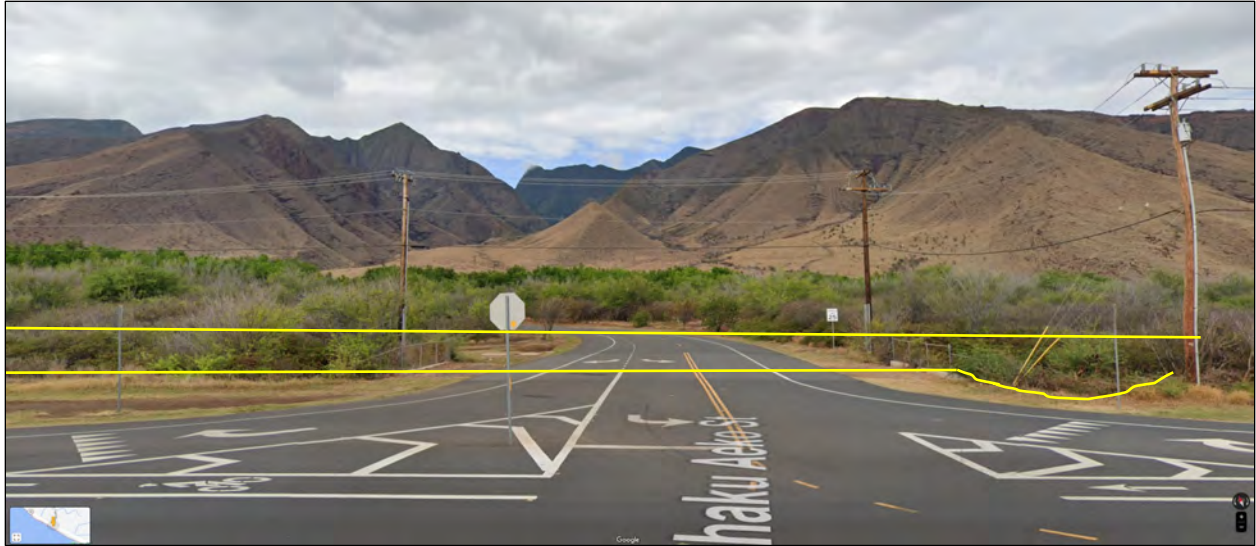
**Photo 65. Ditch 8 at Pohaku Aeko Street.** [Ditches on Either Side of Pohaku Aeko Street Are Connected Via a Concrete Culvert. Also, the Ditch to the South [Right] of the Road Flows Under the Existing Highway into the Pacific Ocean.]

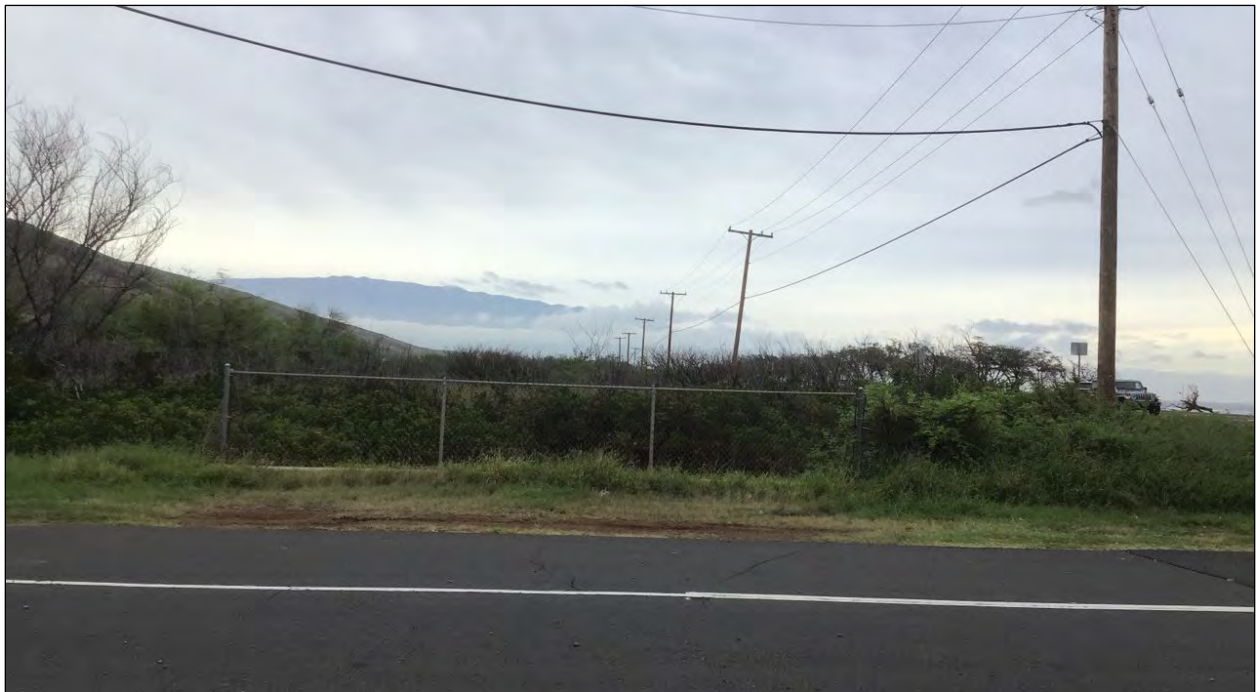
**Photo 66. Fence Lining the Concrete Culvert at Pohaku Aeko Street – View to the South.** [Location of Transect 1 Where the Edge of Culvert was Used to Identify the OHWM Elevation at this Aquatic Feature]

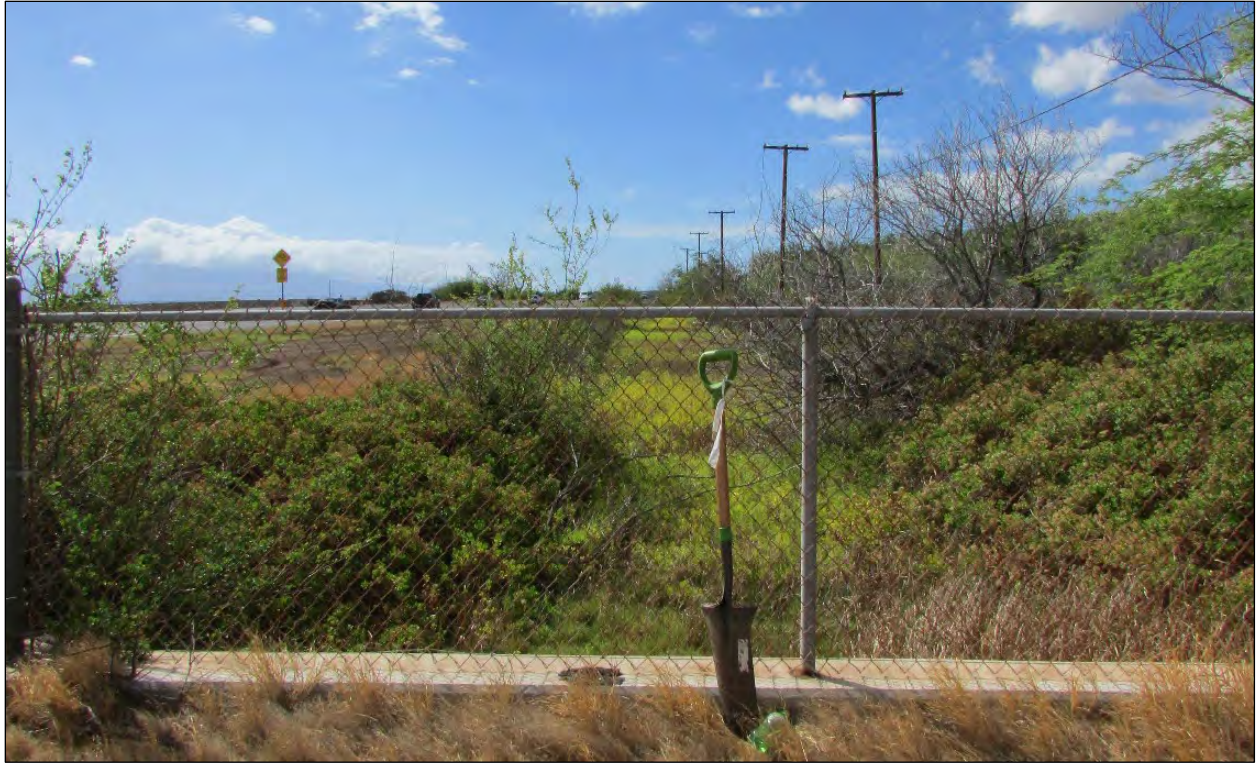
Photo 67. Fenced in Culvert and Ditch 8 at Pohaku Aeko Street – View to the North

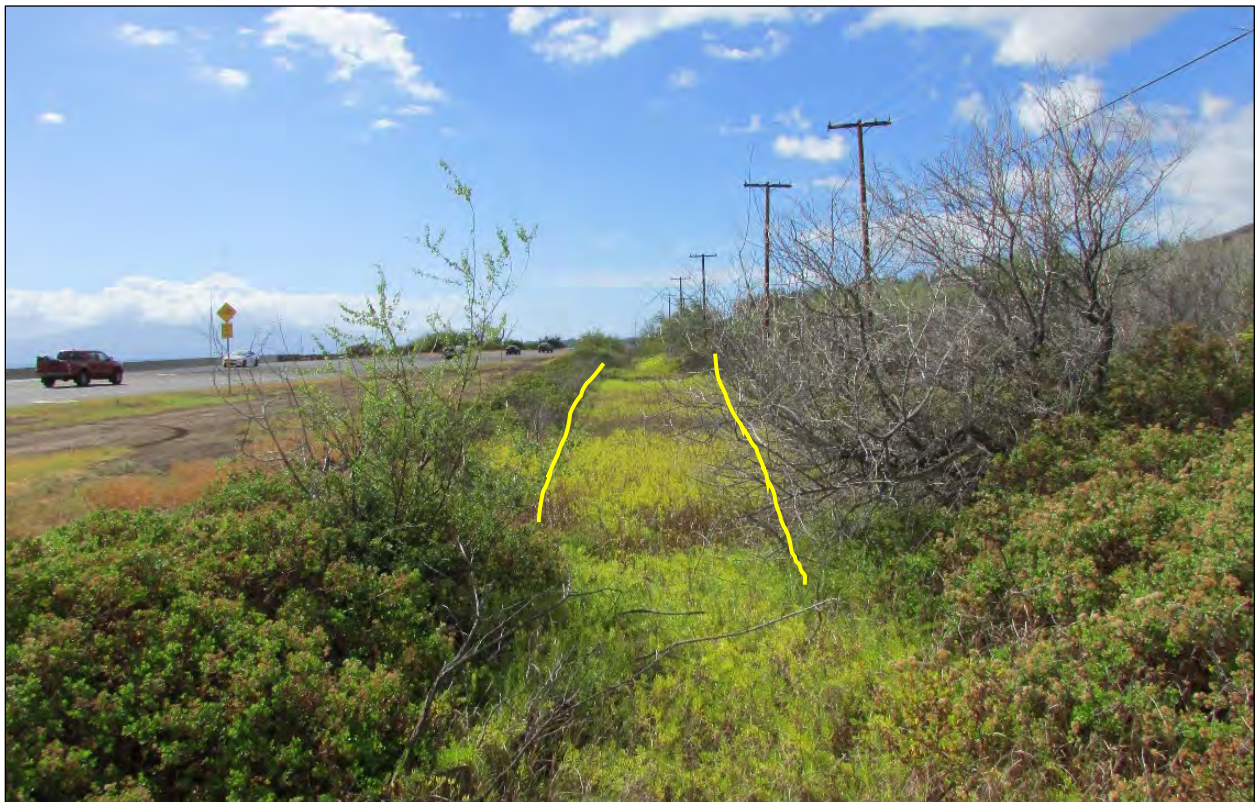
Photo 68. Location of Transect 2; Placed Where Change in Vegetation from Obligate to Facultative was Used to Mark the OHWM Level

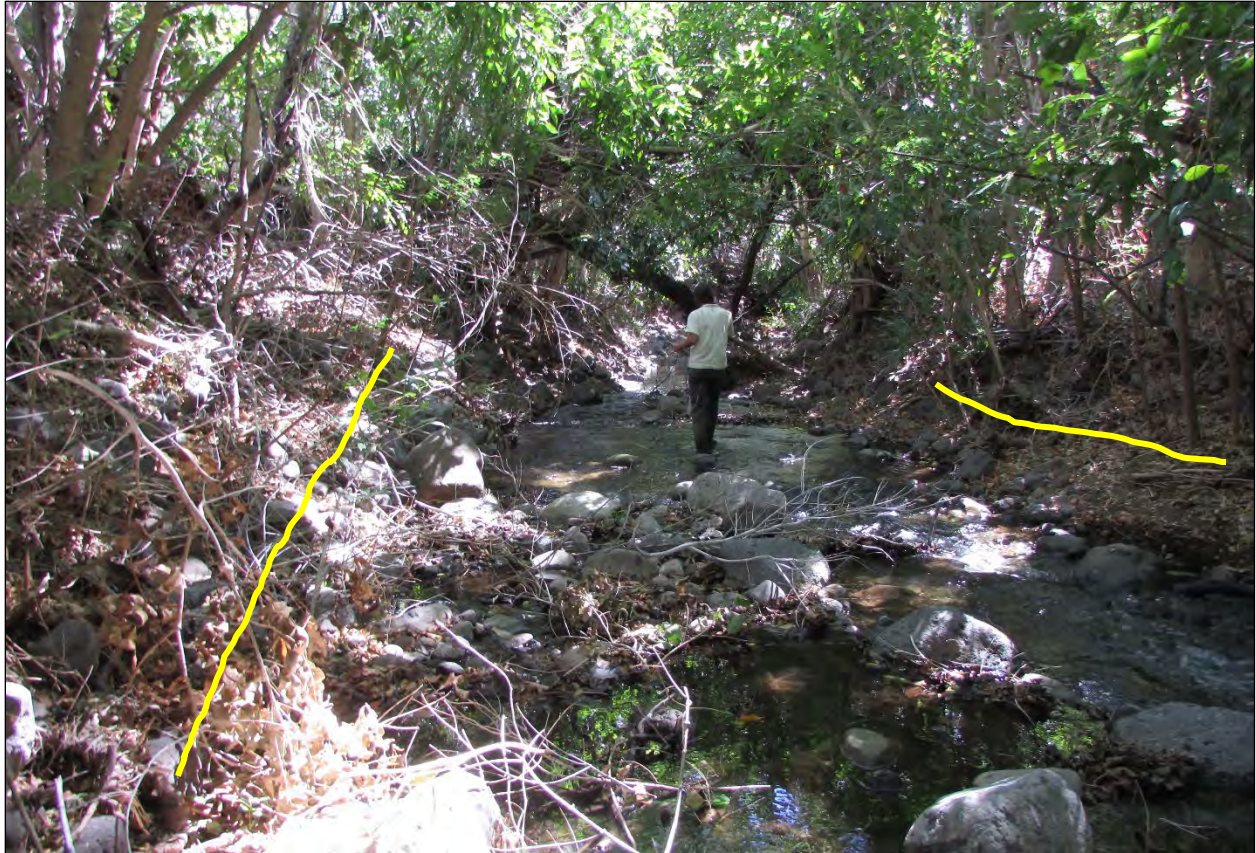
Photo 69. Location of Transect 1; In the Upper Reach of Ukumehame Stream Overlapping Build Alternative 4

Transect 1 is representative of the uppermost reach of the stream. OHWM level selected at elevation clearly showing the undercut banks with exposed roots and shelving on top of bank. Transect 2 is representative of the middle reach of the stream where sediment sorting from boulders to finer sediment and wracking were used to identify OHWM elevation. Transect 3 is representative of the lowermost reach of the stream where the width of the bridge and the water staining on the concrete were used to identify the OHWM elevation.

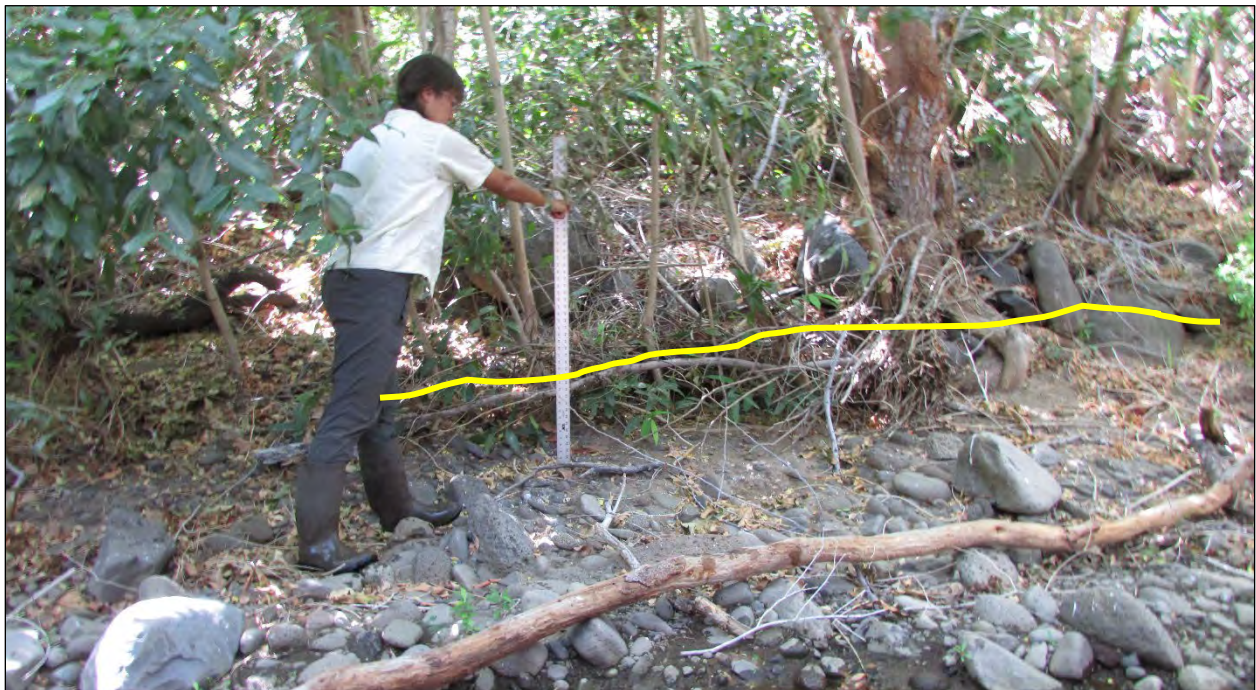
Photo 70. OHWM Level Indicators at Transect 1; OHWM Level Selected at the Elevation of Undercut Bank, Exposed Roots Below this Level, and Shelving of Debris Above the Level

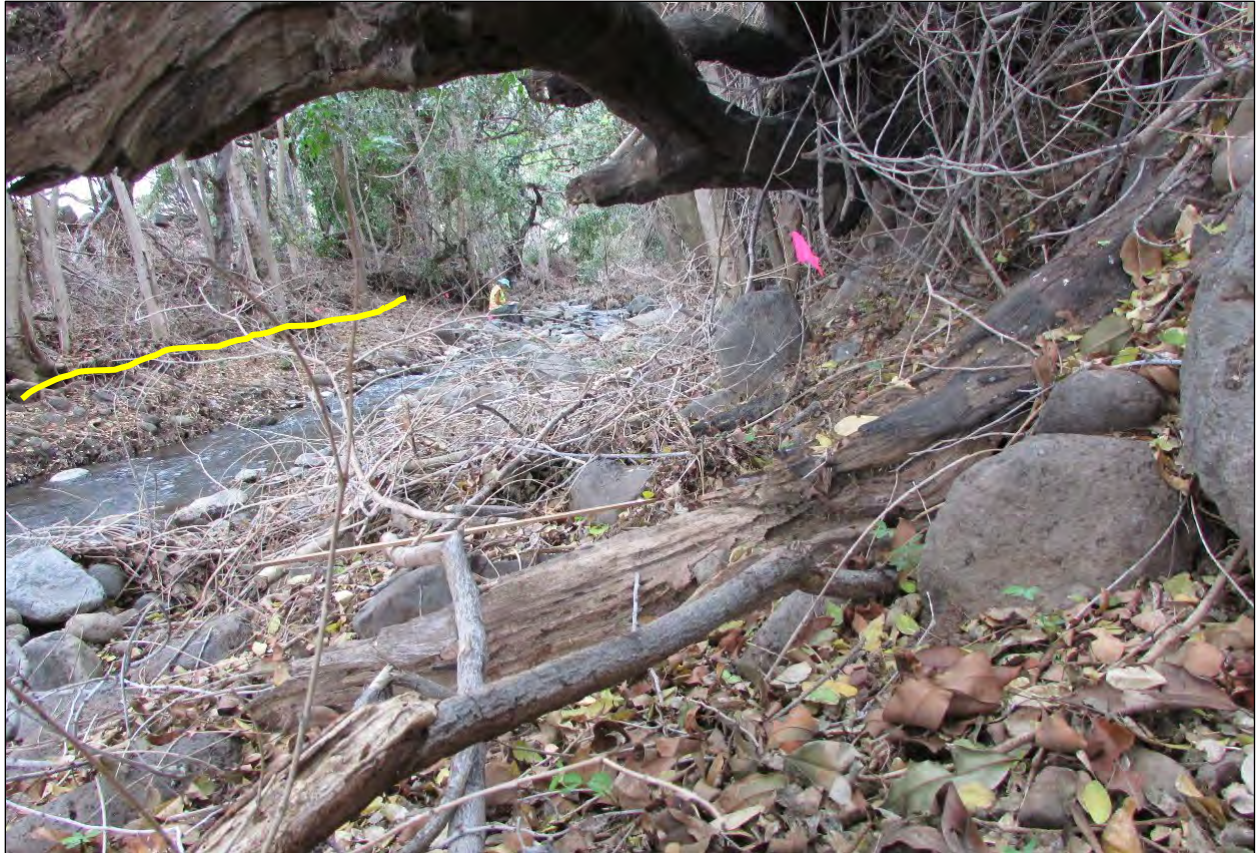
**Photo 71. Location of Transect 2 in Middle Reach of Stream; Transect Placed Where Clear Lining on the Bank was Visible at the OHWM Level Along with Sediment Sorting from Boulders to Sediment**

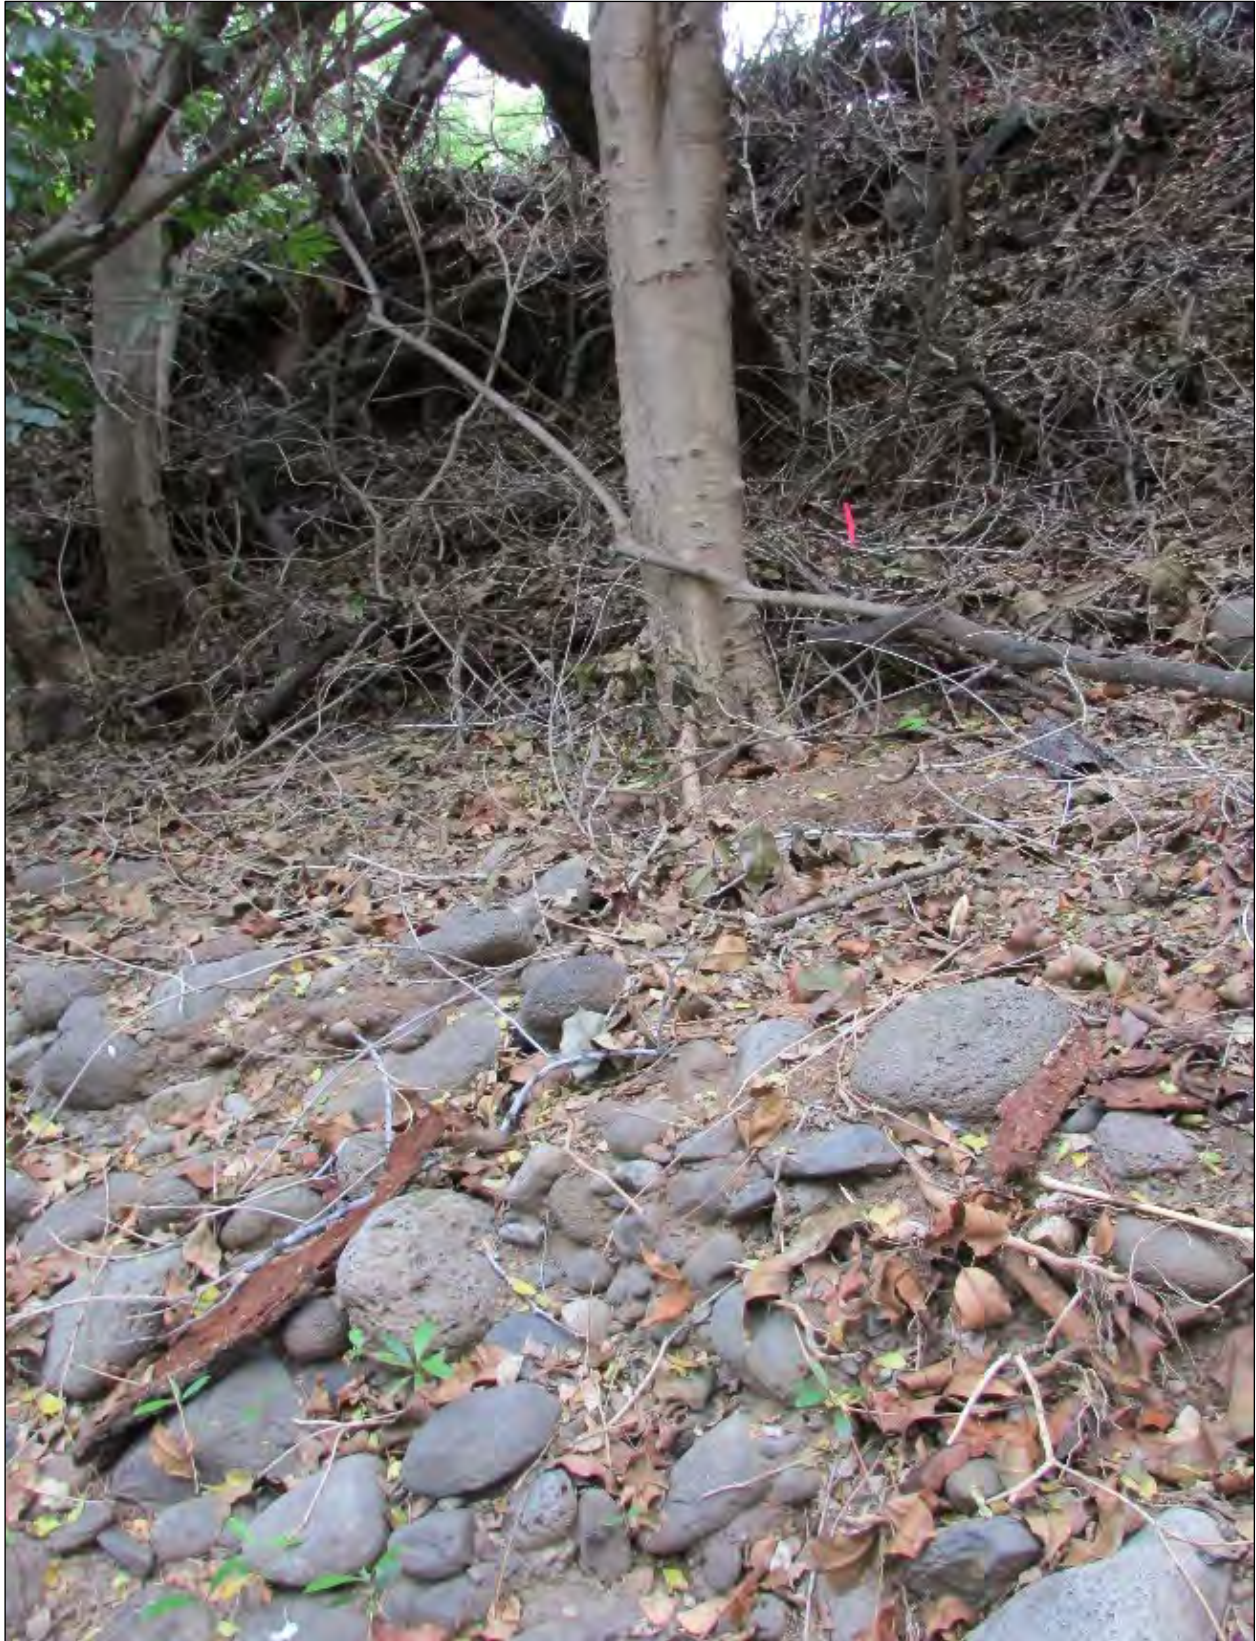
**Photo 72. Sediment Sorting at Transect 2; Sorting of Sediment from Boulders to Finer Sediment Below the OHWM and Wracking at the OHWM were Main Indicators at this Transect**

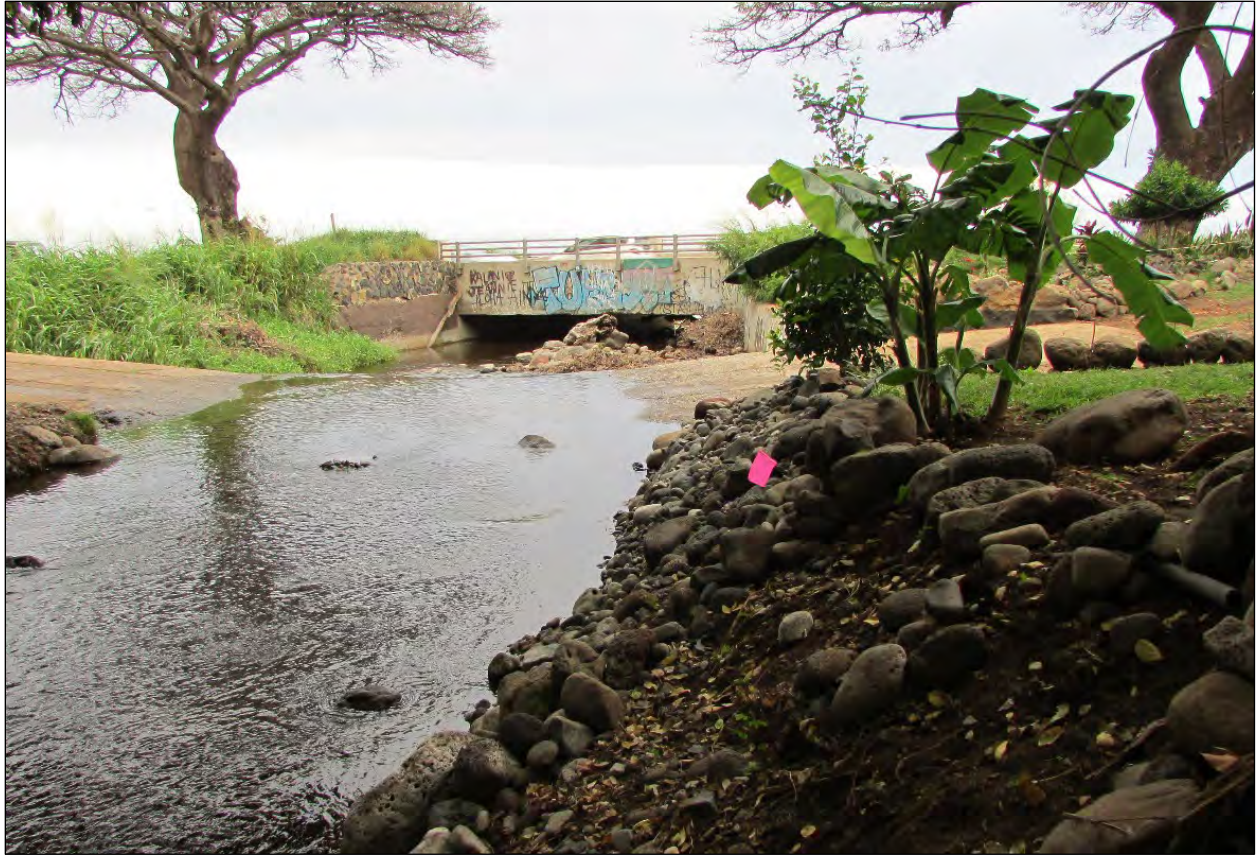
**Photo 73.** Location of Transect 3 at Lowermost Reach of Stream; Ukumehame Stream Bridge and the Concrete Ford at the Lowermost Reach (The Bridge Footing and Water Staining on the Concrete Defined the OHWM Level for this Lower Reach)

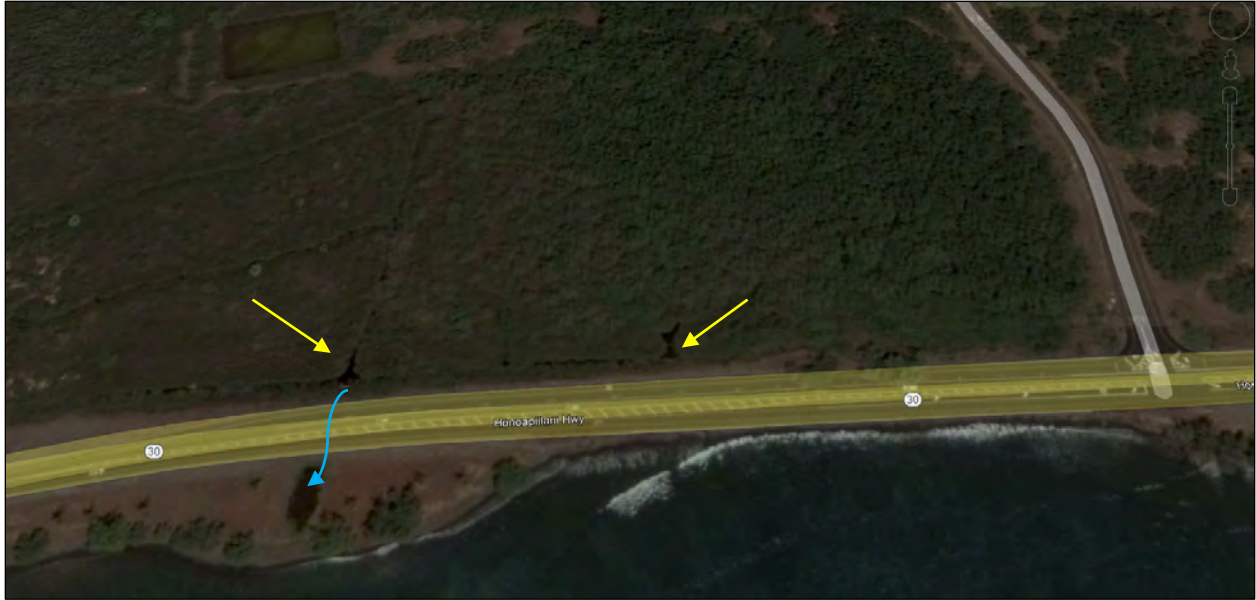
Photo 74. Imagery the Ditch (System) 9 in the Vicinity of Ehehene Street; Yellow Arrows Showing Two East-West Running Ditches that Meet the North South Running Ditch and the Connection of the Northern Ditch with the Pacific Ocean

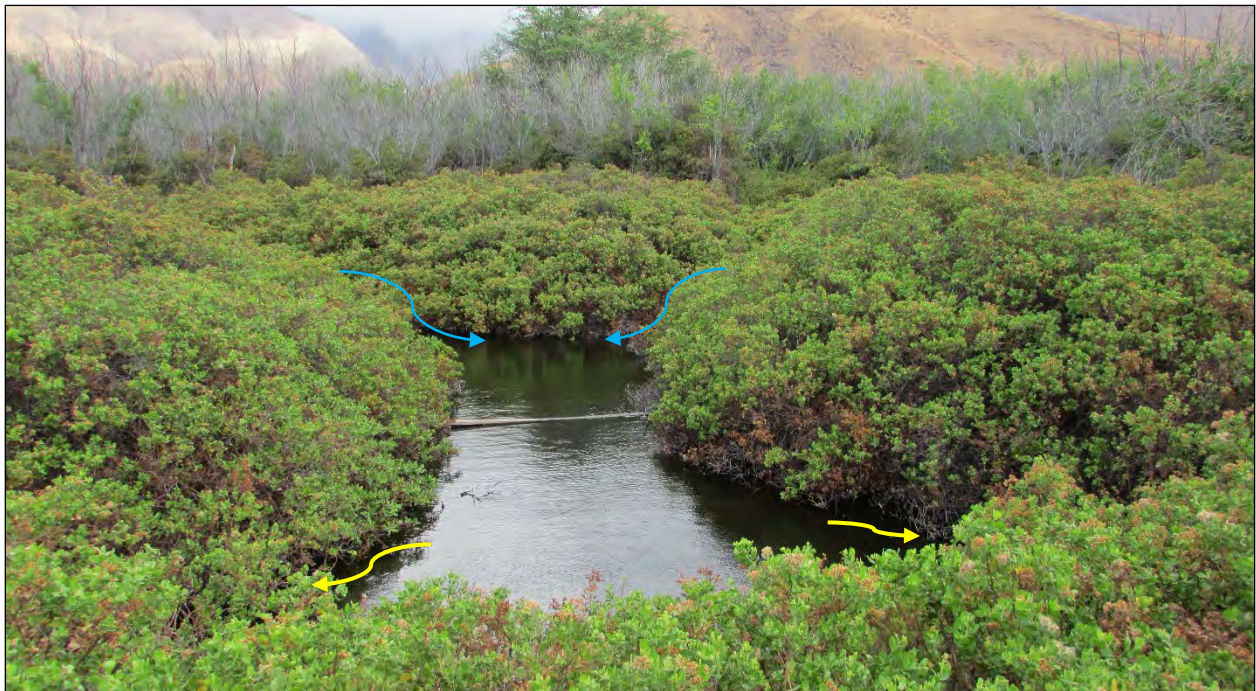
Photo 75. The Southern of the Two East-West Running Ditches in the Vicinity of Ehehene Street; Ditch is Surrounded by Thickets of Pluchea Shrubs (the Blue Arrows Indicate Smaller Ditches that Fed into this Main East-West Ditch, the Yellow Arrows Show the Connection to the North-South Ditch that Runs Parallel to the Existing Highway)

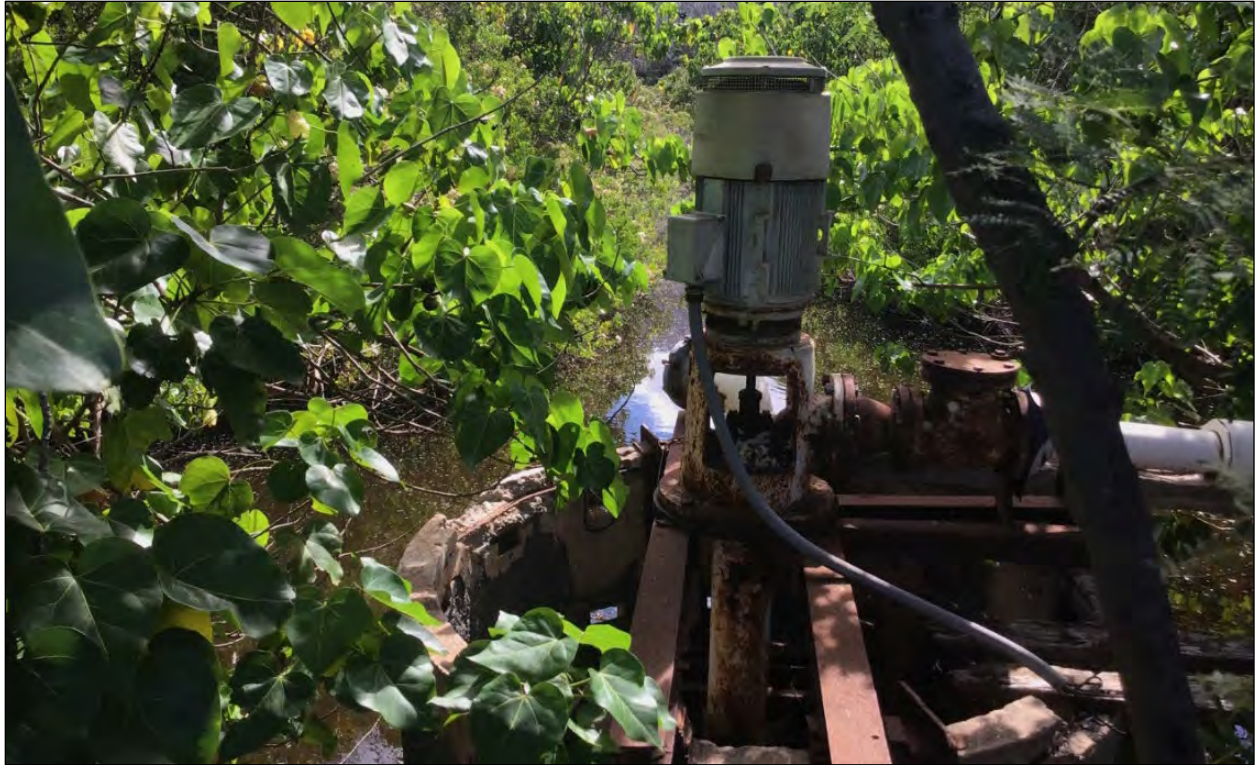
Photo 76. The Northern of the Two East-West Running Ditches in the Vicinity of Ehehene Street; Large Water Pump Remnant from the Sugar Plantation Time

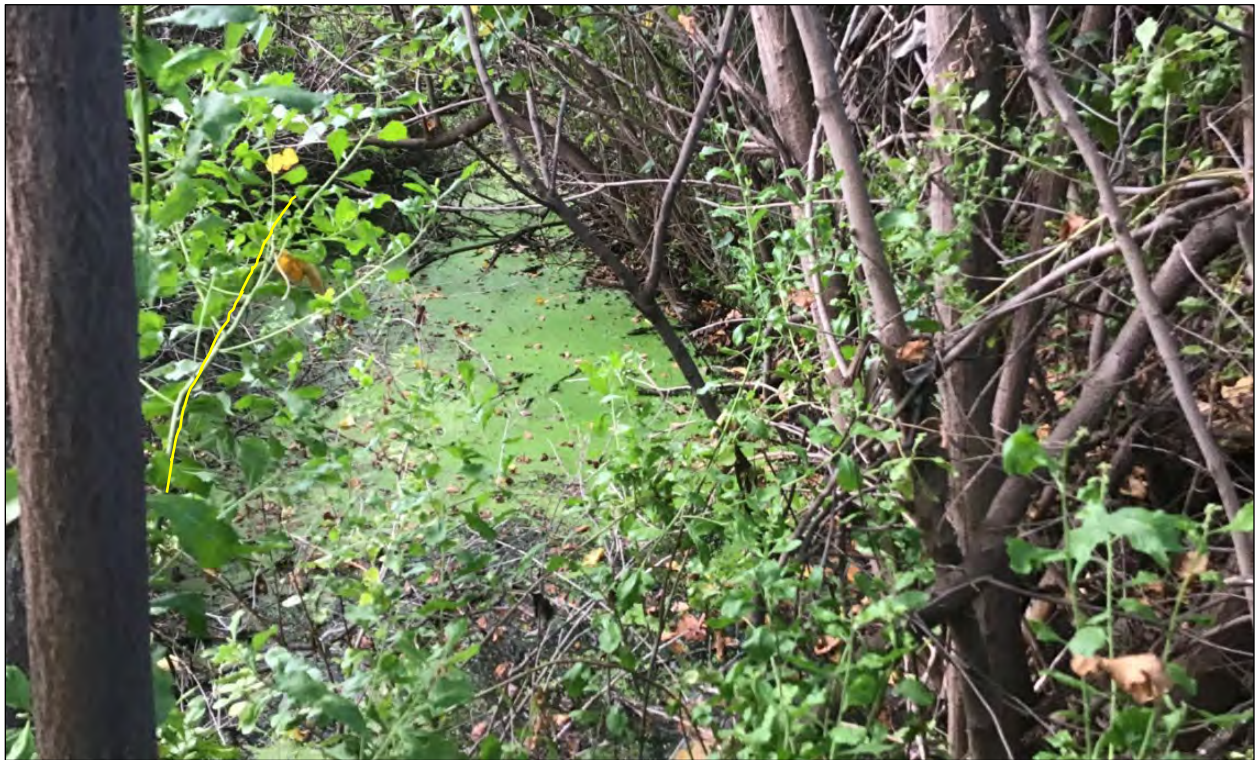
Photo 77. North-South Running Ditch in the Vicinity of Ehehene Street; Location of Transect 1, OHWM was Mostly Indicated by the Break in Bank (Water in the Ditch, Seen Here, is Covered with Duckweek [Lemna sp.] )

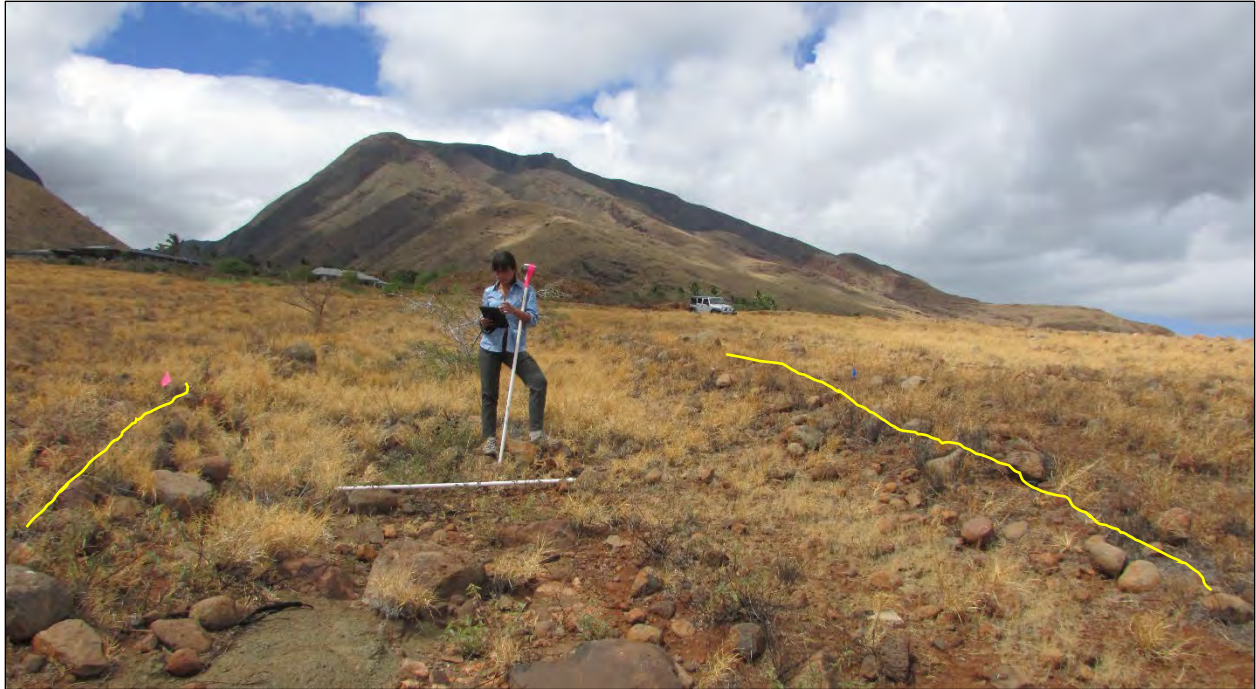
Photo 78. Mapua Stream – Shallow and Dry Stream Channel in September 2023; Break in Bank and Sediment Sorting from Boulders and Rocks to Sediment on Bank were Strong Indicators of OHWM in this System

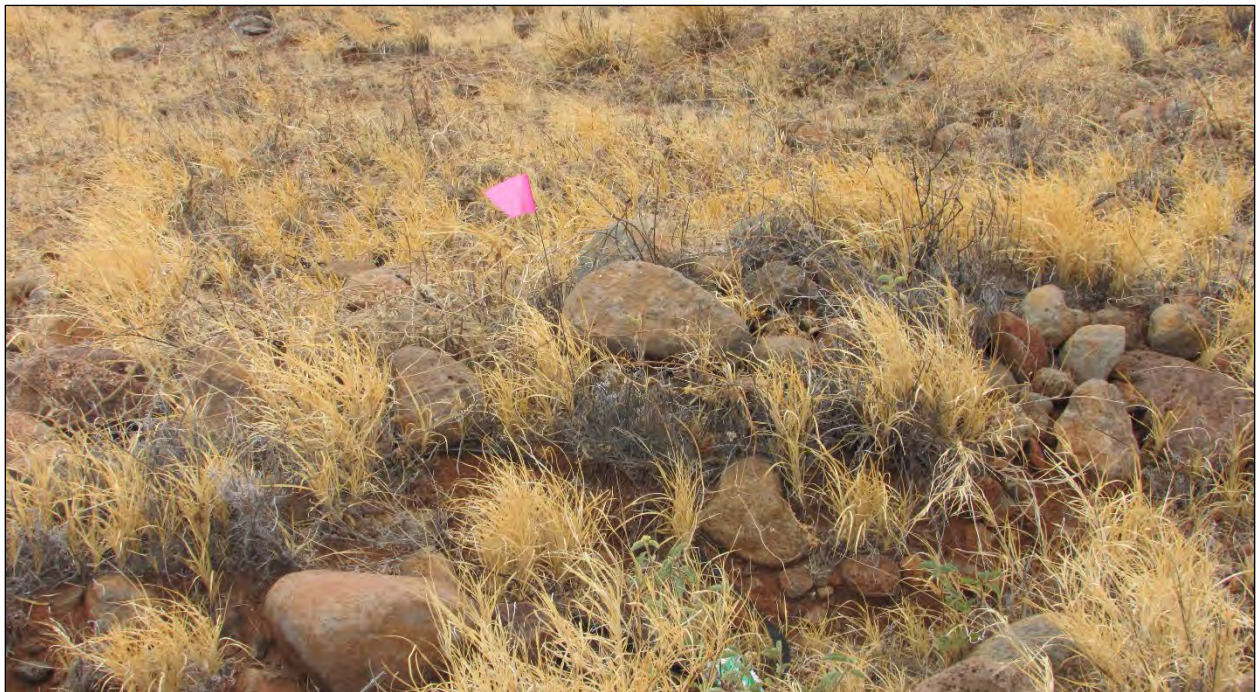
Photo 79. Mapua Stream, Transect 1 Location; Somewhat Undercut Bank and Sorting of Sediment from Boulders to Finer Sediment

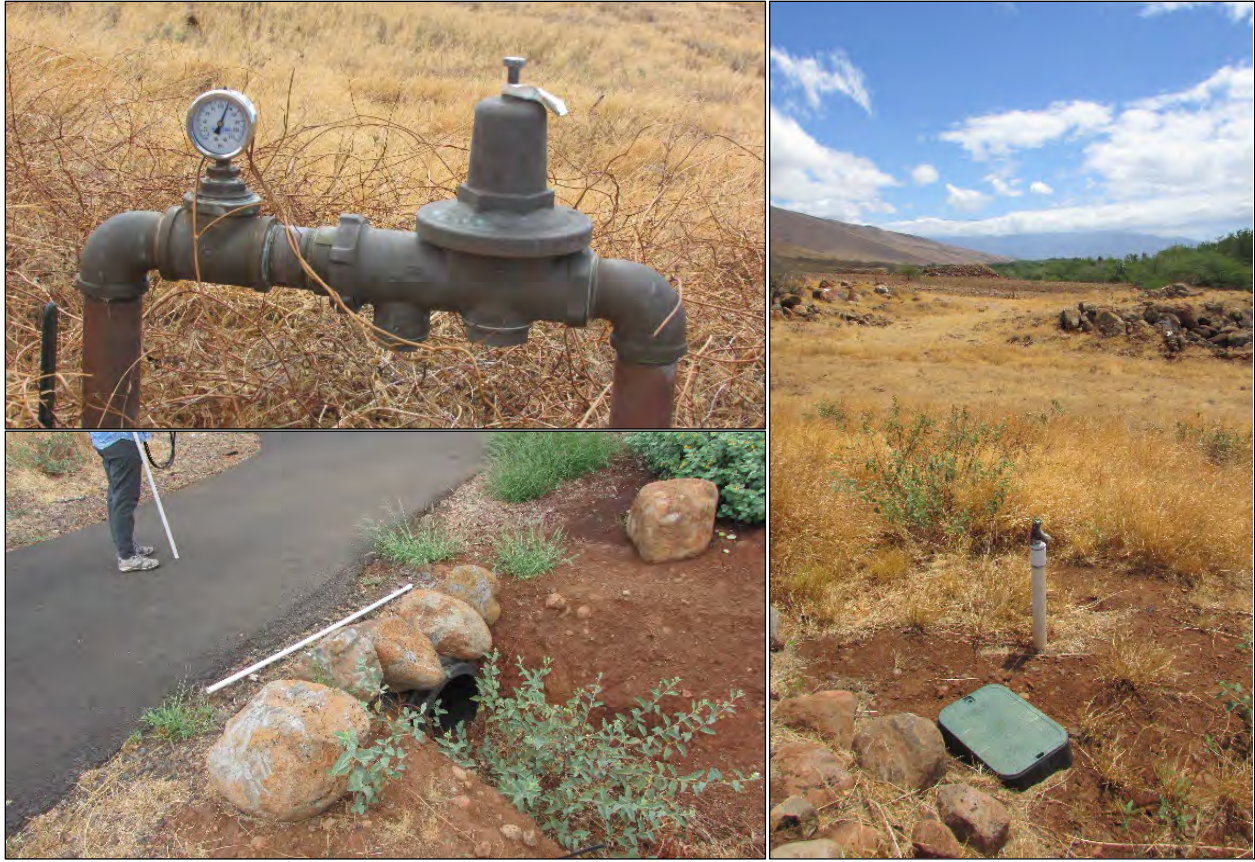
Photo 80. Culverts, Water Pumps, and Water Meter Suggest Mopua Stream Runs Underground

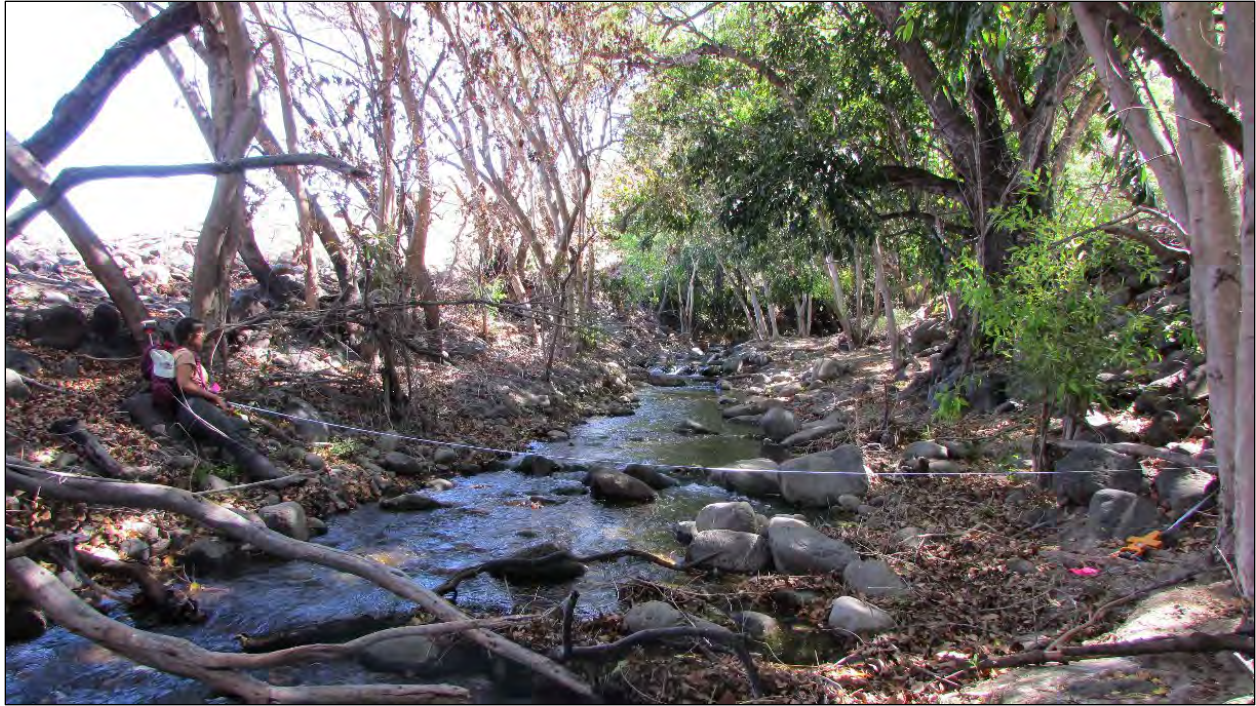
Photo 82. Location of Transect 1; Representative of the Portion of the Stream with Runs Overlapping the Innermost Build Alternative 4 (Burned Trees from the Fires in June-July 2023 Visible on the North (Left) Bank

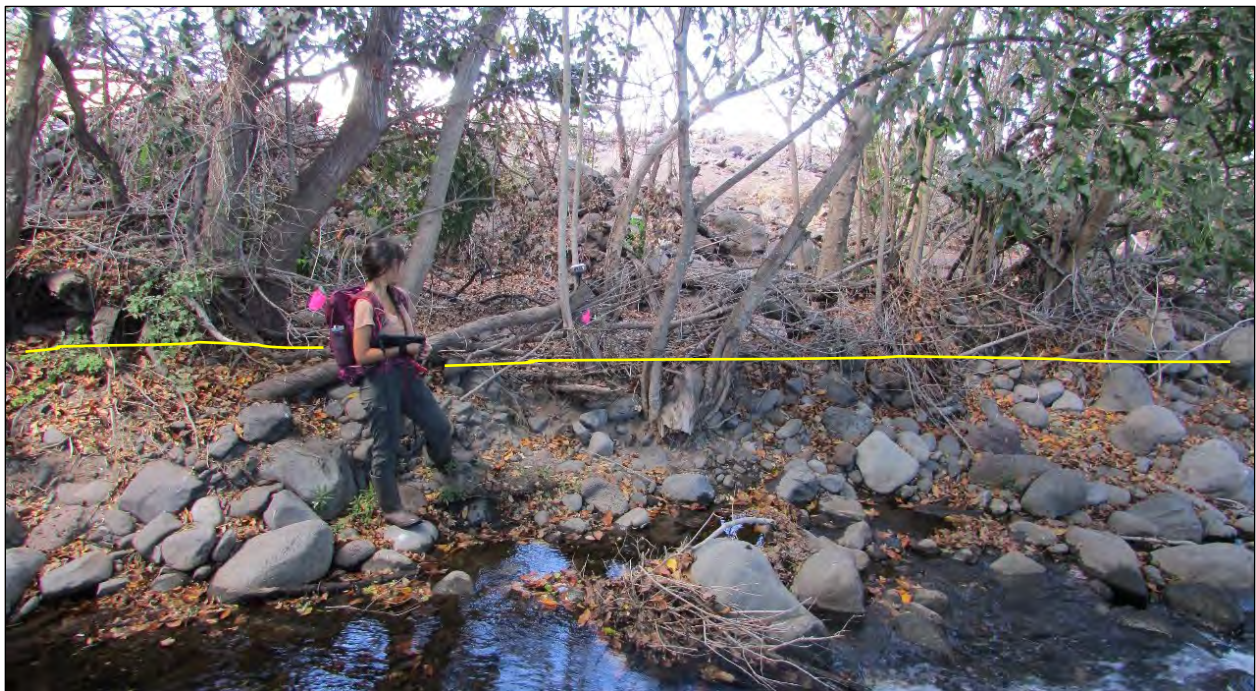
Photo 83. Indicator of Accumulation of Large Debris at the OHWM Level in the Up Stream Section of the Study Area

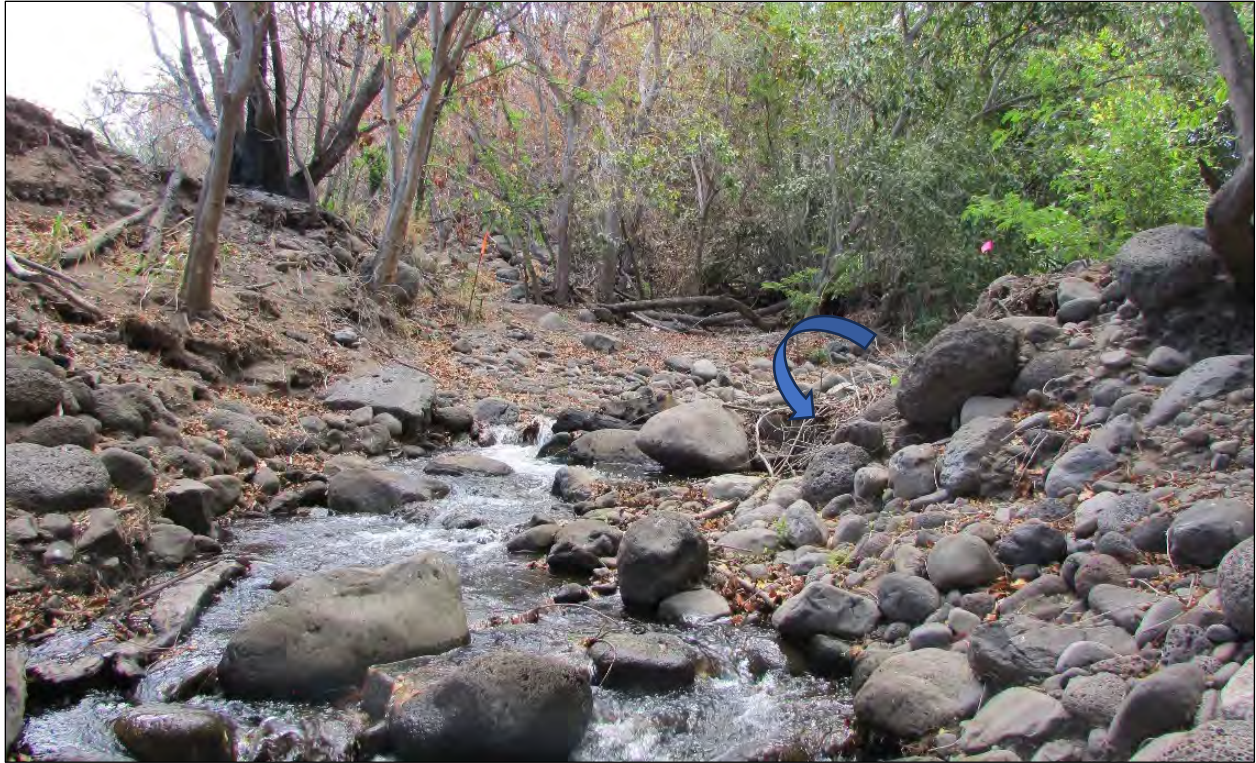
**Photo 84. Location of Transect 2 Representative of the Middle Reach of the Stream in the Study Area at Bend in Stream; Blue Arrow Indicates the Bend in Stream**

Transects 1 representative of the upper reach of the stream in the study area and placed where undercut banks with exposed roots and wracking and shelving of debris caused by water were more evident as OHWM level indicator. Transects 2 representative of the middle reach of the stream in the study area and placed where the stream takes a sharp turn and where exposed roots were a stronger indicator of OHWM level compared to erosion caused by wind and soil. Transects 3 representative of the lower reach of the stream in the study area and placed near the Olowalu Stream Bridge where sediment staining on the concrete and accumulation of debris under the bridge helped identify the OHWM in this area.
