HONOAPI'ILANI HIGHWAY IMPROVEMENTS PROJECT,  
WEST MAUI: UKUMEHAME TO LAUNIUPOKO

# Appendix 3.9 – Water Resources, Wetlands, and Floodplains - Supplemental Information

**Honoapiilani Highway Improvement Project  
Preliminary Identification of Waters of the United States  
Technical Report**

**Project # 4692-02**

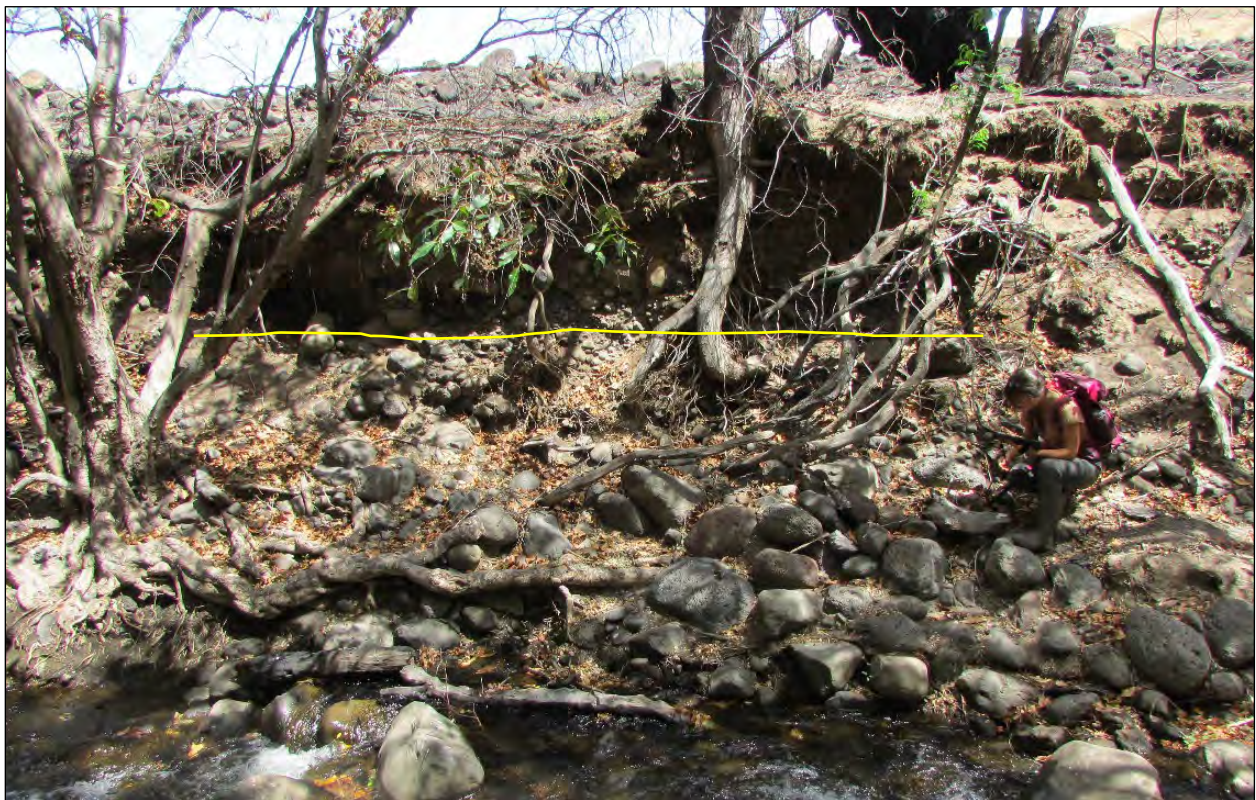
**Photo 85. OHWM Level in the Middle Reach of the Stream in Study Area Below the Soil Erosion Seen on Top of the Bank**

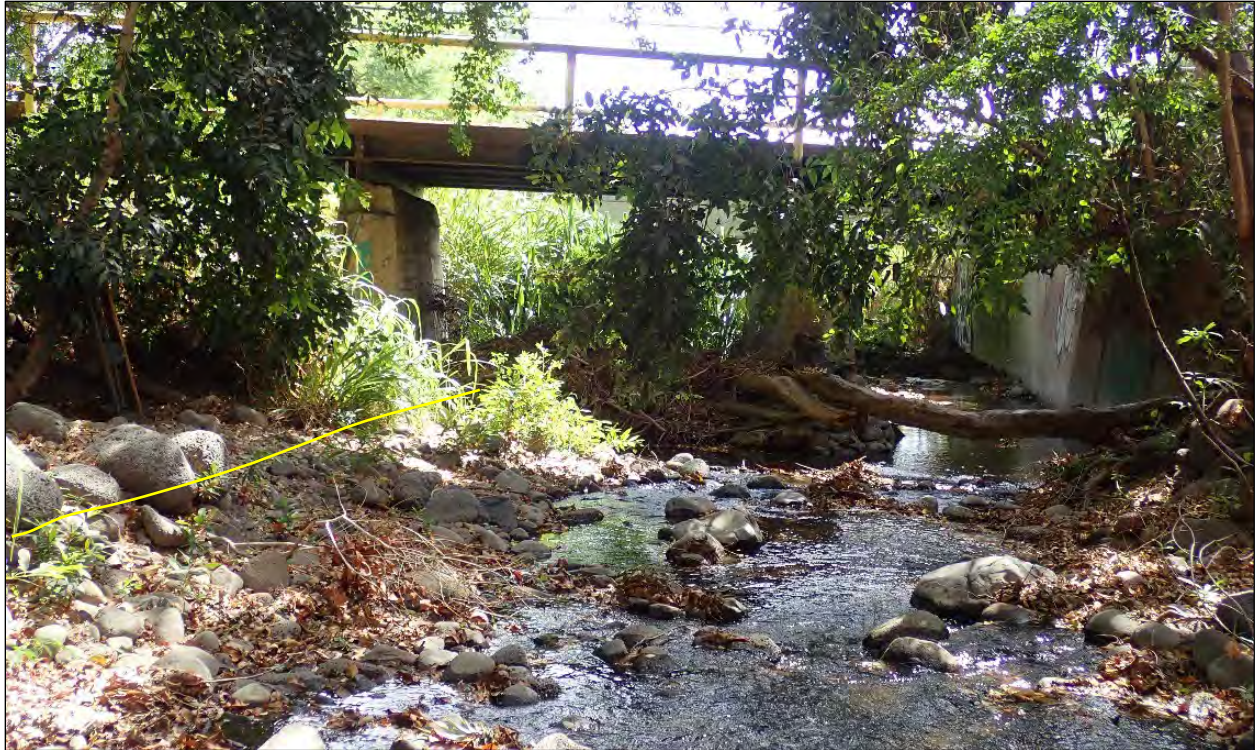
Photo 86. Location of Transect 3 At the Olowalu Stream Bridge; Sediment Staining on the Concrete Bridge Contributed to Determining the OHWM Level in this Area

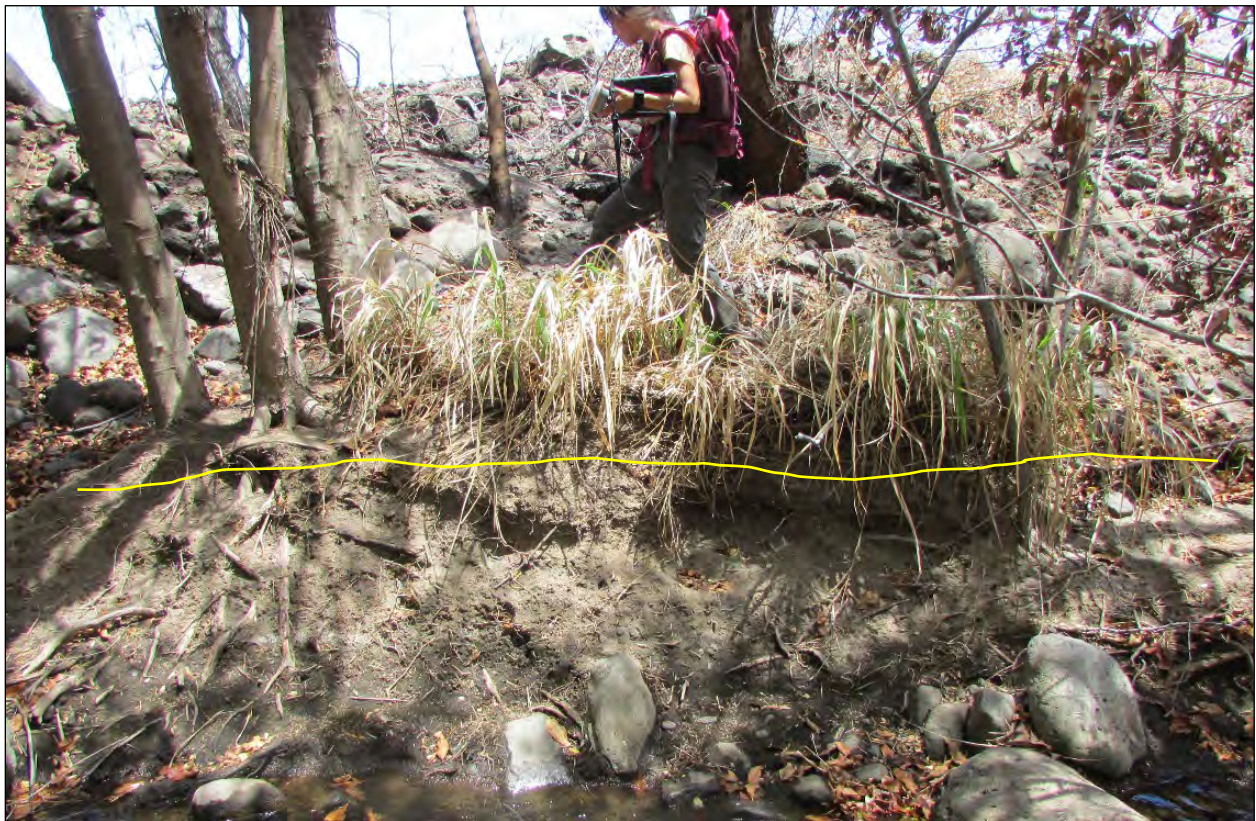
Photo 87. Undercut Banks with Exposed Roots Was Key in Separating Impacts from Confounding Soil and Wind Erosion Caused Due to Recent Fire

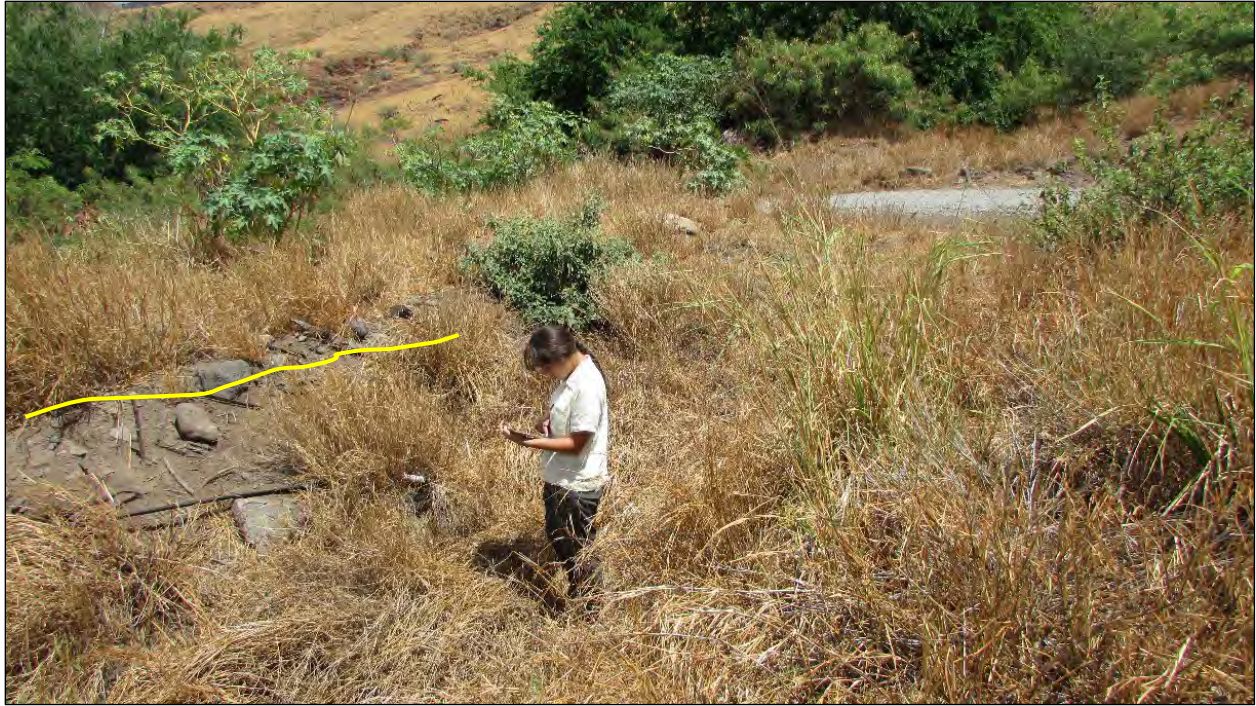
Photo 88. Location of Transect 1; Representative of the Uppermost Reach of the Stream in the Study Area (Break in Slope and Washed of Debris Were Used as Indicators of OHWM)

Transect 1. was placed in the upper reach of the stream where cut in bank slope and destruction of vegetation below the OHWM level indicated the OHWM level. here. Transect 2 was placed in the lower reach of the stream. The bed was moist and the presence of green/live vegetation to dead grass on the bank helped identify the OHWM level in addition to the break in slope.

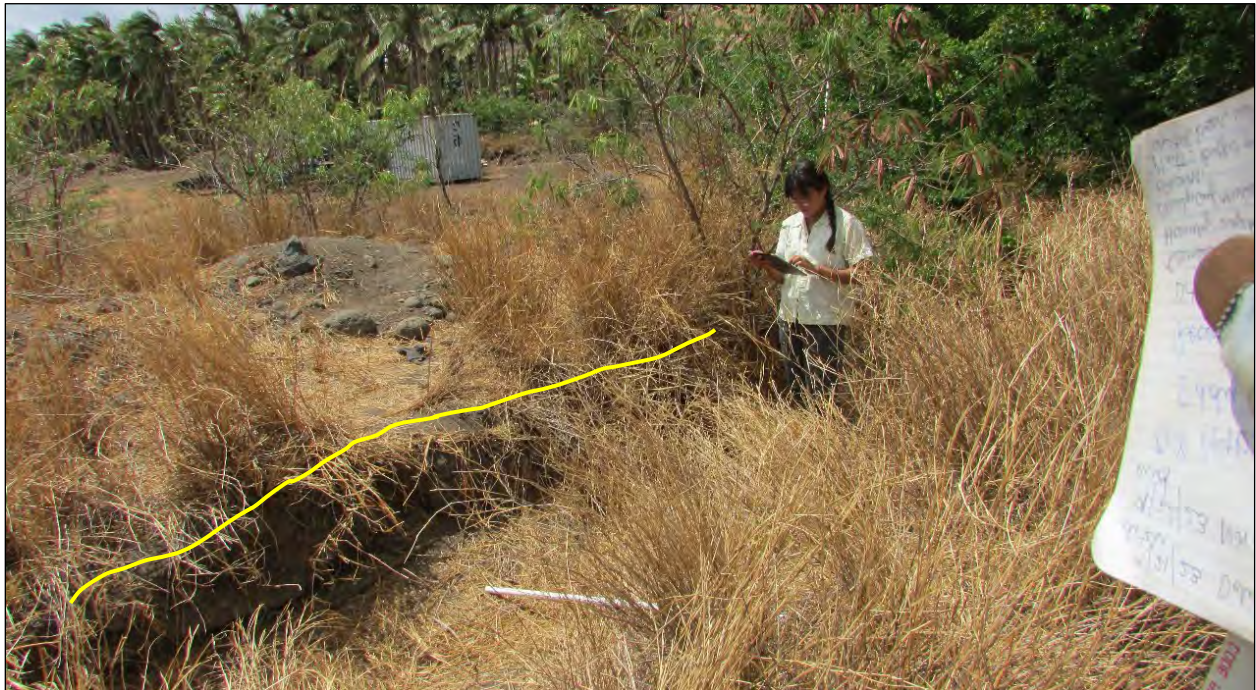
Photo 89. Break in Bank as OHWM Indicator in the Upper Reaches of Lihau Stream in Study Area

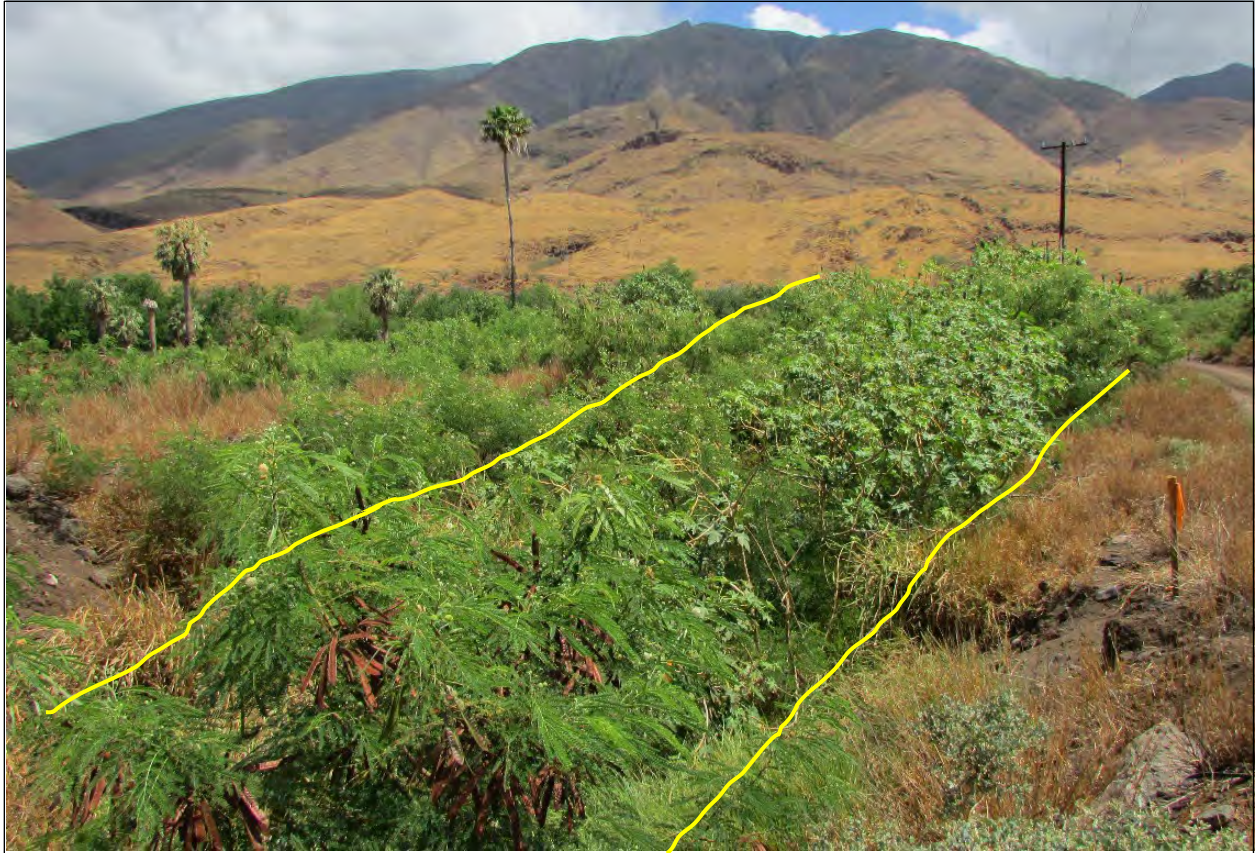
Photo 90. Location of Transect 2 at the Lower/Western Reach of Lihau Stream in the Study Area; Heavily Vegetated Moist Bed Compared to the Upper Drier Banks and Break in Bank Slope Used as OHWM Indicators

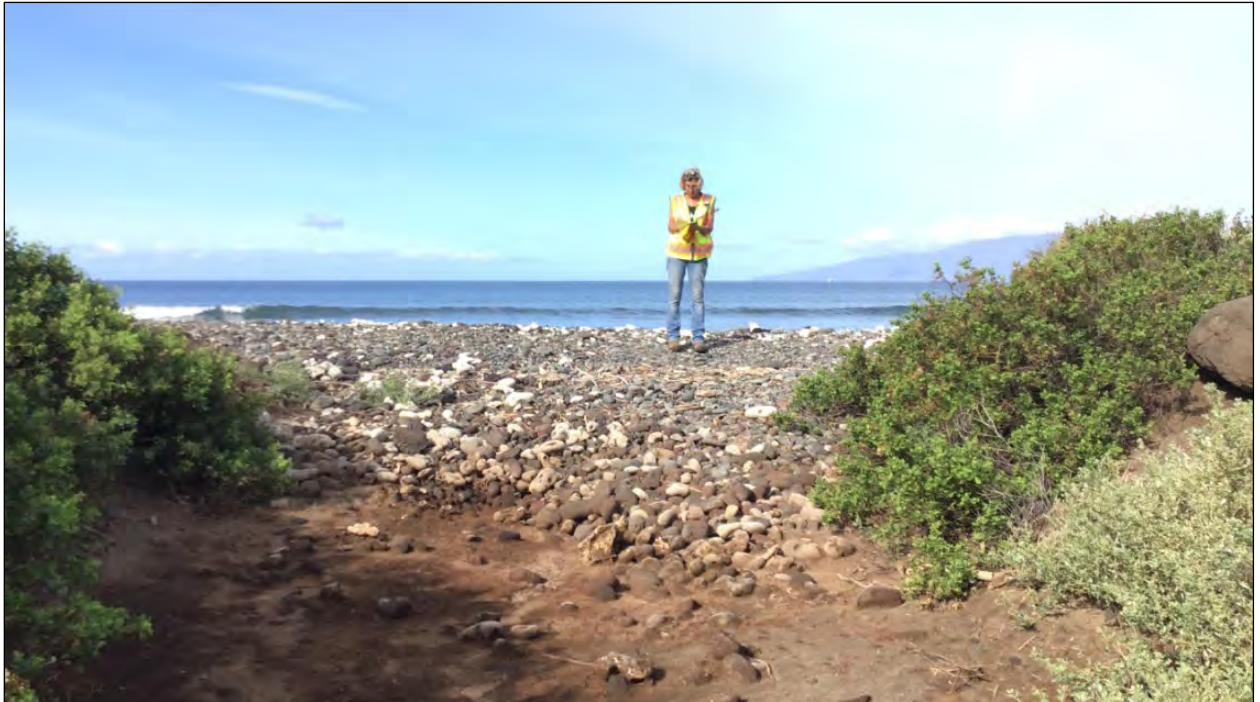
Photo 91. Lihau Stream Entering the Pacific Ocean in the Western Most Portion of the Study Area

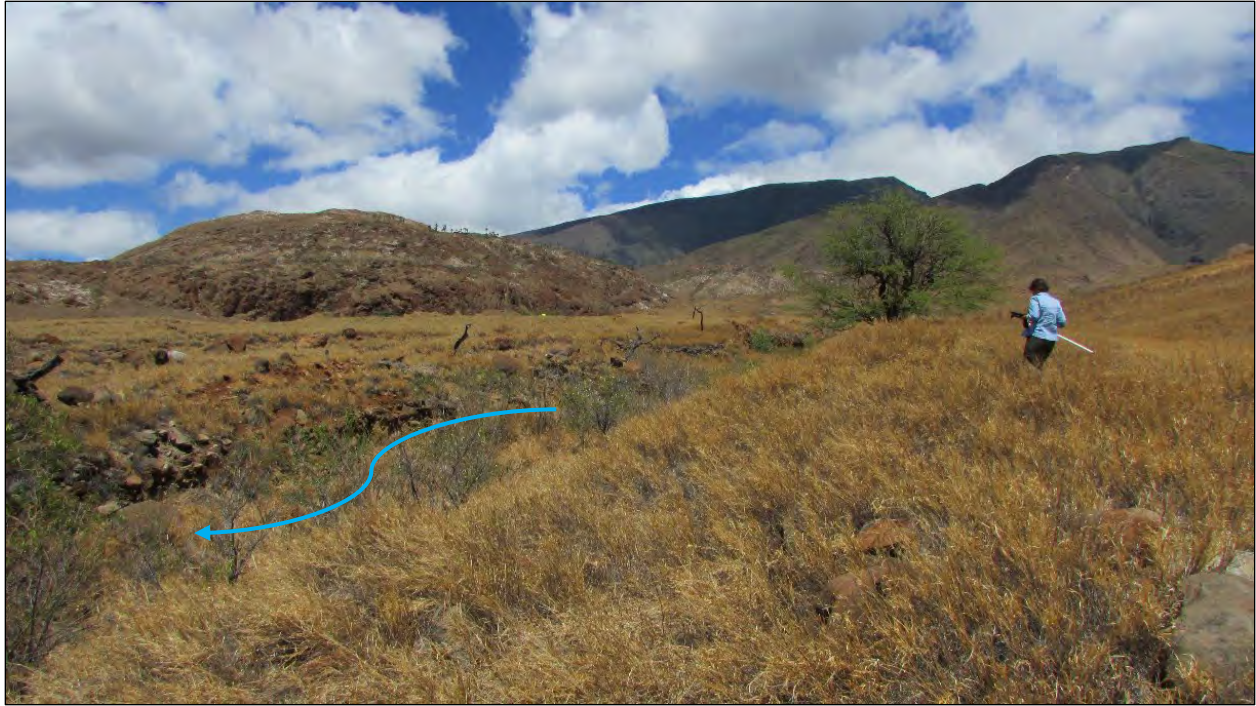
Photo 92. Awalua Stream – East View

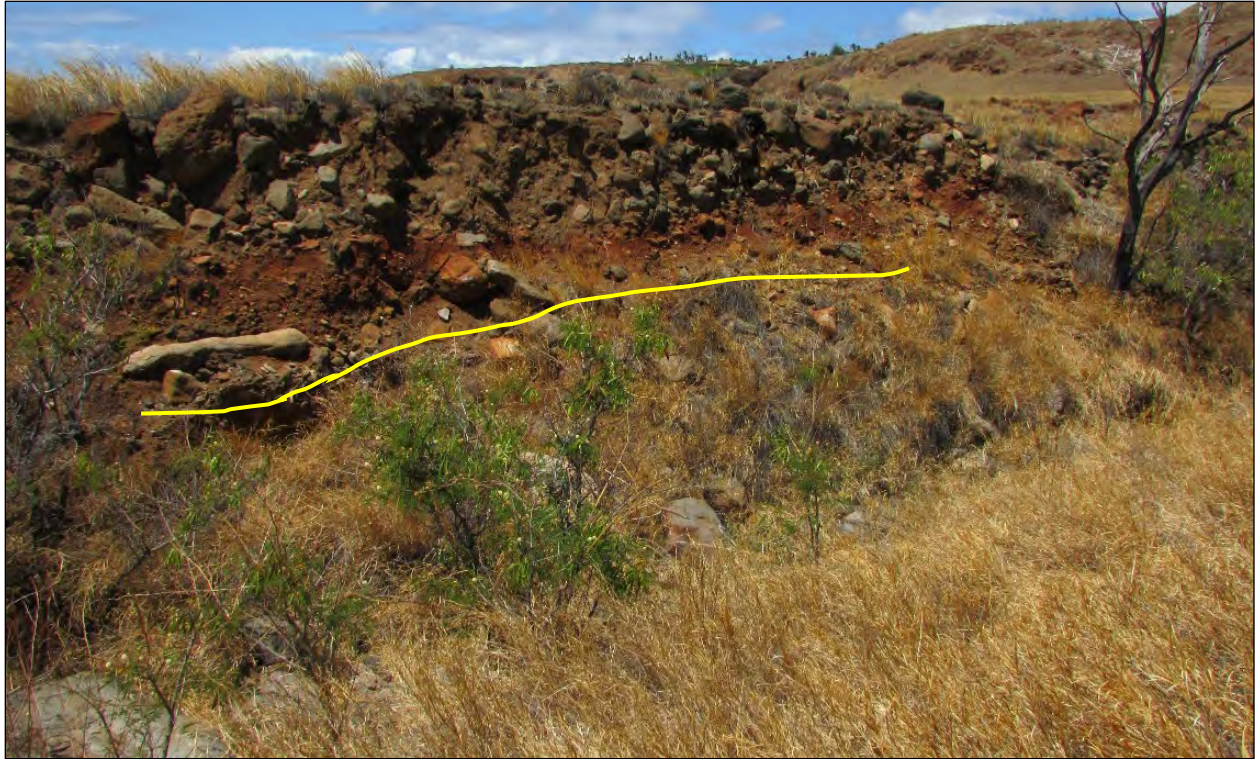
Photo 94. Awalua Stream Location of Transect 2 in the Upper/Eastern Reach of Stream in Study Area; the Dry Vegetation in the Bed was Indicative of Moisture Levels that Supported Plant Growth in the Bed and Helped Distinguish Between Erosional Features and OHWM Level

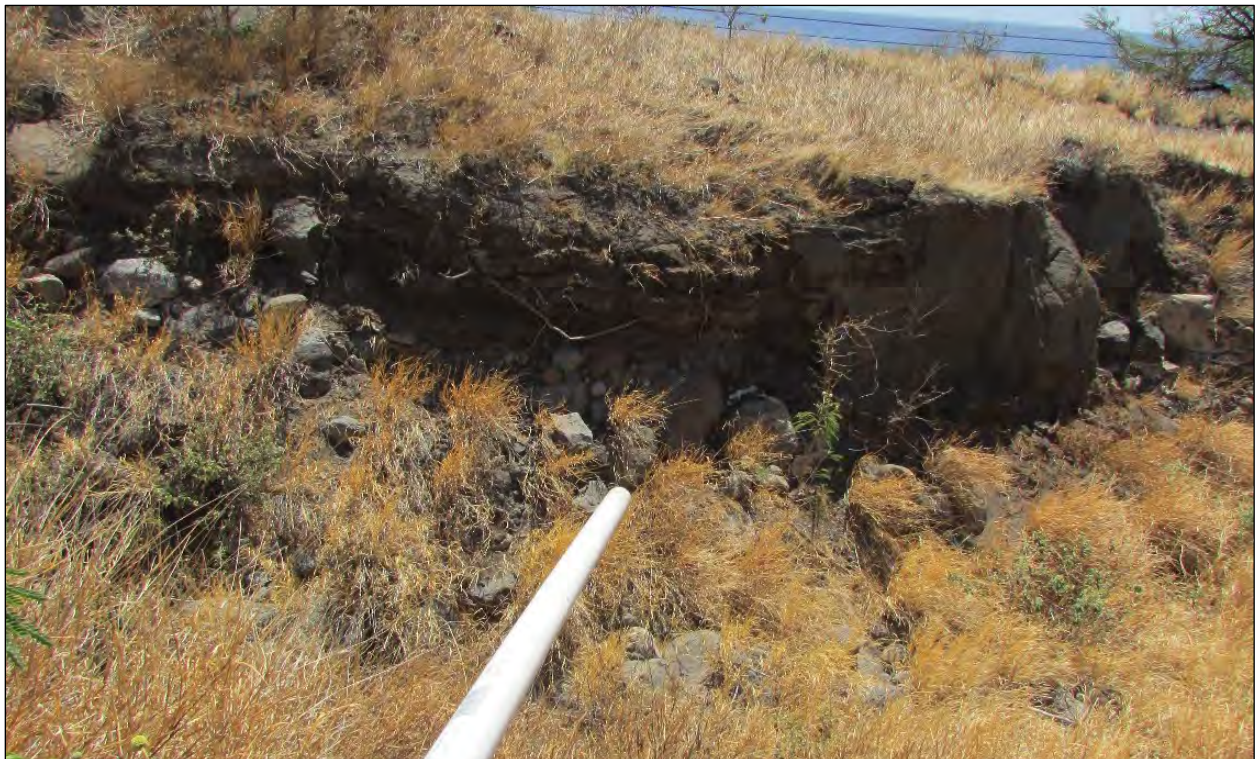
Photo 95. Awalua Stream Undercut Bank; Vegetation Line Together with Undercut Bank Allowed for Identifying OHWM Level Here

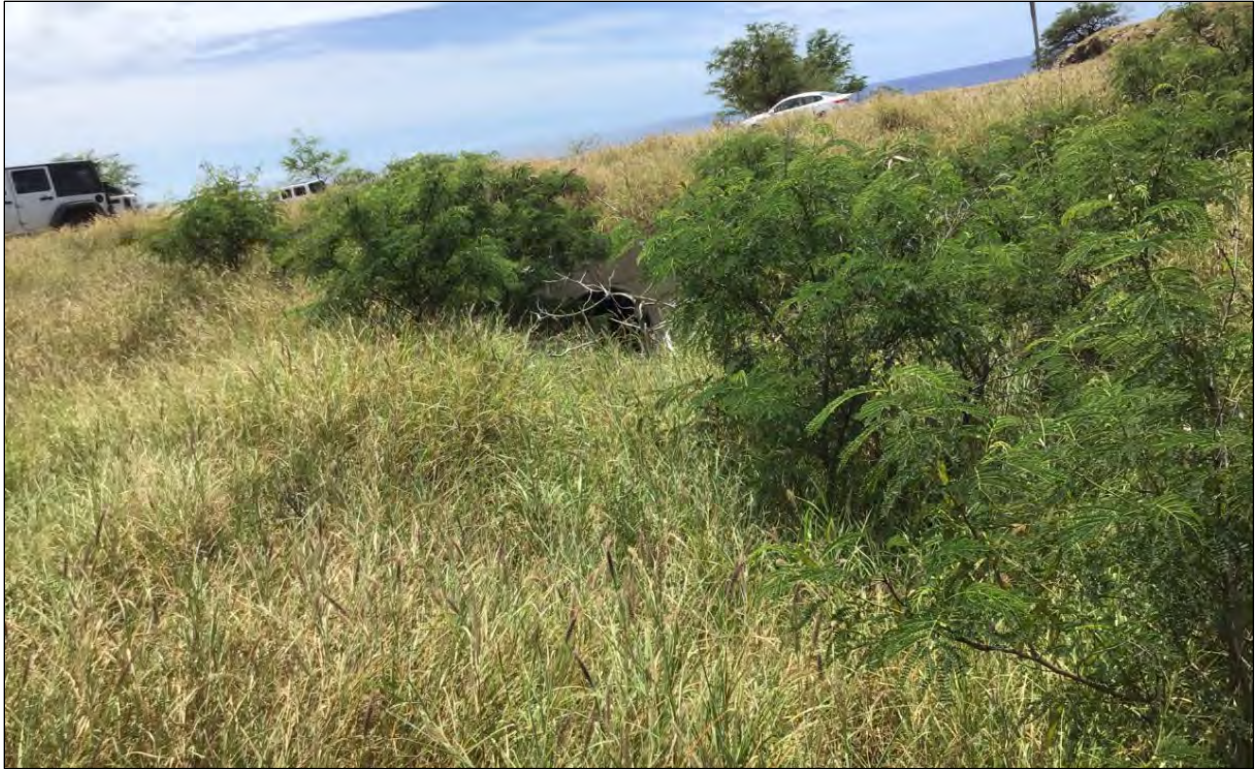
Photo 96. Ka Puali Stream – West View with Concrete Culvert; Location of Transect 1 (Heavily Vegetated Bed with Shrubs and Bank with Grasses)

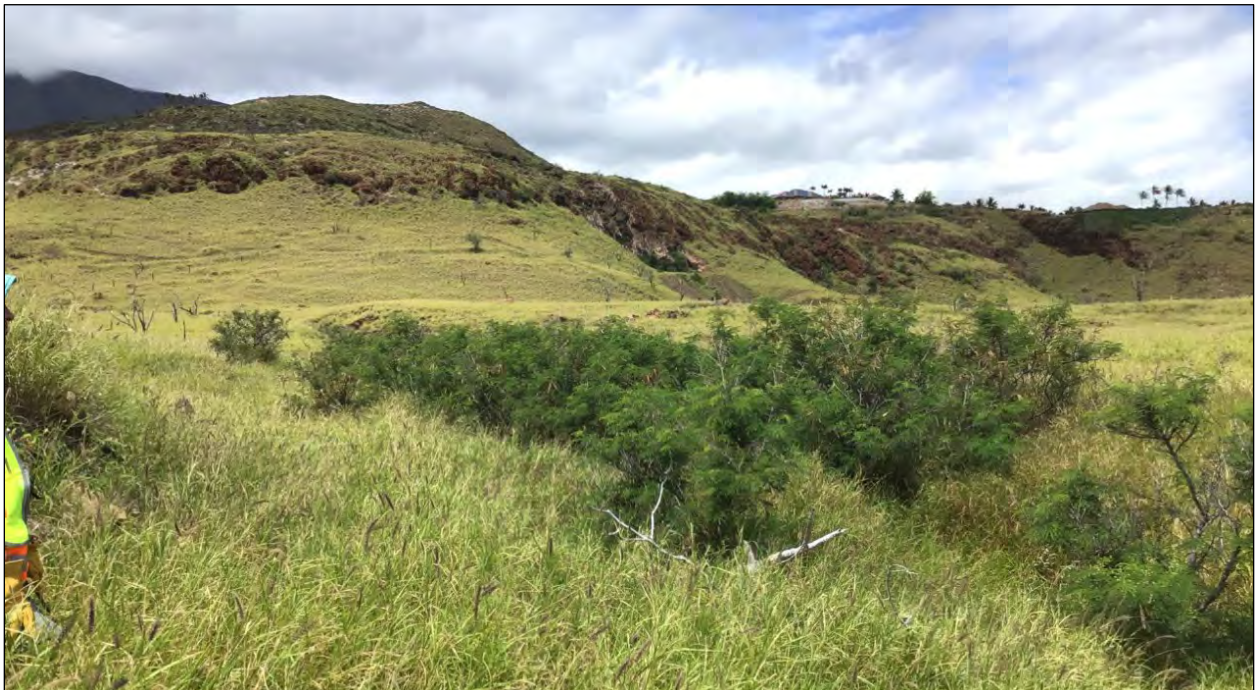
Photo 97. Ka Puali Stream – East View; Heavily Vegetated Bed with Shrubs and Bank with Grasses

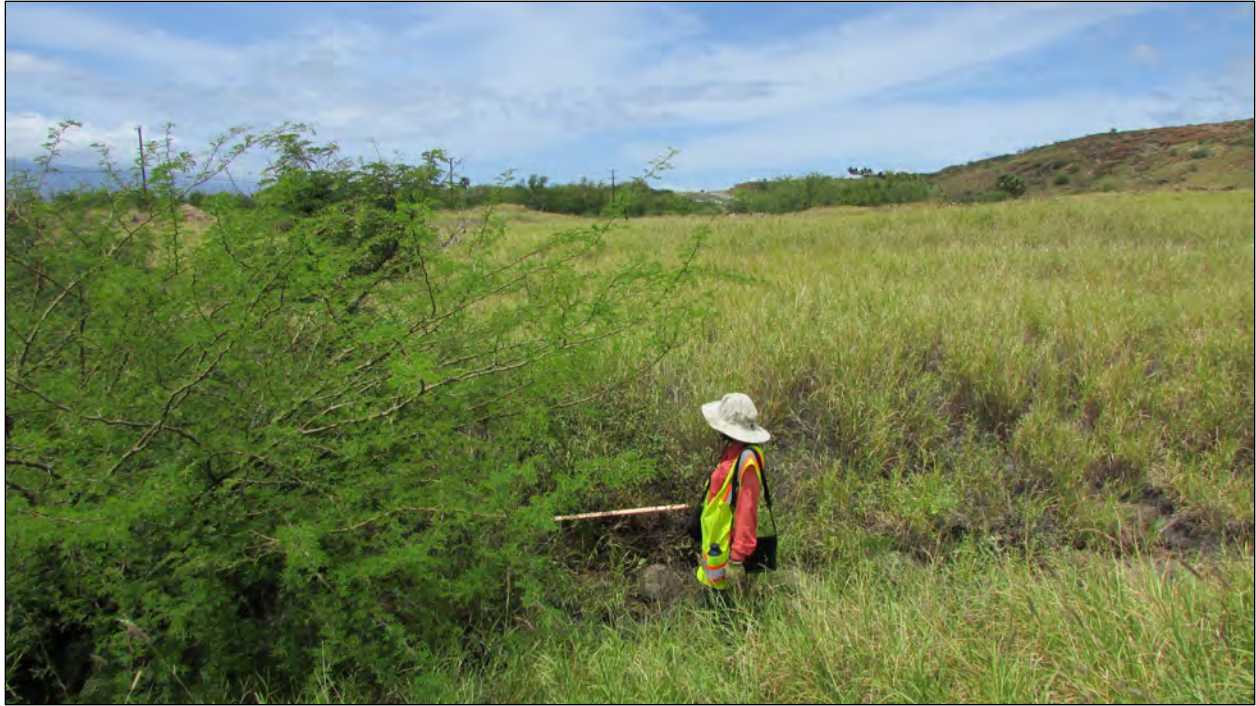
**Photo 98. Ka Puali Stream Bed; Location of Transect 2 (Change in Vegetation from a Combination of Shrubs, Trees, and Grasses to Only Grasses on the Bank and Presence of Rocks and Boulders Helped Determine the OHWM for this Stream)**

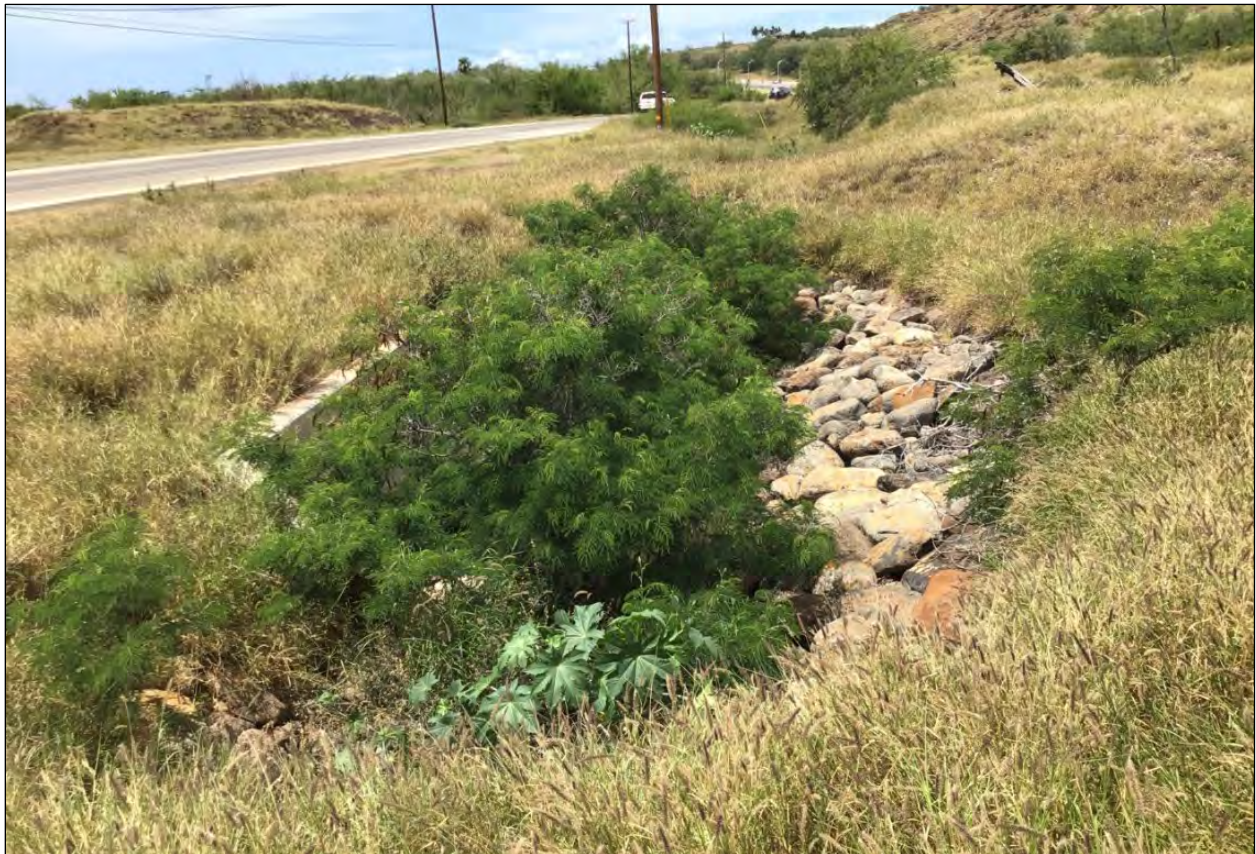
**Photo 99. Ka Puali Stream Culvert**

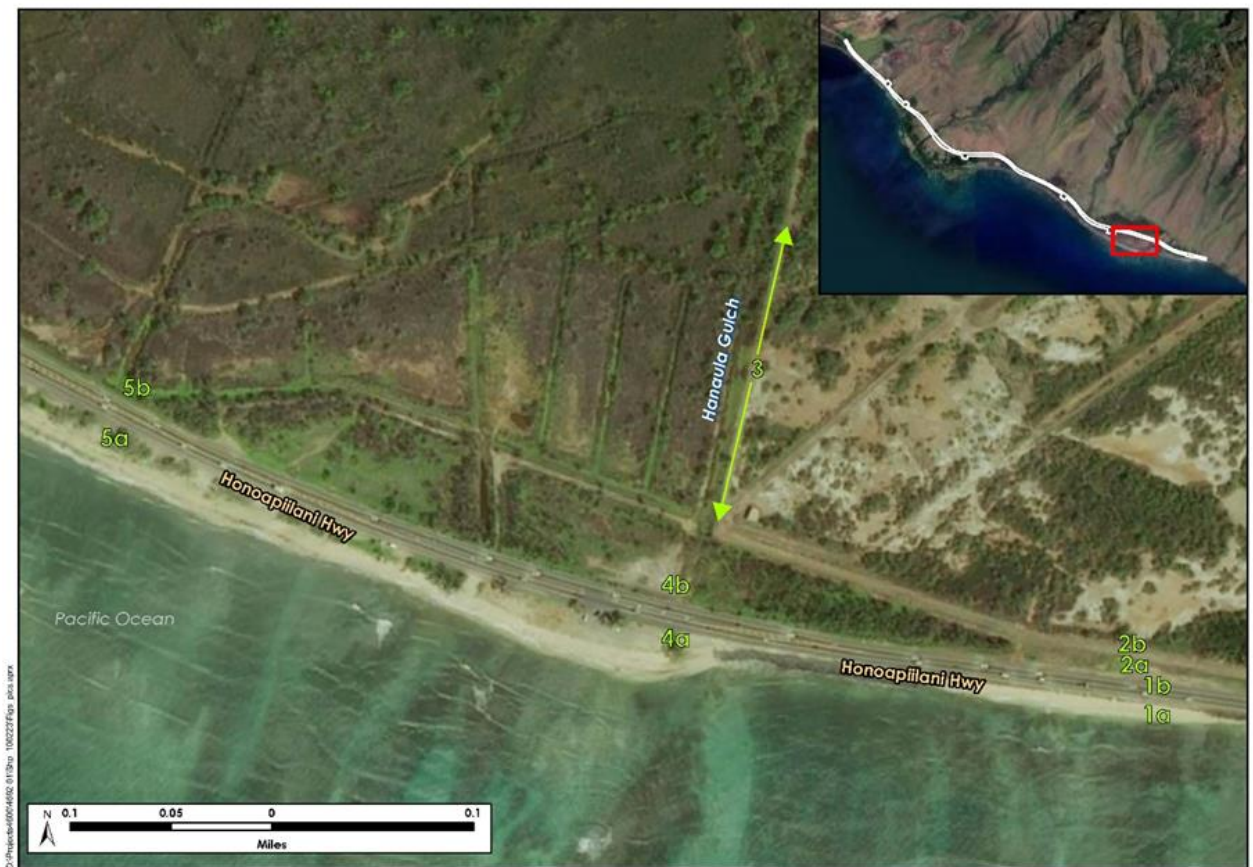
Figure 3: Aerial View of All Locations

**Figure 3. Aerial View of All Locations Investigated on May 2, 2024**  
Honoapiʻilani Highway Improvement Project (4692-02)  
Field Investigations About Surface Connections of Potentially Non-Jurisdictional  
and Potentially Jurisdictional Wetlands to Waters of the U.S.  
May 2, 2024

The Project’s proposed jurisdictional and potentially non-jurisdictional wetlands are illustrated in Figure 2. Field investigations on May 2, 2024, focused on nine different locations within five separate areas (Locations 1a, 1b, 2a, 2b, 3, 4a, 4b, 5a, and 5b) to determine if the Project wetlands (W1 through W11\*) illustrated in this figure have “continuous surface connections” to the ocean under the conforming rule. It is our understanding that an active, working culvert can constitute a continuous surface connection, but that subsurface flows and seeps cannot. Detailed below are the findings from each of these nine locations and our assessment of the surface connectivity among these delineated wetlands and to the ocean. The location numbers, depicted in green, in Figures 3 and 4 correspond to the numbered locations in the discussion below.

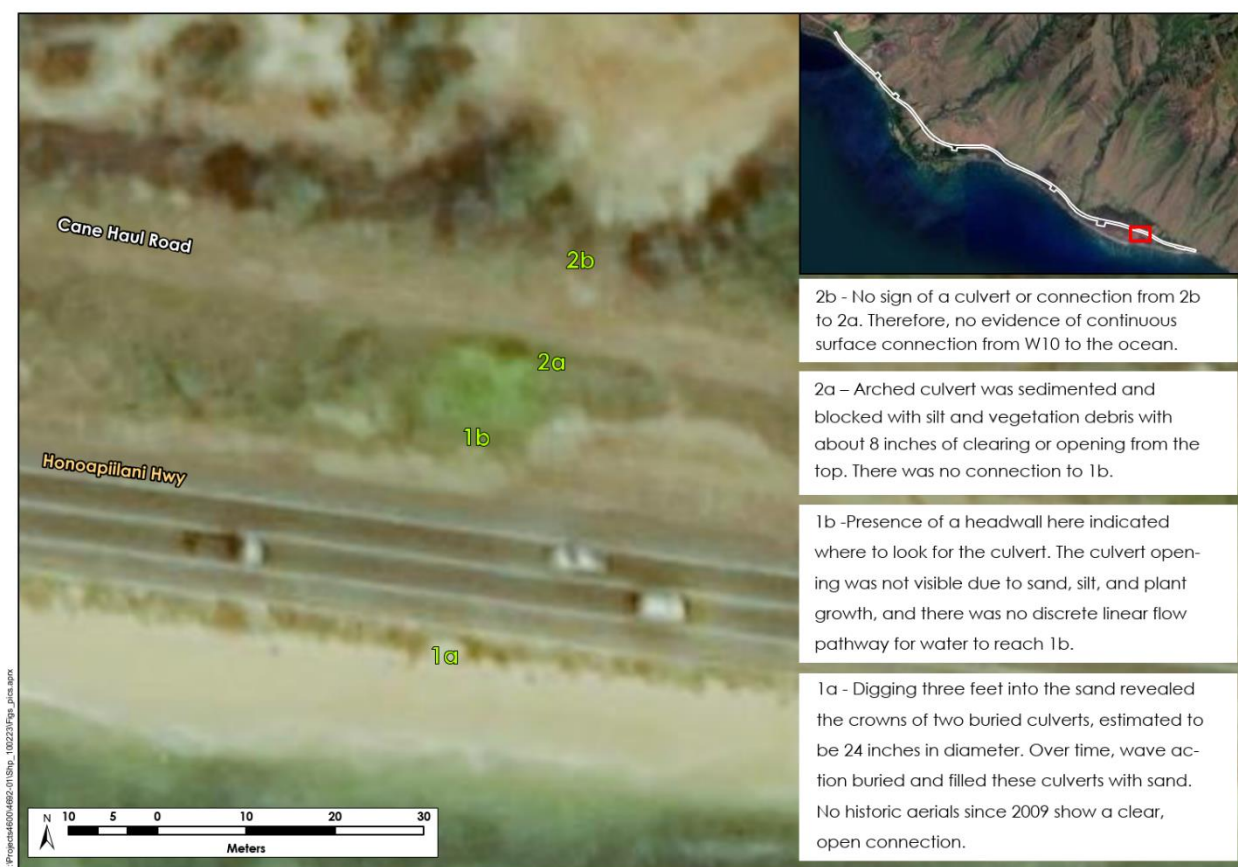
**Figure 4: Aerial View of Locations 1a, 1b, 2a, and 2b with Key Takeaways**

**Figure 4. Aerial View of Locations 1a, 1b, 2a and 2b with Key Takeaways**

Location 1b corresponds with the east side (land side) of the same culvert 1 (discussed in 1a) and is located opposite of Location 1a on the land side of the existing Honoapiilani Highway (Figure 4). The presence of a headwall here indicated where exactly to look for the culvert. The culvert opening was not visible as the area downslope was saturated and densely covered with pickleweed (*Batis maritima*), a wetland plant species with an obligate indicator status (Figure 6). A shovel placed downward along the headwall revealed that the depth of the pickleweed vegetation was at least four to five feet indicating that the top of the culvert was below five feet. The wet shovel blade and saturated soils indicate that even if the culvert (the inside of which was not visible) is mostly blocked with sand and/or silt it allows for subsurface seepage of water landward as well as seaward. Historic aerials show no open culvert in this area, and the amount of vegetation cover and silt and sand blocking the culvert indicate that it has not been maintained/cleared of sediment for quite some time. The ground was progressively drier inland from Location 1b toward Location 2a (discussed below), and there was no discrete linear flow pathway (such as a ditch or swale) for water to reach Location 1b. These observations indicate that water could be ponding at Location 1b, but that it is unlikely that the surface water is flowing from Location 2a and W10. See discussion on Locations 2a and 2b for more details.

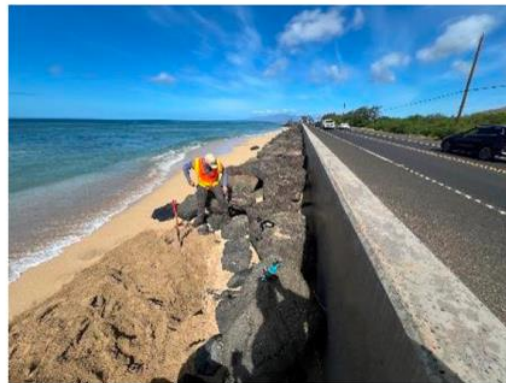
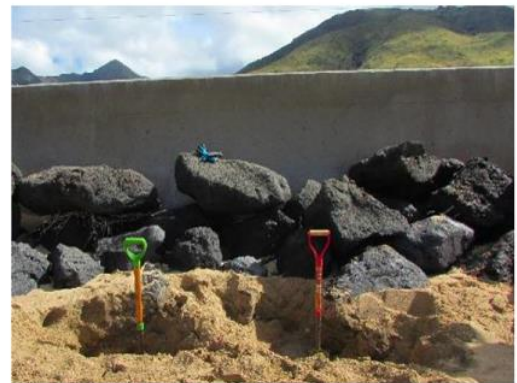
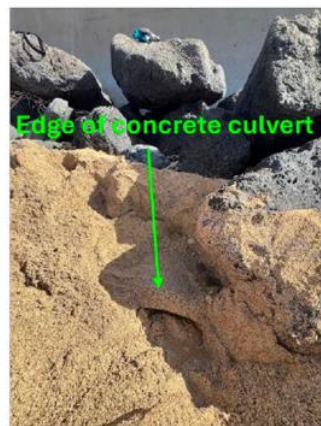
**Figure 5: Photos of Location 1a**

Photo depicting the sand blocking the culvert at Location 1a.

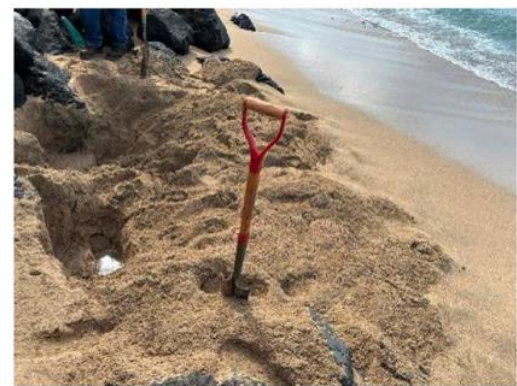
Photo depicting water ponding on the ocean side of the culvert at the existing Honoapiilani Highway.

a clear and open culvert connection dating back to 2009 (Google Earth 2024<sup>1</sup>). There was no direct evidence observed of seep through the accumulated sand and silt in this blocked culvert from inland towards the ocean (also see notes on Location 1b). Although the culvert is entirely blocked by sand, the presence of water in a freshly dug pit on the beach indicated that, at least during high tides, there is some small amount of subsurface movement of water from the ocean towards the buried culvert and the land (Figure 5). However, this amount of flow is insufficient to conclude a functioning continuous surface connection via the culvert. While subsurface seep from inland rain and stormwater is not impossible, it is highly improbable that any consequential flow would traverse the roughly 60 feet through the existing sand block from Location 1b to Location 1a, which was buried approximately three feet deep during the May 2024 investigation, particularly given the regular wave action. Observations at Location 1a evidenced an insufficient flow to constitute a continuous surface connection to the Pacific Ocean.

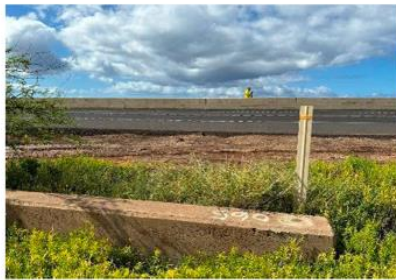
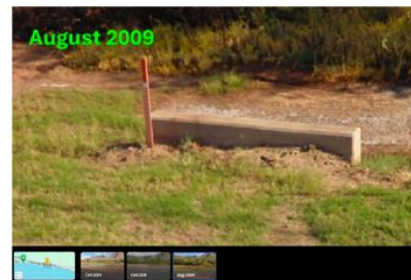
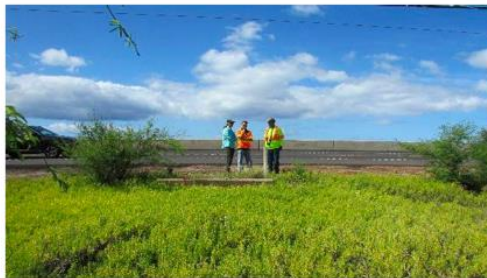
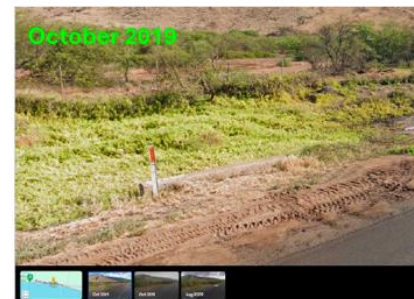
**Figure 6: Photos of Location 1b**

Presence of a concrete culvert headwall on the land side of the existing Honoapiilani Highway. This culvert appears to be buried in historic imagery from 2009 and 2019 obtained from Google Maps.

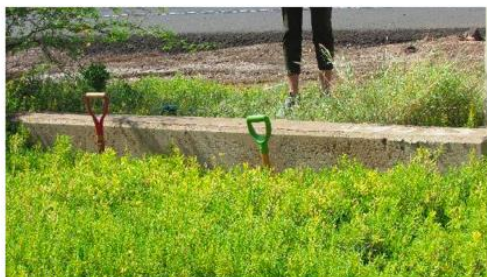
Dense growth of pickleweed (*Batis maritima*) located within saturated soils in front of the culvert blocked visibility.

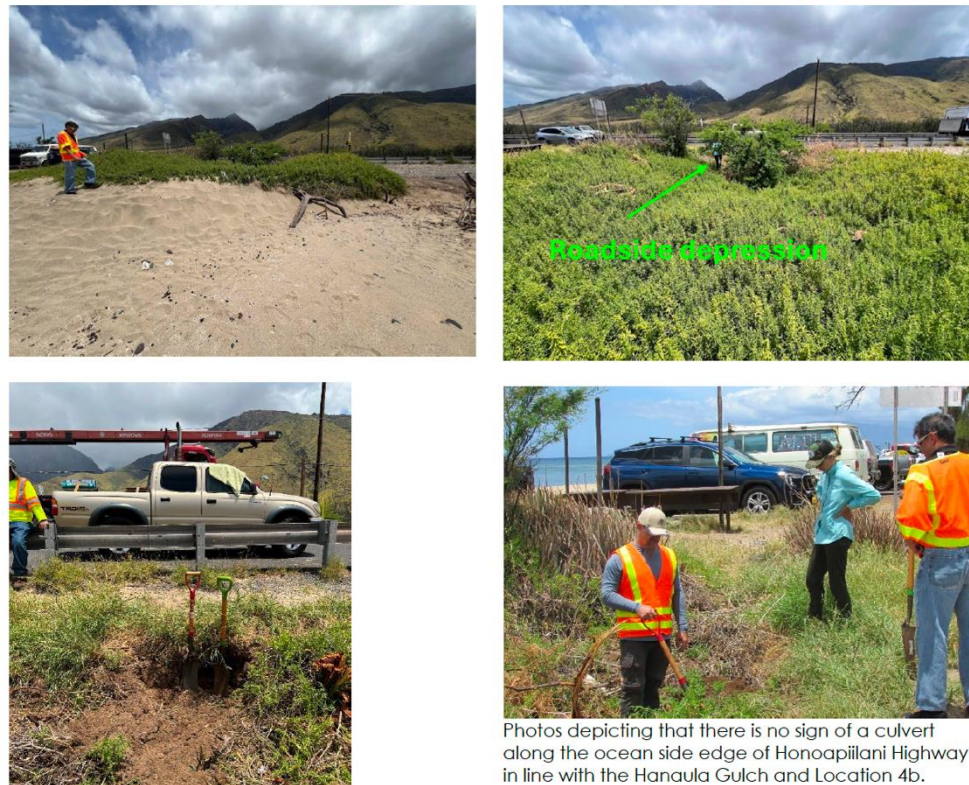
**Figure 11: Photos of Location 4a**

ends and deeper toward the center. It is heavily vegetated with a mix of weedy species, mostly buffel grass, toward the Highway (land side) end but otherwise surrounded and dominated by pickleweed thickets (a wetland plant species – see Figure 11) that is assumed to be supported via subsurface seepage that could occur during heavy rain events. The soil in the depression was dry with no saturation or signs of recent ponding.

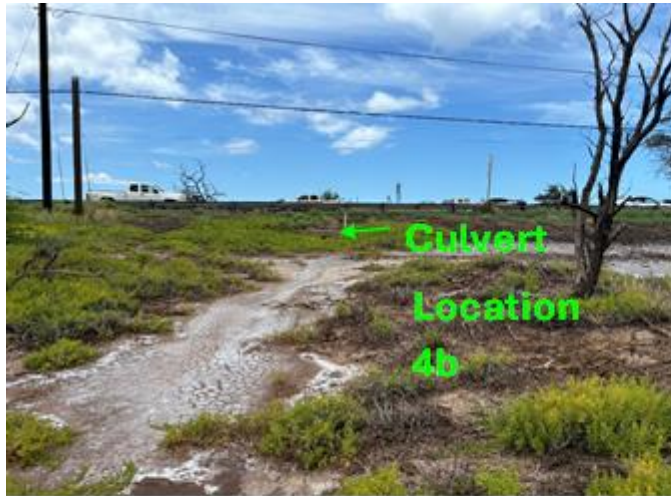
Figure 12: Photos of Location 4b

Land side of the culvert under the existing Honoapiilani Highway at Hanalei Gulch is open only at the mouth but progressively blocked under the highway and toward the ocean side end.

Location 4b corresponds with 4a; it is located opposite of Location 4a and is the land side opening of the same culvert discussed above in 4a. This location was investigated to confirm if Hanaula Gulch, as stated in the wetland delineation report, has a surface connection to the ocean on the land side of the existing Honoapiilani Highway. The culvert opening on the land side of the Highway appears to be open and somewhat functioning. The mouth of the culvert was not blocked. However, as it was investigated further, silt and sediment blocked the culvert completely towards the ocean side (where Location 4a is situated). The invert of this culvert is about 15 feet below grade of the Highway (Figure 12). With field observations indicating no functioning connection between Location 4a and 4b, there is no evidence of continuous surface connection from Hanaula Gulch to the ocean. Therefore, there is no continuous surface connection between wetlands W1, W3, and W4 to the ocean, as well as no continuous surface connection between Ditches 1-7 (D1-D-7) to the ocean (Figure 2). These features can all be considered potentially non-jurisdictional in light of the May 2<sup>nd</sup> field visit.

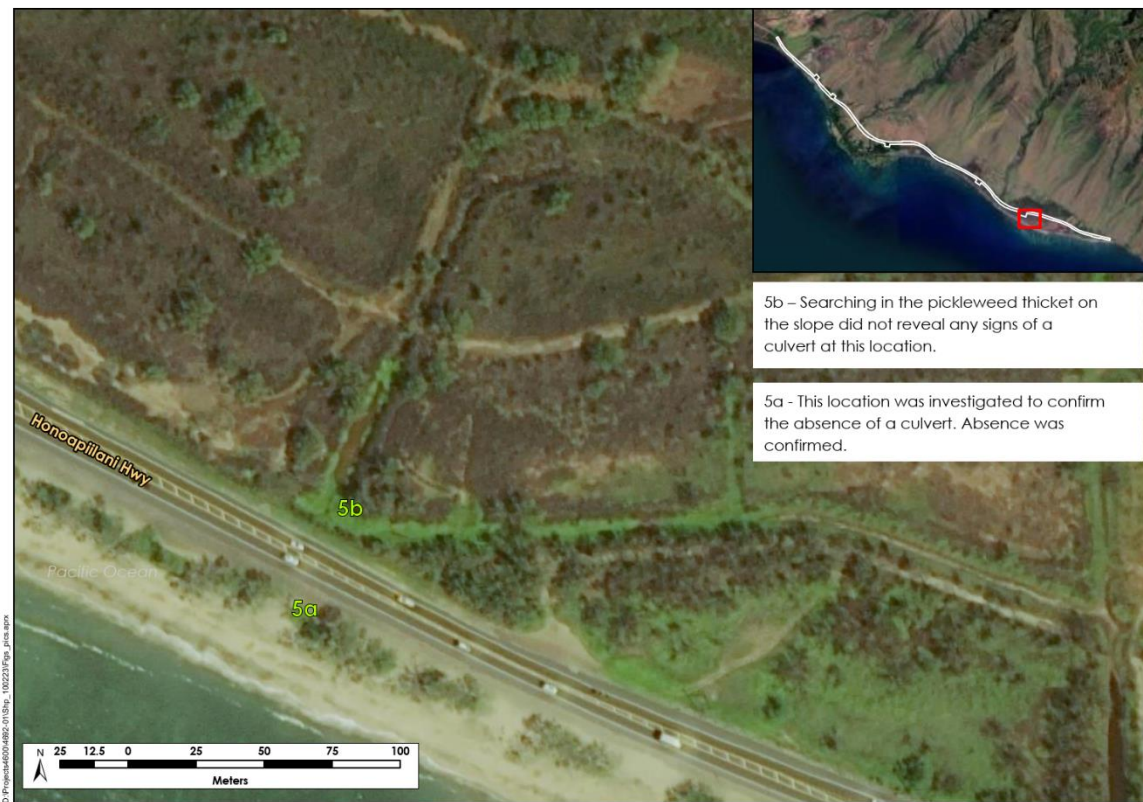
**Figure 13: Aerial View of Locations 5a and 5b with Key Takeaways**

**Figure 13. Aerial View of Locations 5a and 5b.**  
Honoapiilani Highway Improvement Project (4692-02)  
Field Investigations About Surface Connections of Potentially Isolated Non-Jurisdictional and Jurisdictional Wetlands to Waters of the U.S.  
May 2, 2024

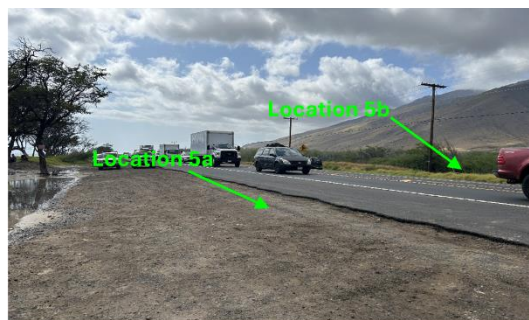
**Figure 14: Photos of Locations 5a, 5b, and Ditch 6**

Location 5a is on the ocean side of the Honoapiilani Highway (Figures 3 and 13) located directly in-line with Location 5b (discussed below). The field visit confirmed the absence of a culvert at Location 5a (Figure 15). There is no evidence of flow from Ditch 6 towards the ocean.

There is no culvert visible on the land side of the existing Honoapiilani Highway at Location 5b in line with Ditch 6.

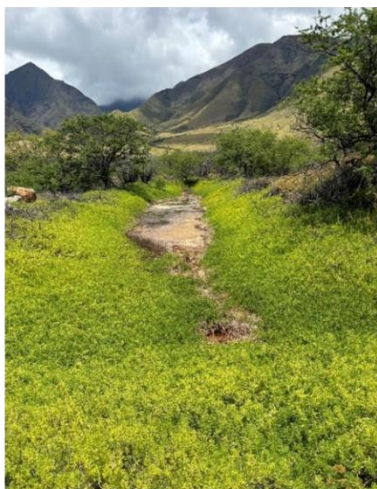
Photo depicting Ditch 6 at Location 5b, land side view.

Location 5b is located at Ditch 6 (D6, Figures 2 and 14), the northernmost end of the delineated wetlands W1 and W2. This location was investigated when field studies conducted earlier in the day indicated that the culvert connecting Hanaula Gulch to the ocean at Locations 4a and 4b was in fact blocked and no longer functional as an open culvert connection. D6 is perpendicular to and terminates at the Honoapiilani Highway. There is a steep drop from the land side edge of the roadway into this ditch, the bottom of which is about 5-8 feet below grade of the Honoapiilani Highway (Figure 14). There are dense thickets of pickleweed down this steep slope and on both banks of the ditch. Searching in the pickleweed thicket on the slope did not reveal any signs of a culvert at this location. Water from D6 runs parallel to the Highway via D7 through the various ditches (D1-D5) toward Hanaula Gulch and does not flow into the ocean at this location (Figure 2). Field observations confirmed that there is no functional surface connection between Location 5b and 5a (Figure 15). This finding

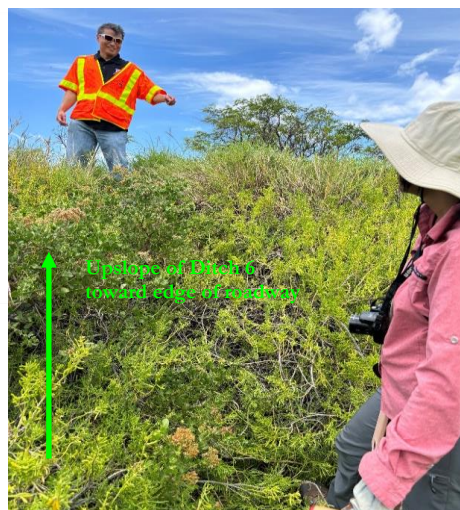
Dense pickleweed with no obvious culvert blocked, at Location 5b, ocean side view.
