HONOAPI'ILANI HIGHWAY IMPROVEMENTS PROJECT,  
WEST MAUI: UKUMEHAME TO LAUNIUPOKO

# Appendix 3.9 – Water Resources, Wetlands, and Floodplains - Supplemental Information

**Honoapiilani Highway Improvement Project  
Preliminary Identification of Waters of the United States  
Technical Report**

**Project # 4692-02**

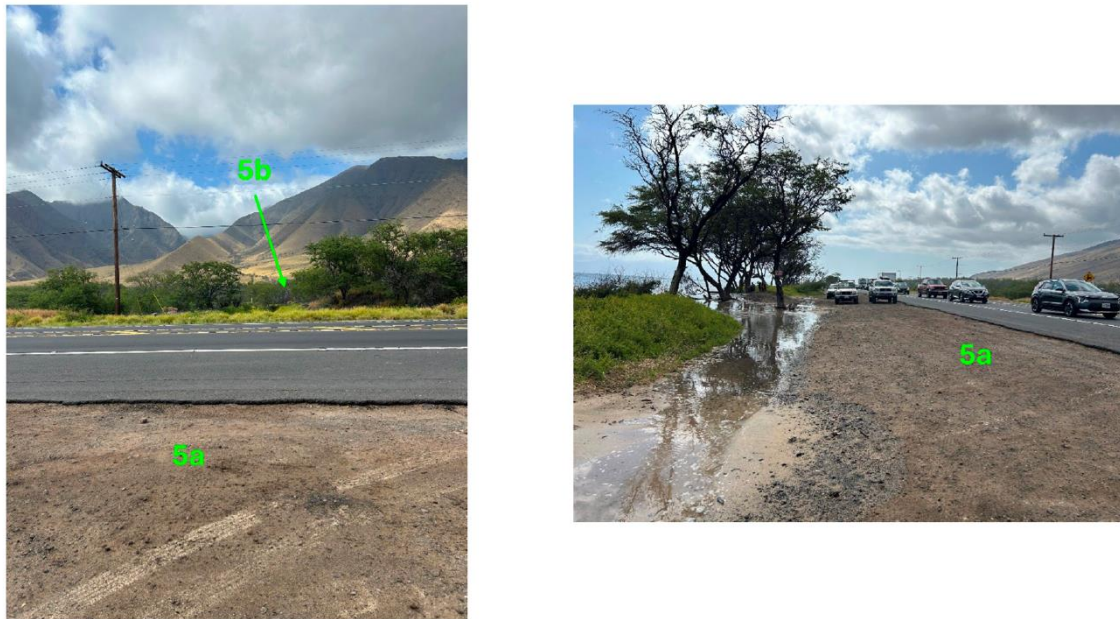
**Figure 15: Photo Evidence of No Culvert at Locations 5a and 5b**

Location 5b is located at Ditch 6 (D6, Figures 2 and 14), the northernmost end of the delineated wetlands W1 and W2. This location was investigated when field studies conducted earlier in the day indicated that the culvert connecting Hanaula Gulch to the ocean at Locations 4a and 4b was in fact blocked and no longer functional as an open culvert connection. D6 is perpendicular to and terminates at the Honoapiilani Highway. There is a steep drop from the land side edge of the roadway into this ditch, the bottom of which is about 5-8 feet below grade of the Honoapiilani Highway (Figure 14). There are dense thickets of pickleweed down this steep slope and on both banks of the ditch. Searching in the pickleweed thicket on the slope did not reveal any signs of a culvert at this location. Water from D6 runs parallel to the Highway via D7 through the various ditches (D1-D5) toward Hanaula Gulch and does not flow into the ocean at this location (Figure 2). Field observations confirmed that there is no functional surface connection between Location 5b and 5a (Figure 15). This finding

reinforces the conclusion that there is no evidence of continuous surface connection from W1, W3, W4 to the ocean, and that these wetlands are therefore potentially non-jurisdictional.

There is no culvert under the existing Honoapiʻilani Highway at the ocean side at this location

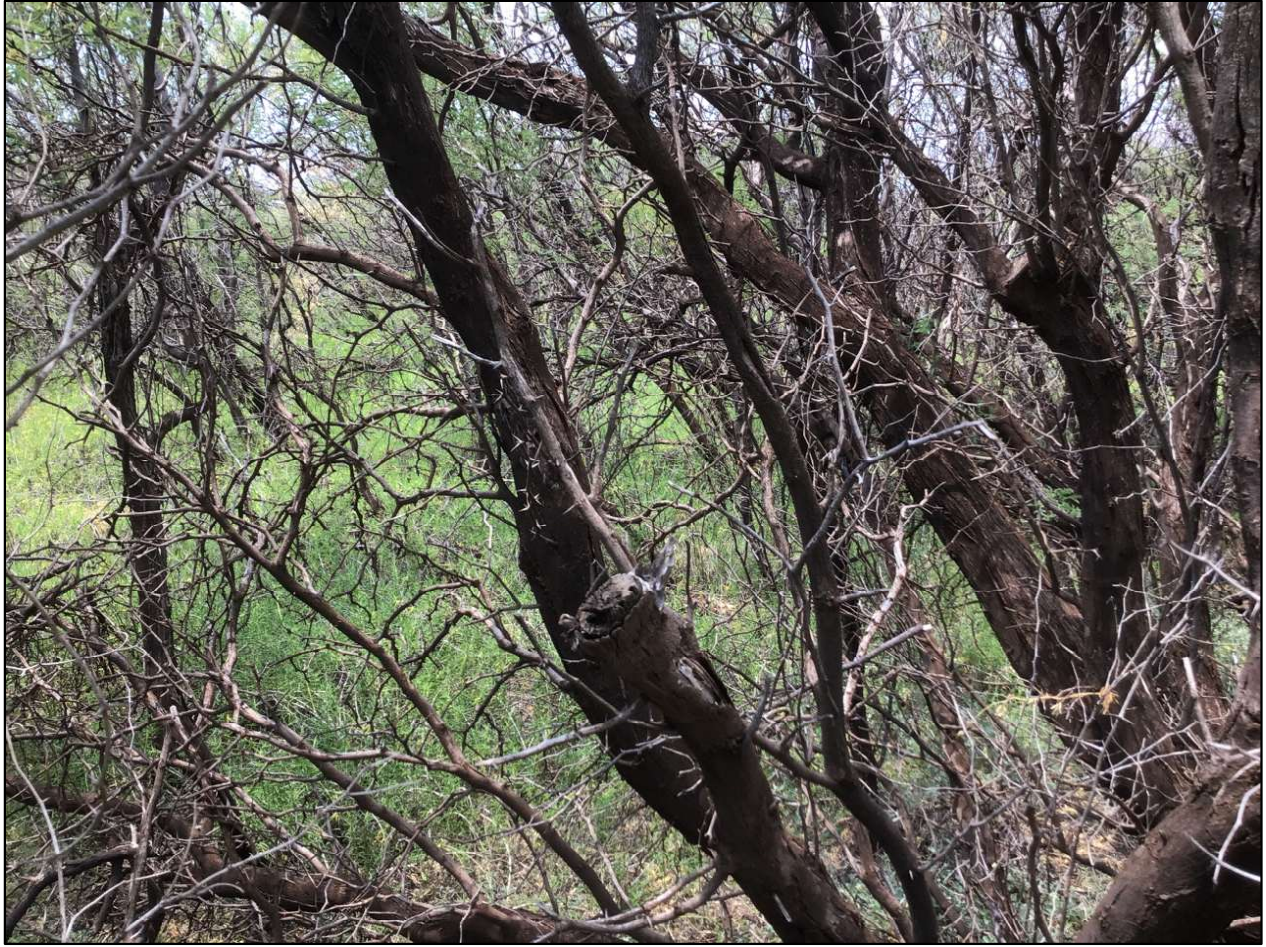
Hydric soil indicator observed at SP12 in 2023 that is representative of wetland W12 had “Redox Depressions (F8)” with the redox features showing prominent contrast and the soil texture was clay. In general, the delineated wetland that W12 is part of has Kealia Silty Loam, 0 to 1 percent slopes and is listed on the National Hydric Soils List as hydric soils (NRCS 2025b). Kealia Silty Loams are common in tidal flat and salt marshes on Maui, are prone to frequent ponding, and are strongly saline.

Similar to the surrounding wetlands, W12 is situated in the Ukumehame floodplain that experiences seasonal flooding during the winter/rainy season. Secondary hydrology indicators of drainage patterns (B10) and stunted and stressed plants (D1) were observed in W12. In general, surface water from streams in West Maui mountains

**Photo 2.** View of wetland 12 taken from the Maui County Road leading to the firing range. View to the north. Stressed kiawe trees in the foreground with dense ground cover of the obligate pickleweed (*Batis maritima*) plants in the background.

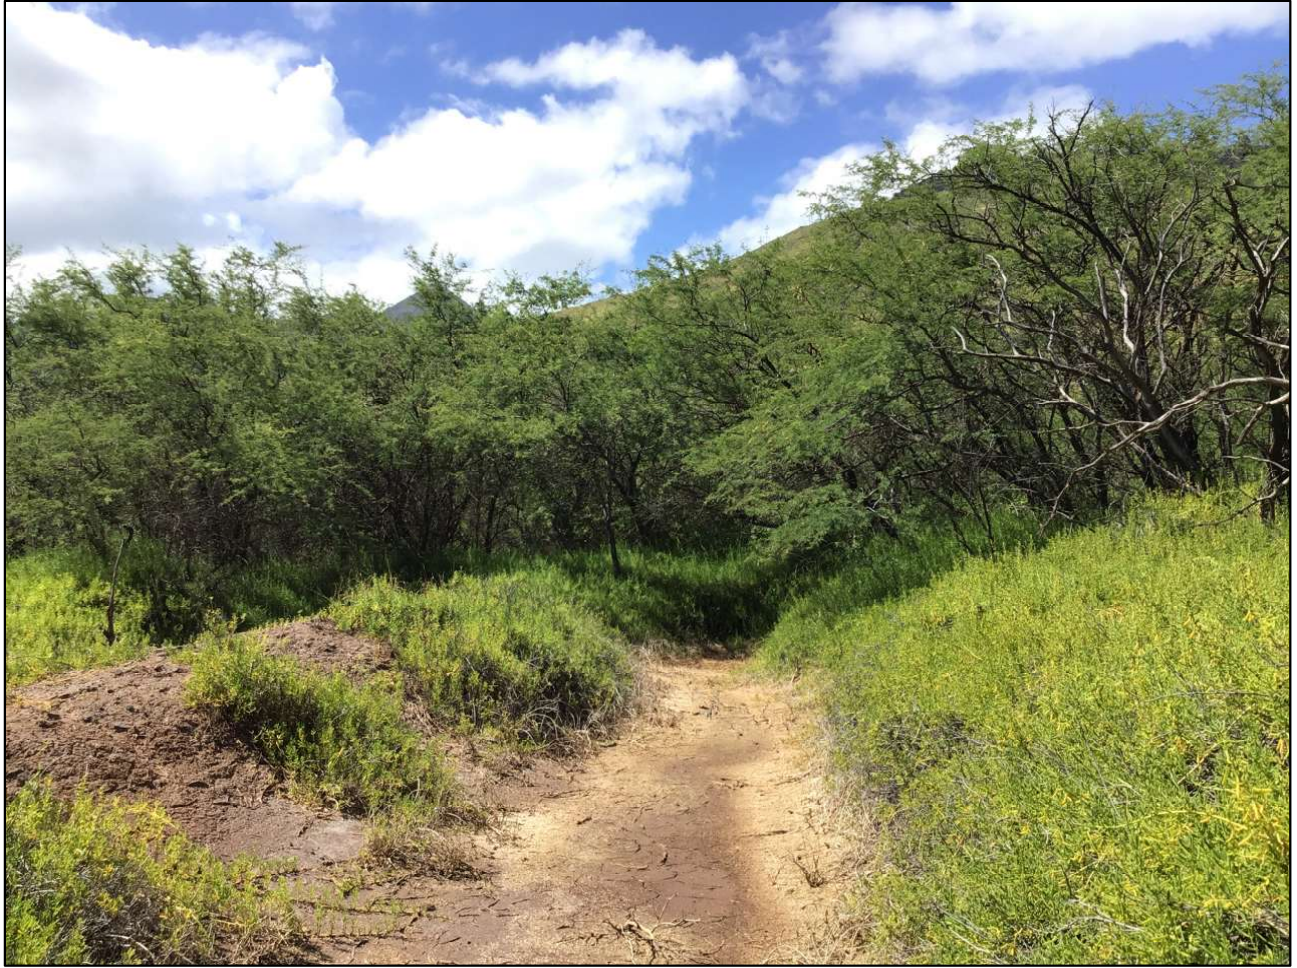
**Photo 3.** Photo taken in 2023 near the northern end (toward tip of the triangular shaped W12 parcel) of W12 with dense pickleweed (*Batis maritima*) ground cover and with dead and dying kiawe (*Prosopis pallida*) trees (right corner). View to the east.

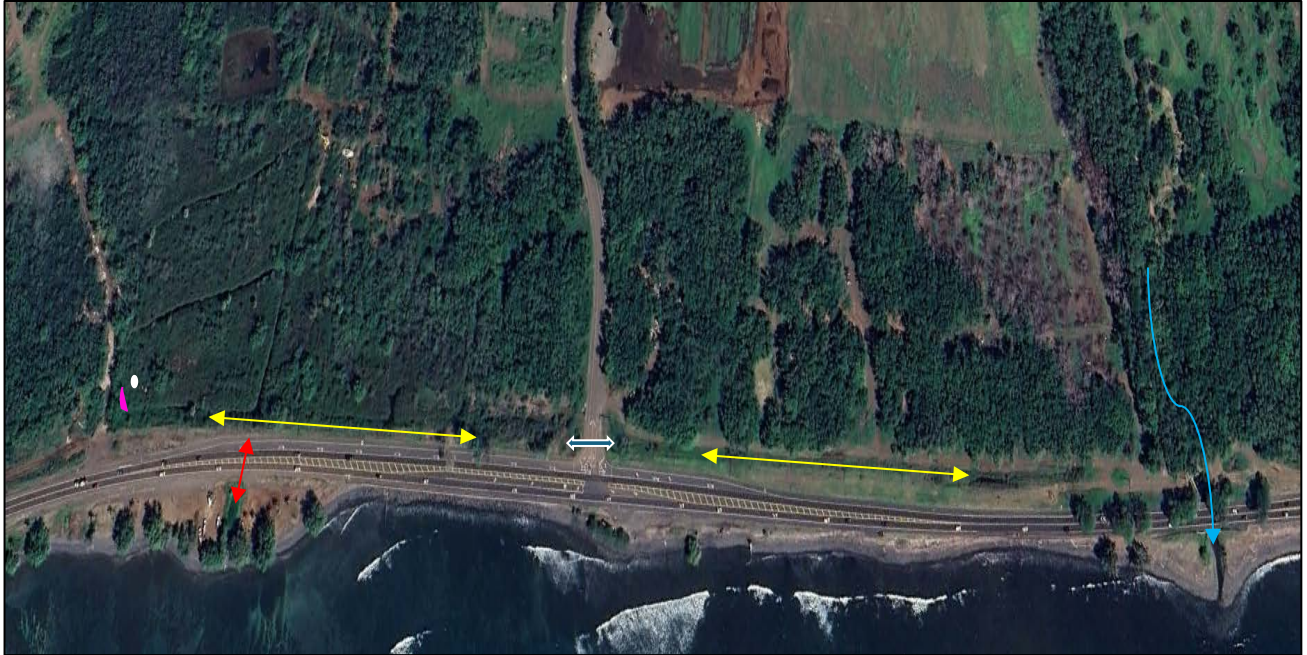
**Photo 4.** Approximate landscape location of SP21 (white dot to the left). Other features illustrated in this landscape picture are Ditch 14 (pink blob), Ditch 9 (yellow arrows), connection of Ditch 9 to the Pacific Ocean (red arrow), culvert at Ehehene Street (white arrow), and the perennial Ukumehame Stream (blue arrow).

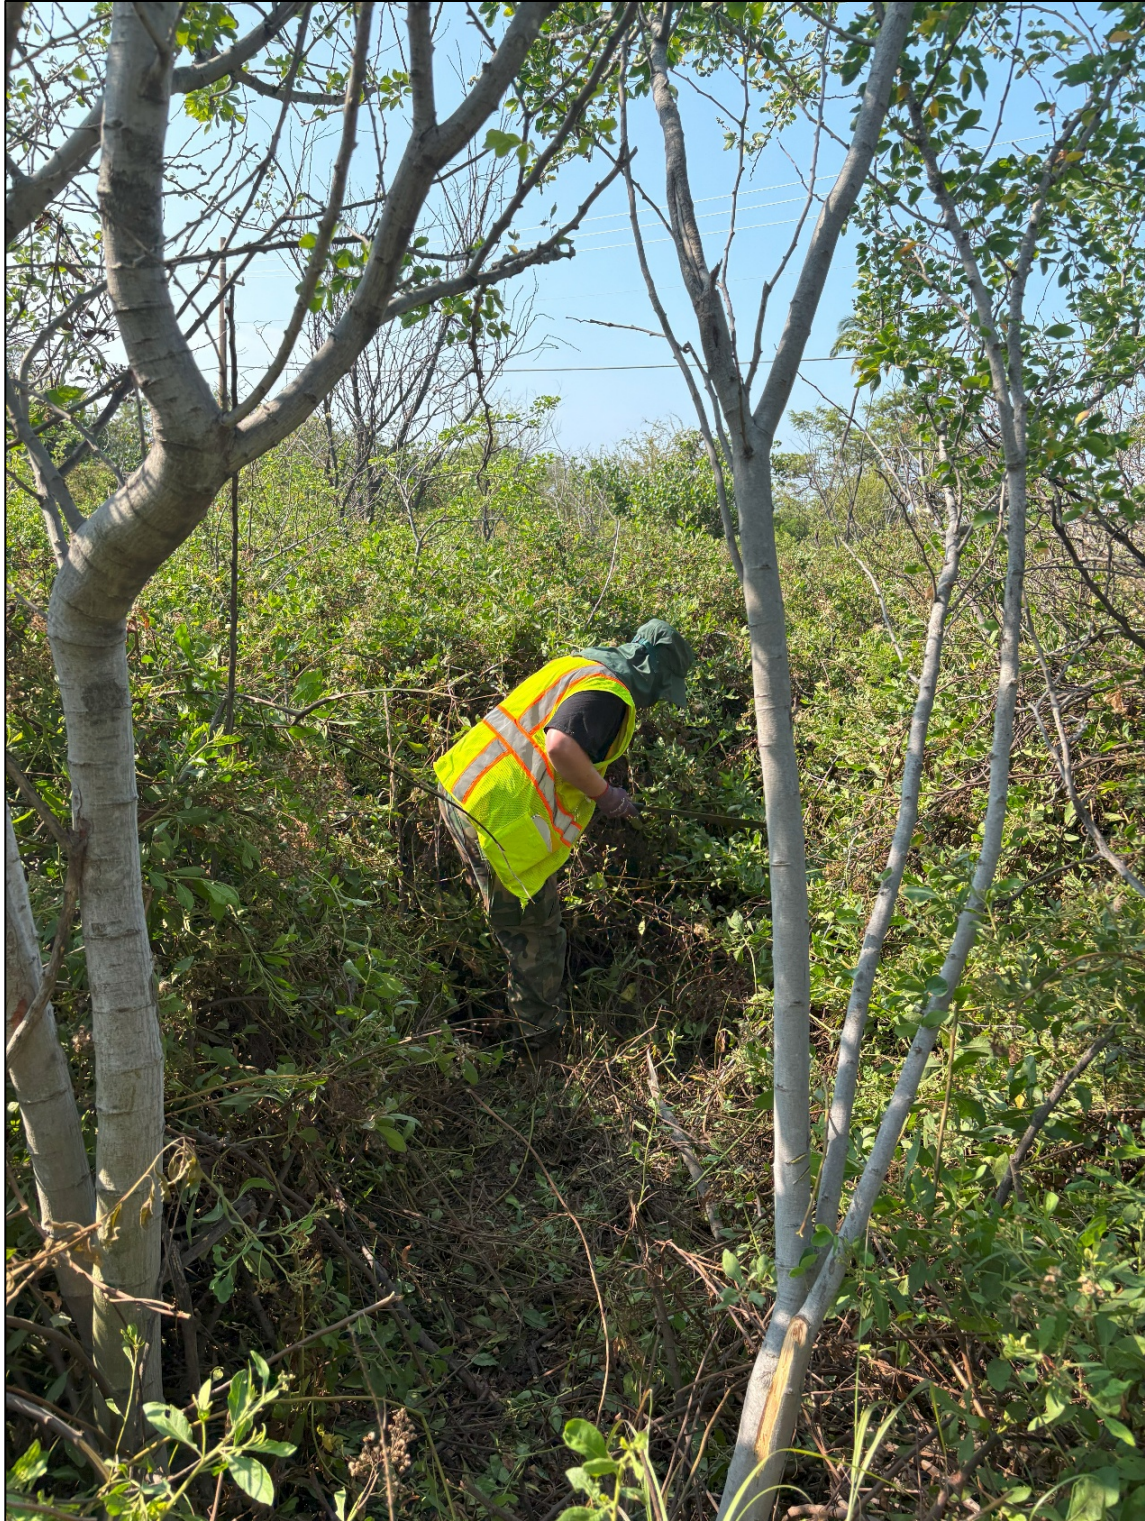
**Photo 5.** Dense thickets of facultative shrubs *Pluchea* spp. (*Pluchea x fosbergii* and *Pluchea indica*) where SP21 was placed. View to the west. Stressed upland kiawe (*Prosopis juliflora*) trees in the backgroud. Facultative milo (*Thespesia populnea*) trees in the foreground.

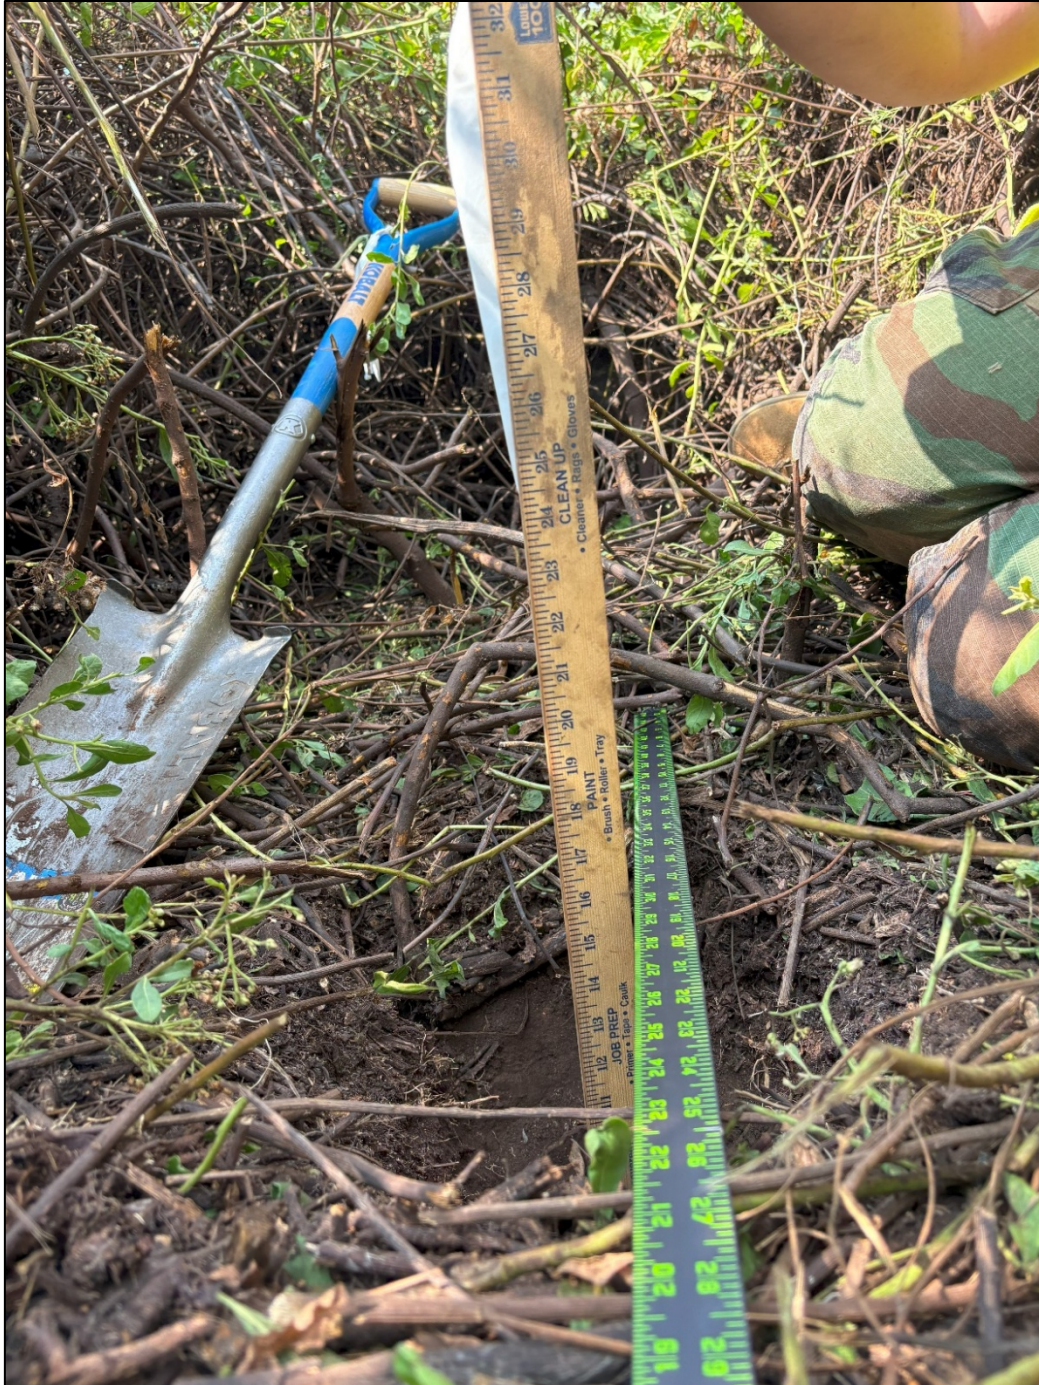
**Photo 6.** Soil pit at SP21 revealed non-hydric soils of loam and clay textures. The top three inches was composed of woody debris/organic matter.

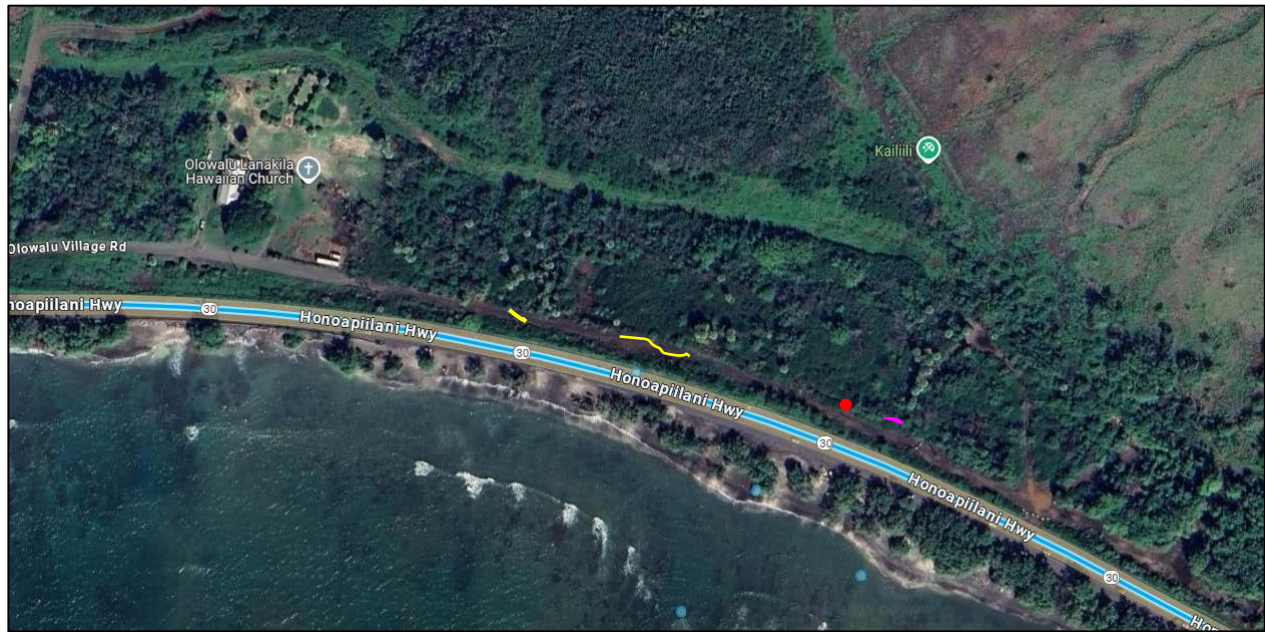
**Photo 4.** Approximate landscape location of SP22 (red dot) in the Olowalu area. The area is relatively disturbed and overlaps remnant ditches from the time of the sugarcane plantation. The yellow lines illustrate the approximate location of the isolated non-jurisdiction ditches (D10 and D 11) that were delineated in 2023 and had water in it. The pink line illustrate the approximate location of the ditch delineated during this 2025 survey.

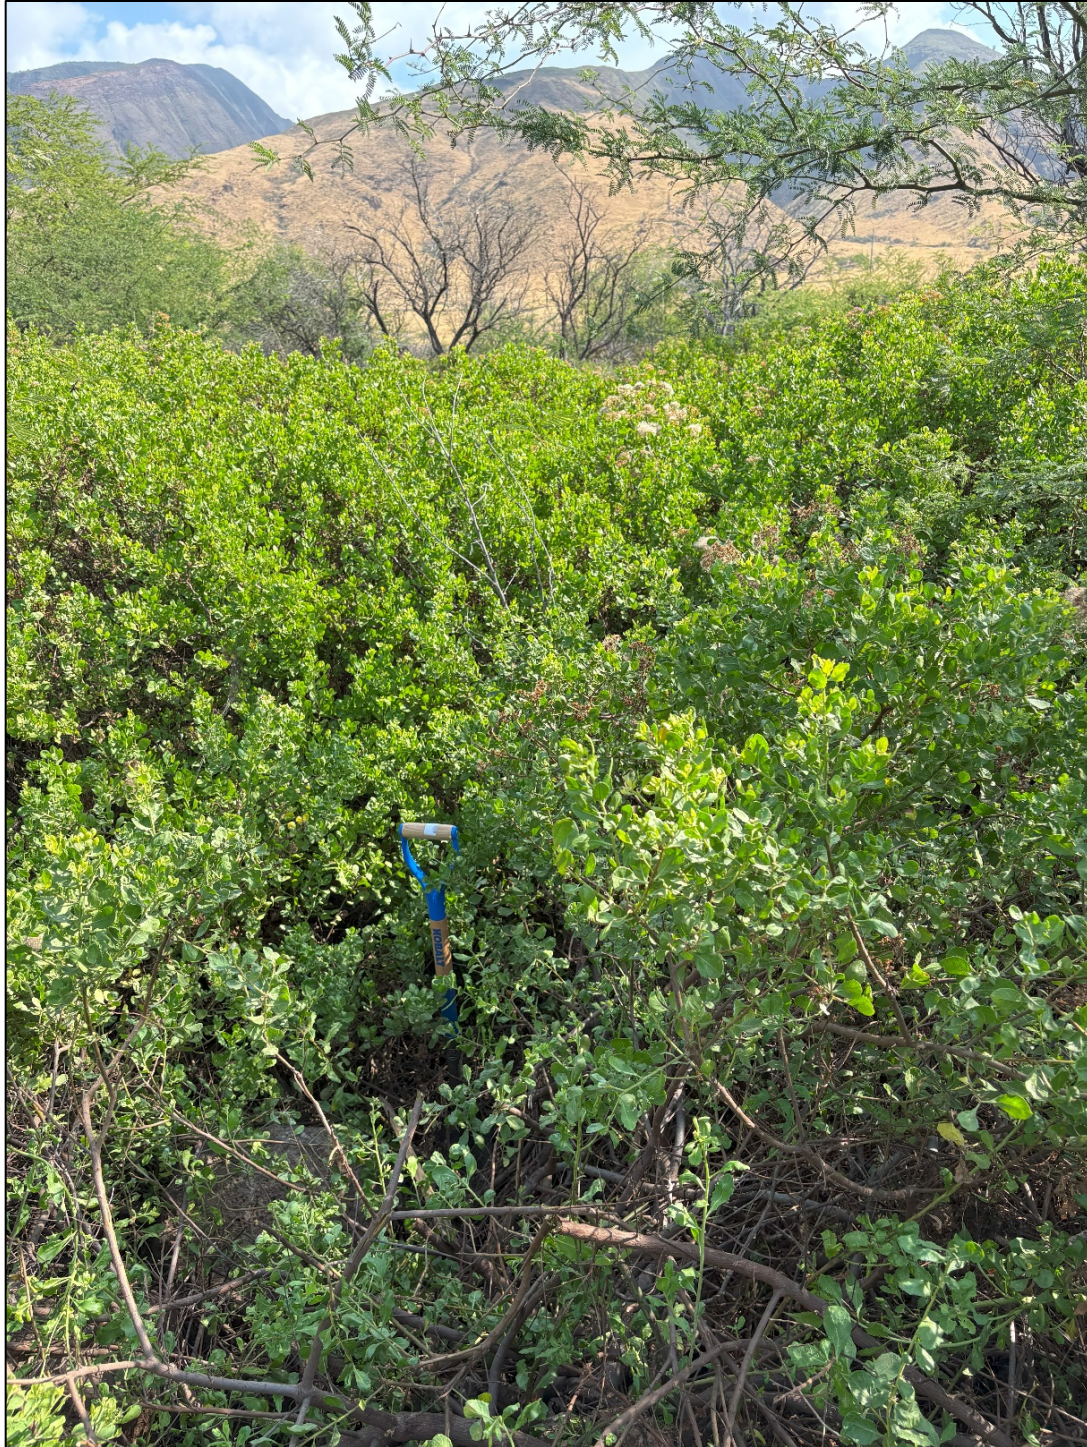
**Photo 5.** SP22 was placed amidst dense thickets of facultative thickets of *Pluchea* spp. (*Pluchea x fosbergii* and *Pluchea indica*). Stressed out kiawe (*Prosopis pallida*) trees seen in the background were scattered amongst the *Pluchea* thickets.

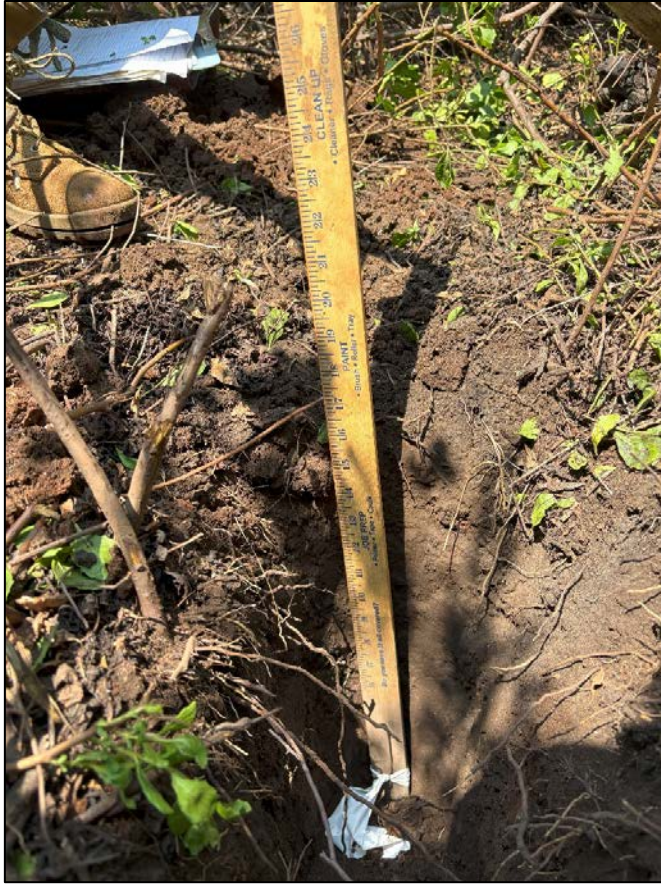
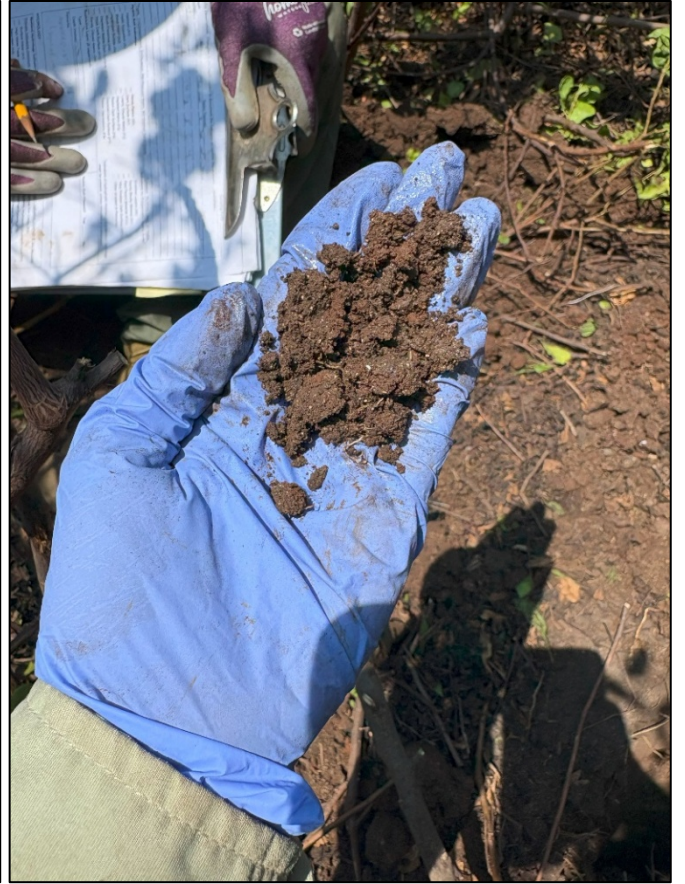
**Photo 6.** Soil sampled at SP22 was dry and did not meet any hydric soil indicators. There were some brick pieces in the profile as seen in the sample (picture to the right) suggesting fill.

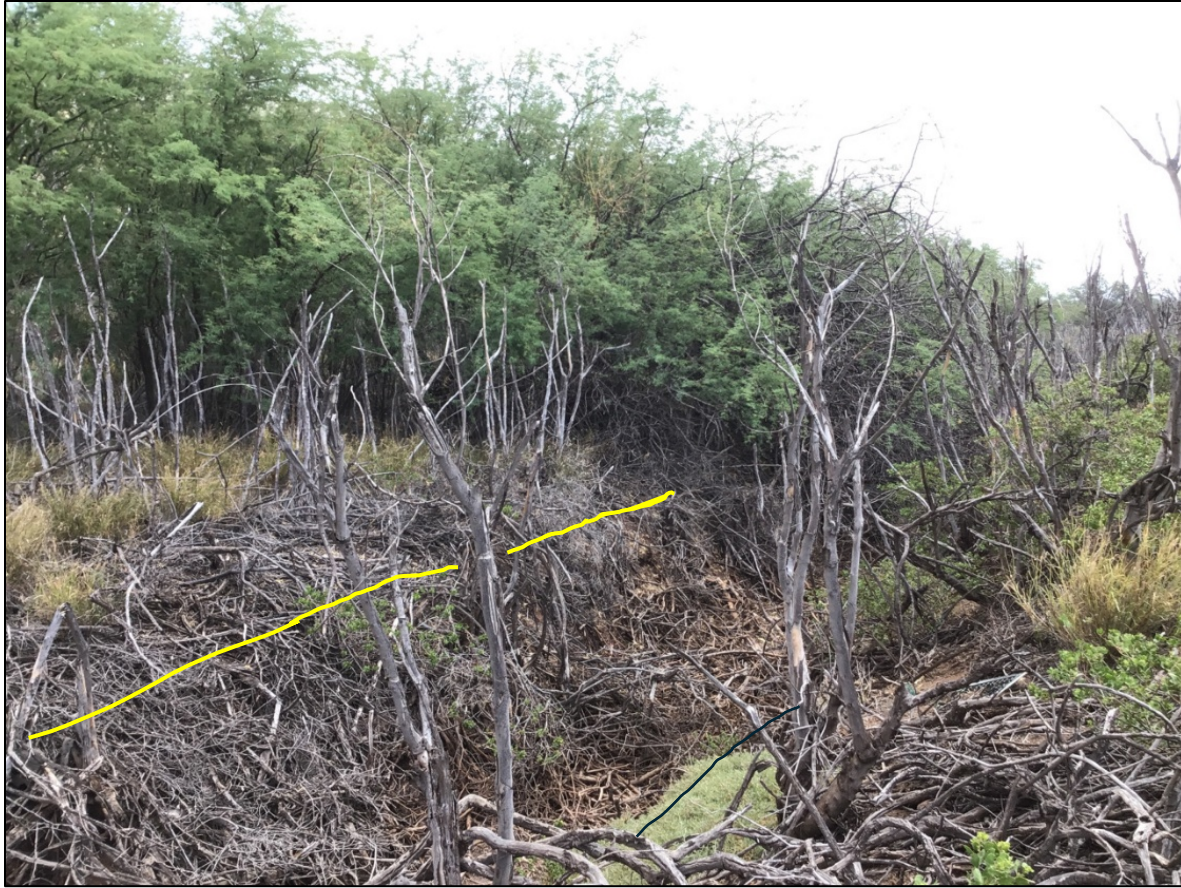
**Ditch 13**—Ditch 13 in parcel 2 is part of the agricultural ditch system in the Ukumehame flood plain (Appendix A, Figure 7) that is remnant from the sugarcane plantation time on Maui. It enters parcel 2 from the southwestern border, runs north for 106 feet and abruptly ends (Appendix C, Photos 10, 11, and 12). Ditch 13 does not have a continuous surface connection to the ocean. It appears to derive its hydrology from the Hanaula Gulch and its associated ditches (D1 to D7 delineated in 2023) which are about 400 feet to the south of Ditch 13 and which also do not have a continuous surface connection to the ocean. Ditch 13 had a clear bed and bank and break in slope, observed above the OHWM level as the main indicator for this feature. The ditch had recently conveyed water as the bed was saturated with some scattered facultative species such as *Atriplex semibaccata*. Dead and dying matted down vegetation was an indicator below the OHWM level in this feature. The ditch was deeper (about 5 feet) at the southern end where it enters parcel 2, gets shallower toward the north and appeared to be filled at the northern end where it abruptly ends.

**Photo 10.** Break in slope (yellow line), dead matted down woody debris with mostly unvegetated bed with some recently recruited herbaceous plants in the saturated bed were the main OHWM indicators in Ditch 13. The approximate location where ditch enters parcel 2 of the Biological Study Area.

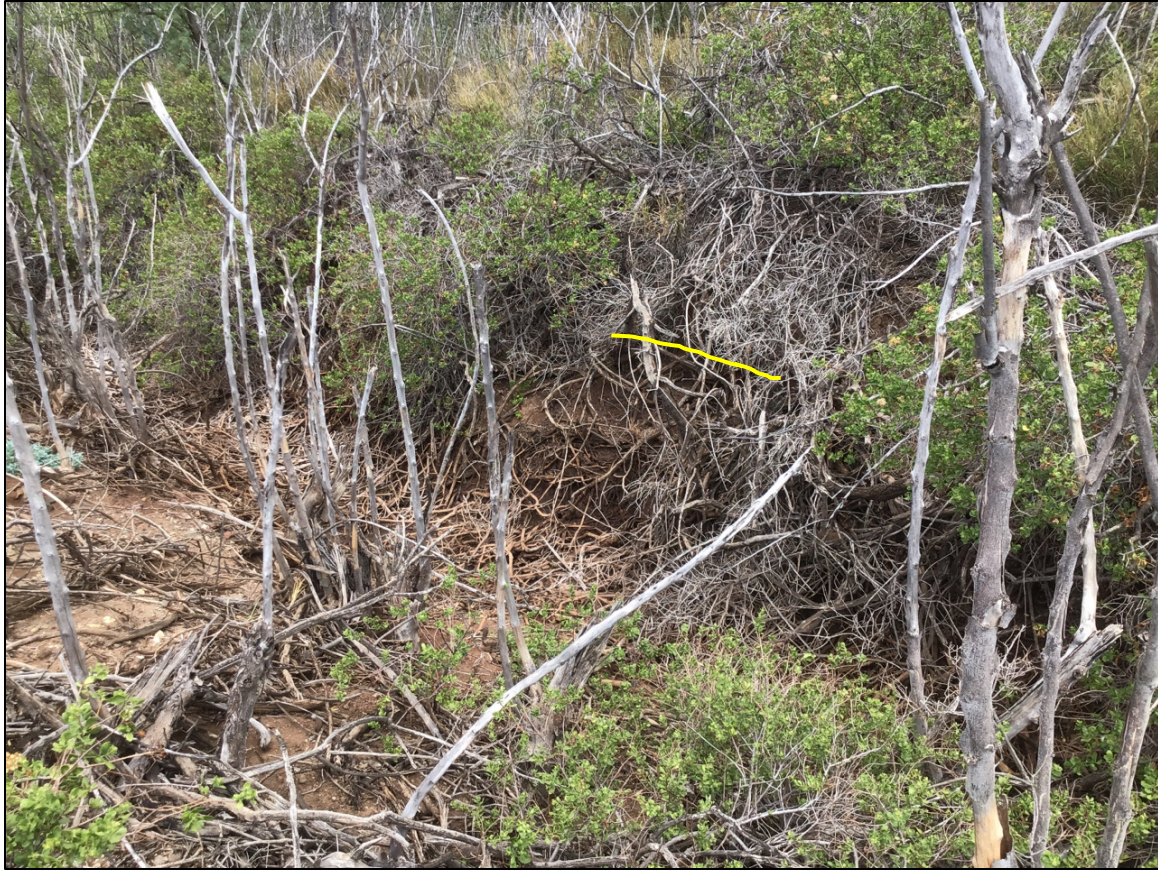
**Photo 11.** Undercut bank (yellow line) at some places and change in vegetation from unvegetated to vegetated banks were also used to determine the OHWM level in Ditch 13.

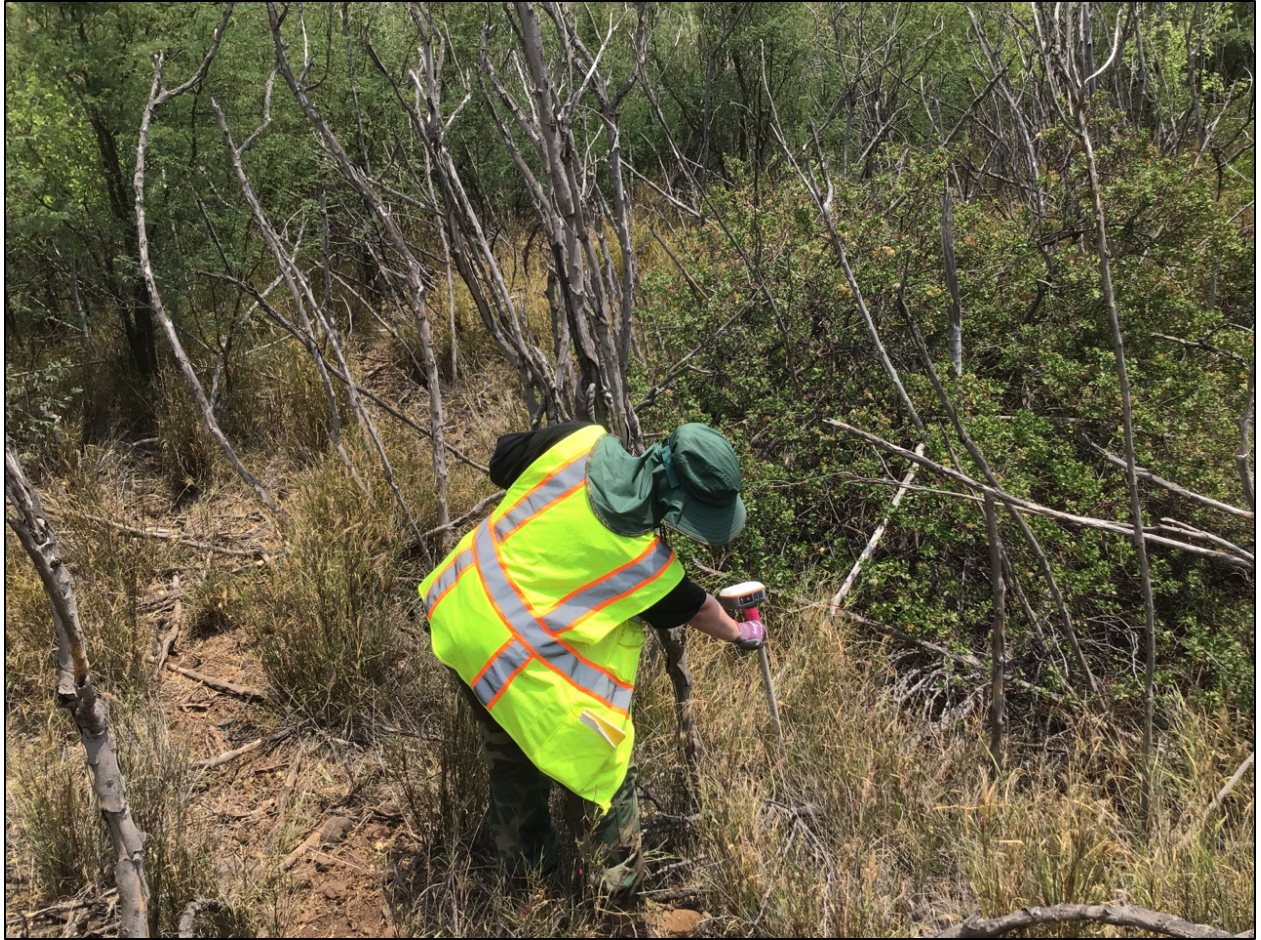
**Photo 12.** Location where Ditch 13 abruptly terminates in the northern portion of parcel 2 of the Biological Study Area.

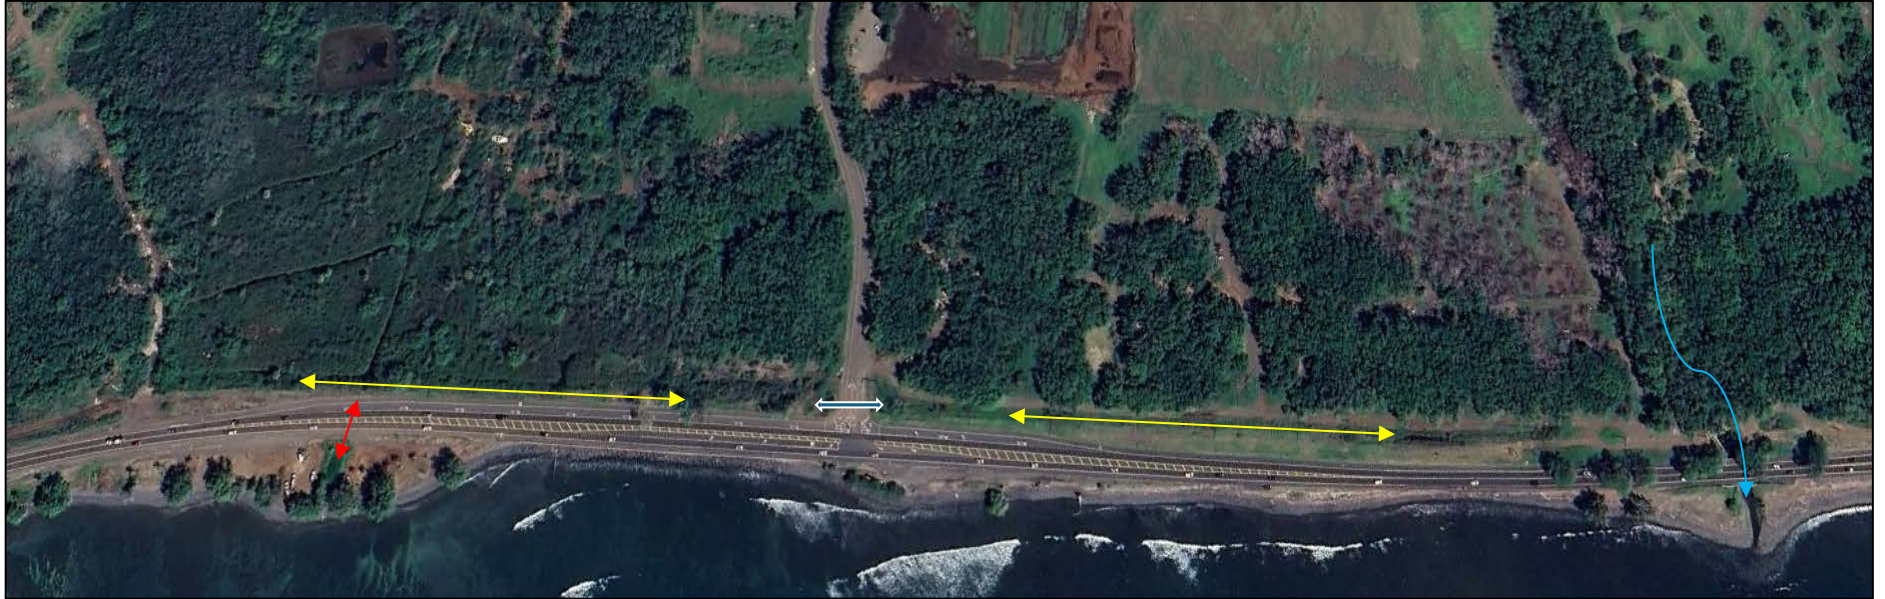
**Culvert – Ehehene Street**—This is a concrete culvert situated in parcel 5 (Appendix A, Figures 2 and 8). It runs in the north south direction below Ehehene Street, right where the street connects with the existing Honoapiilani Highway (Appendix C, Photos 13, 14, and 15). The culvert is about 150 feet from the Pacific Ocean and runs parallel to the ocean and the existing Honoapiilani Highway. It does not have a continuous surface connection to the ocean and conveys water in the north south direction amongst the remnant agricultural ditch system east of the existing Highway. It appears to derive its hydrology via surface flows (during and after rains) from Ukumehame Stream about 0.3 miles to the south and perennial ditch system (D9 and D14) about 350 feet to the north. The culvert was dry at the time of the survey and heavily overgrown with mostly upland plant species such as haole koa and buffel grass. The top beam of the concrete and the wings of the culvert that lead down to the ditch were used to identify the OHWM level here. Observations made and photos taken during the 2023 wetland delineation survey when the vegetation around this culvert was mowed (H. T. Harvey & Associates 2023) were also used to guide the OHWM delineation for this feature.

**Photo 13.** Landscape position of the Ehehene Street culvert (white two-way arrow), the ditch system (yellow arrows) that runs parallel to the existing Honoapiilani Highway, perennial Ukumehame Stream (blue arrow), and the location where the ditch system connects to the Pacific Ocean (red arrow) under the Highway.

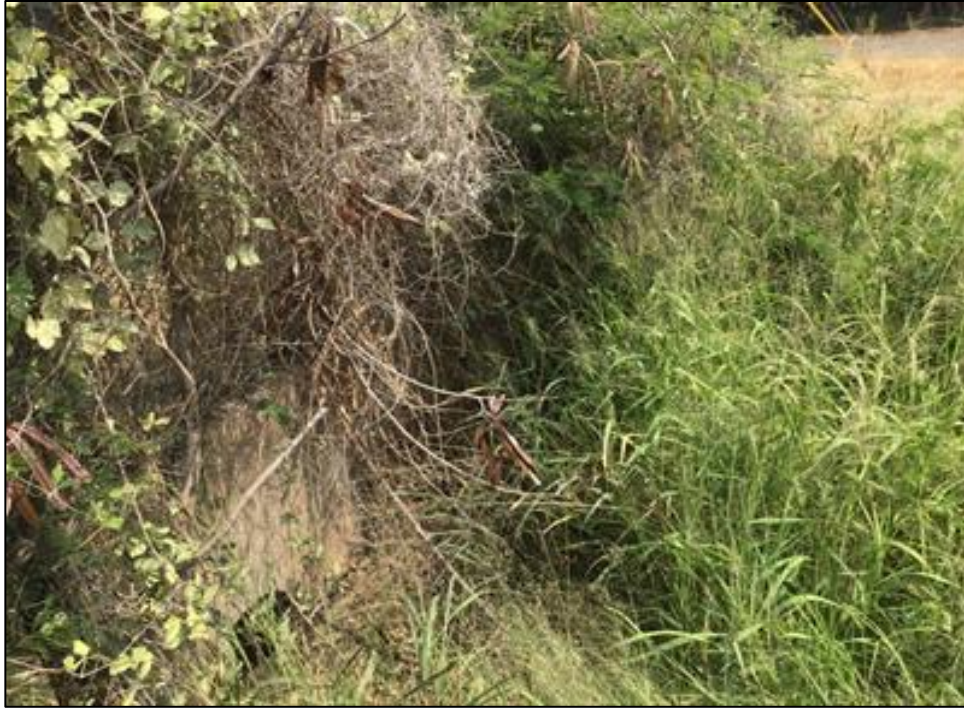
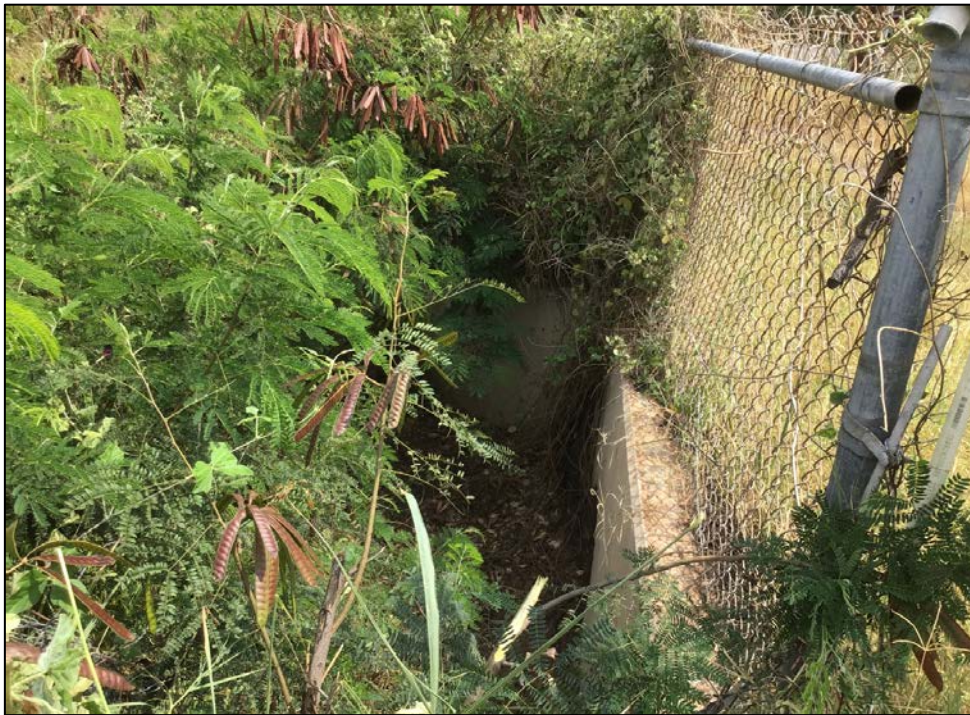
**Photo 14.** Ehehene Street culvert (south opening on top and north opening below) was overgrown with vegetation at the time of the 2025 survey.

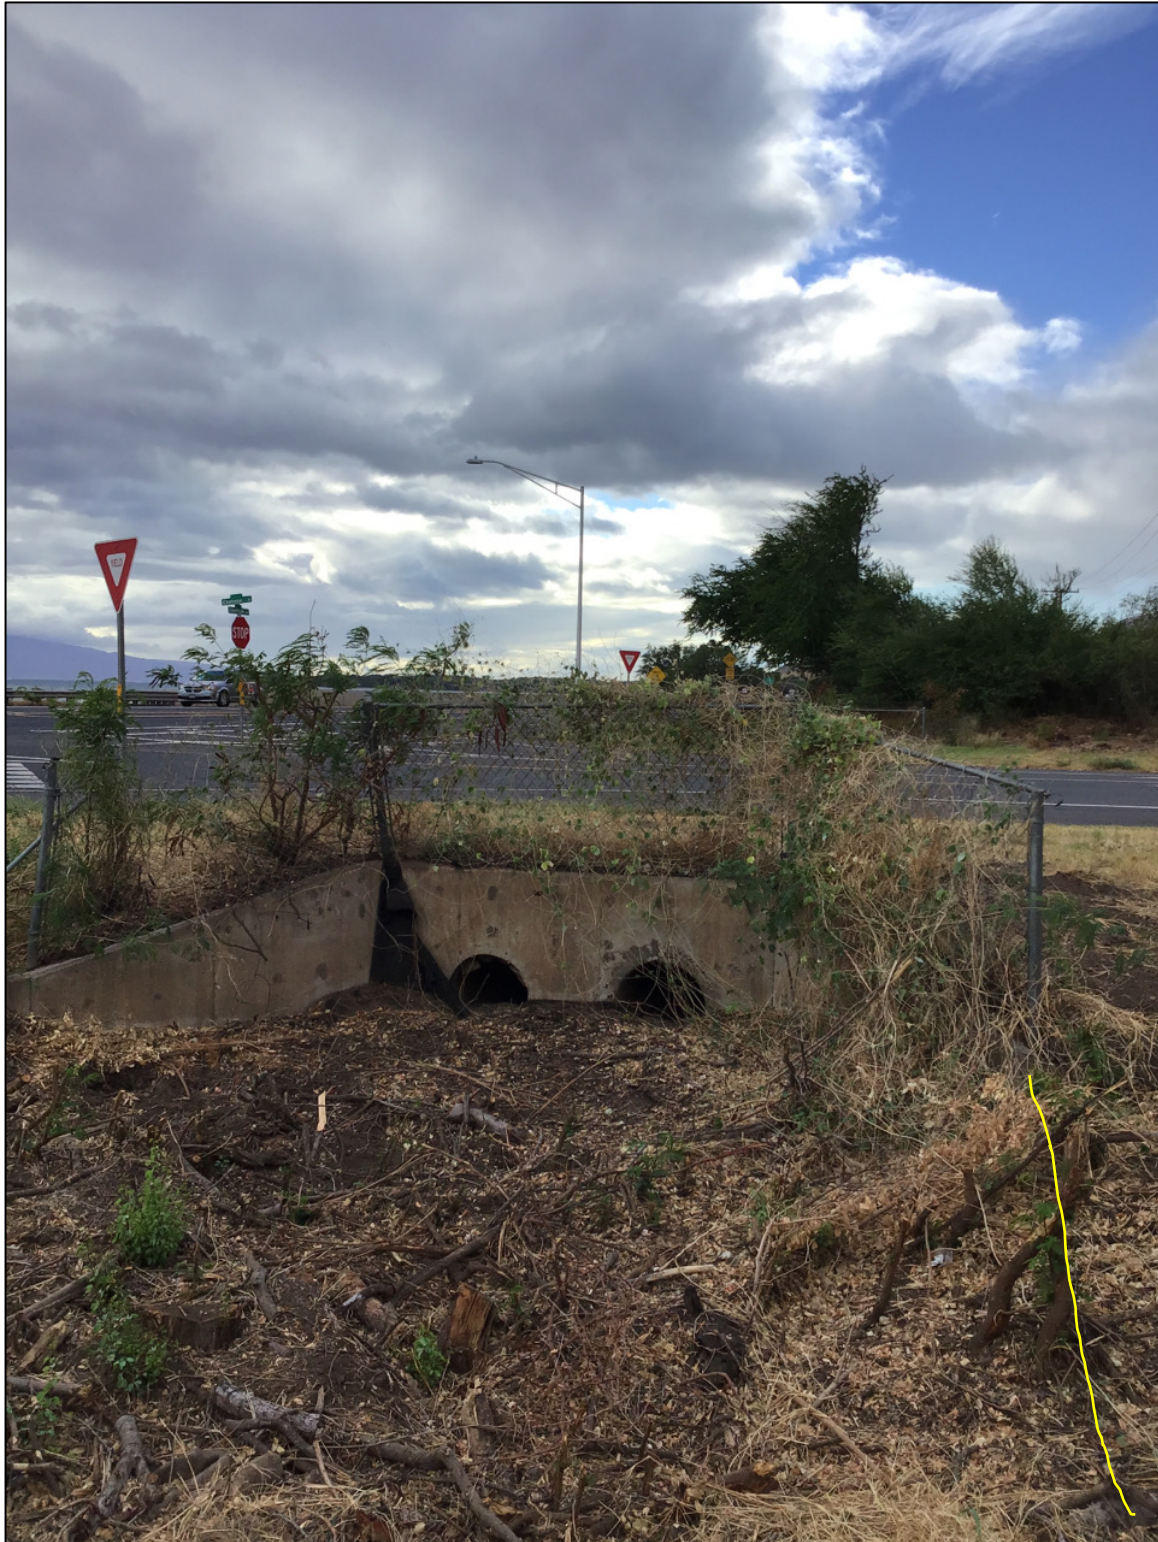
**Photo 15.** Ehehene Street culvert – south side (north view) as observed during the 2023 survey. Other than for a slight break in the slope (yellow line) no OHWM indicators were obvious at this disturbed and manipulated culvert location.

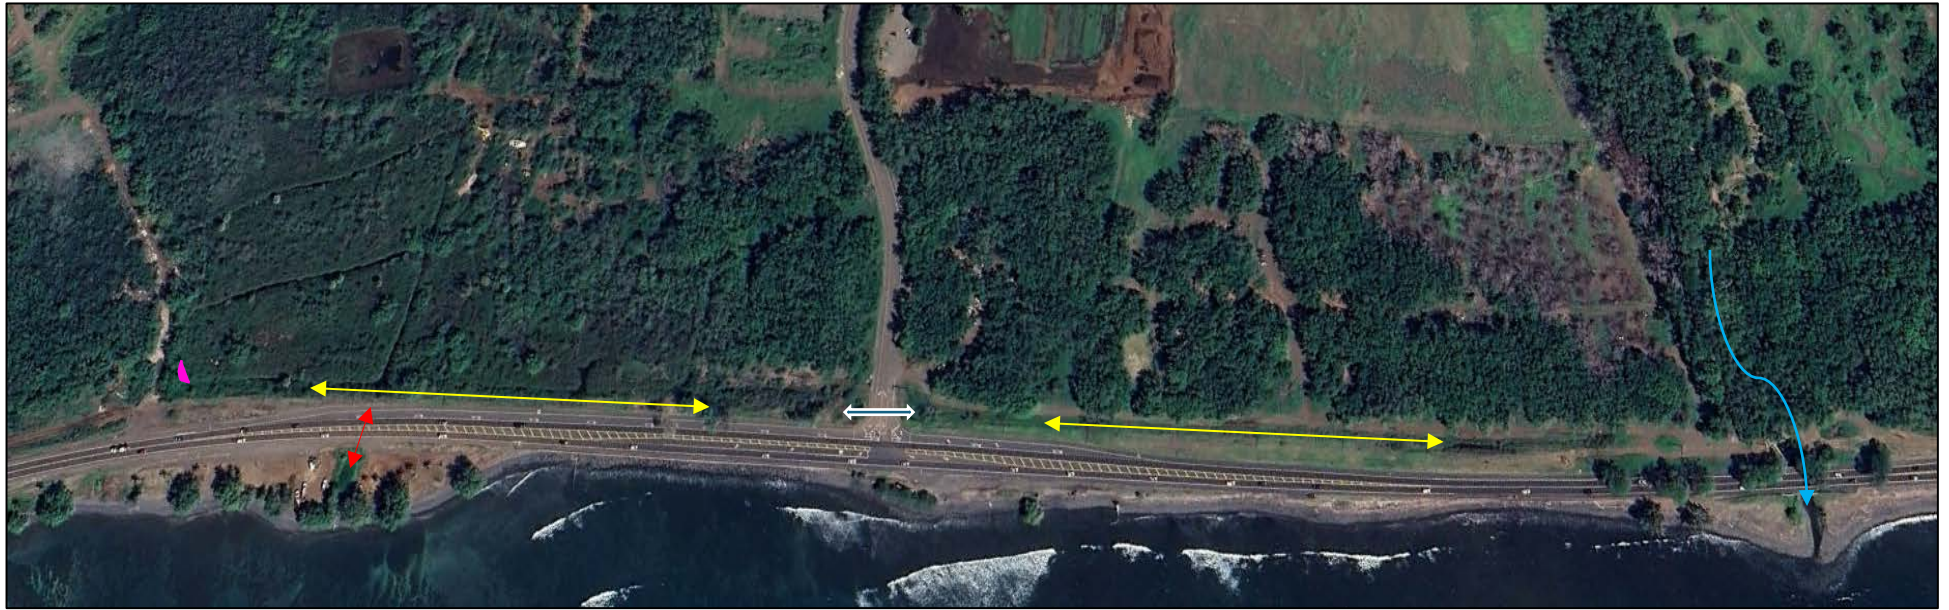
**Ditch 14**—This feature is located in parcel 6 of the 2025 BSA (Appendix A, Figures 2 and 8). It enters the parcel at the northwestern corner, bends to the west and abruptly ends (Appendix C, Photos 16-19). The ditch was heavily overgrown with dense thickets of facultative *Pluchea* spp. shrubs that made access and observations of OHWM features challenging. At one corner standing water was seen with break in bank and water-stained leaves along the top of the bank as OHWM indicators. As seen on the aerial imagery and based on field observations, Ditch 14 is connected to Ditch 9 that was delineated during the 2023 wetland study and has a continuous surface connection to the Pacific Ocean (H. T. Harvey & Associates 2023). Ditches D7 and D14 have year-long flows and probably deriving from hydrology from Ukumehame Stream (Appendix C, Photos 16-19). The dense cover of vegetation perhaps also helps retain water year-round in the ditches outside of rain events.

**Photo 16.** Landscape position of the Ditch 14 (pink blob to the left), the ditch system (yellow arrows) that runs parallel to the existing Honoapiilani Highway, Ehehene Street culvert (white two-way arrow), perennial Ukumehame Stream (blue arrow), and the location where the ditch system connects to the Pacific Ocean (red arrow) under the Highway.
