HONOAPI'ILANI HIGHWAY IMPROVEMENTS PROJECT,  
WEST MAUI: UKUMEHAME TO LAUNIUPOKO

# Appendix 3.9 – Water Resources, Wetlands, and Floodplains - Supplemental Information

**Honoapiilani Highway Improvement Project  
Preliminary Identification of Waters of the United States  
Technical Report**

**Project # 4692-02**

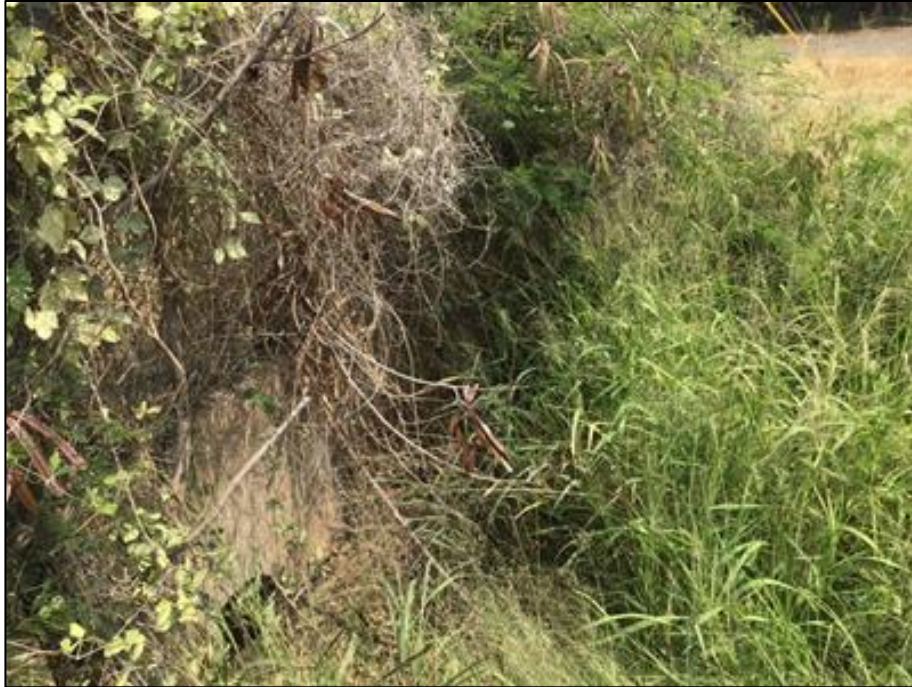
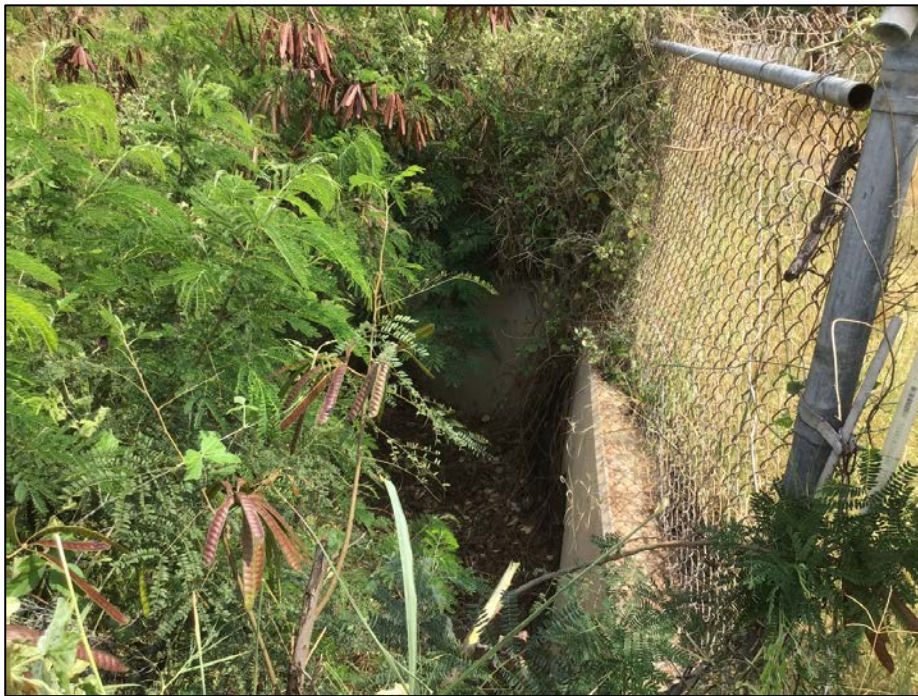
**Photo 17.** Ekehene Street culvert (south opening on top and north opening below) was overgrown with vegetation at the time of the 2025 survey.

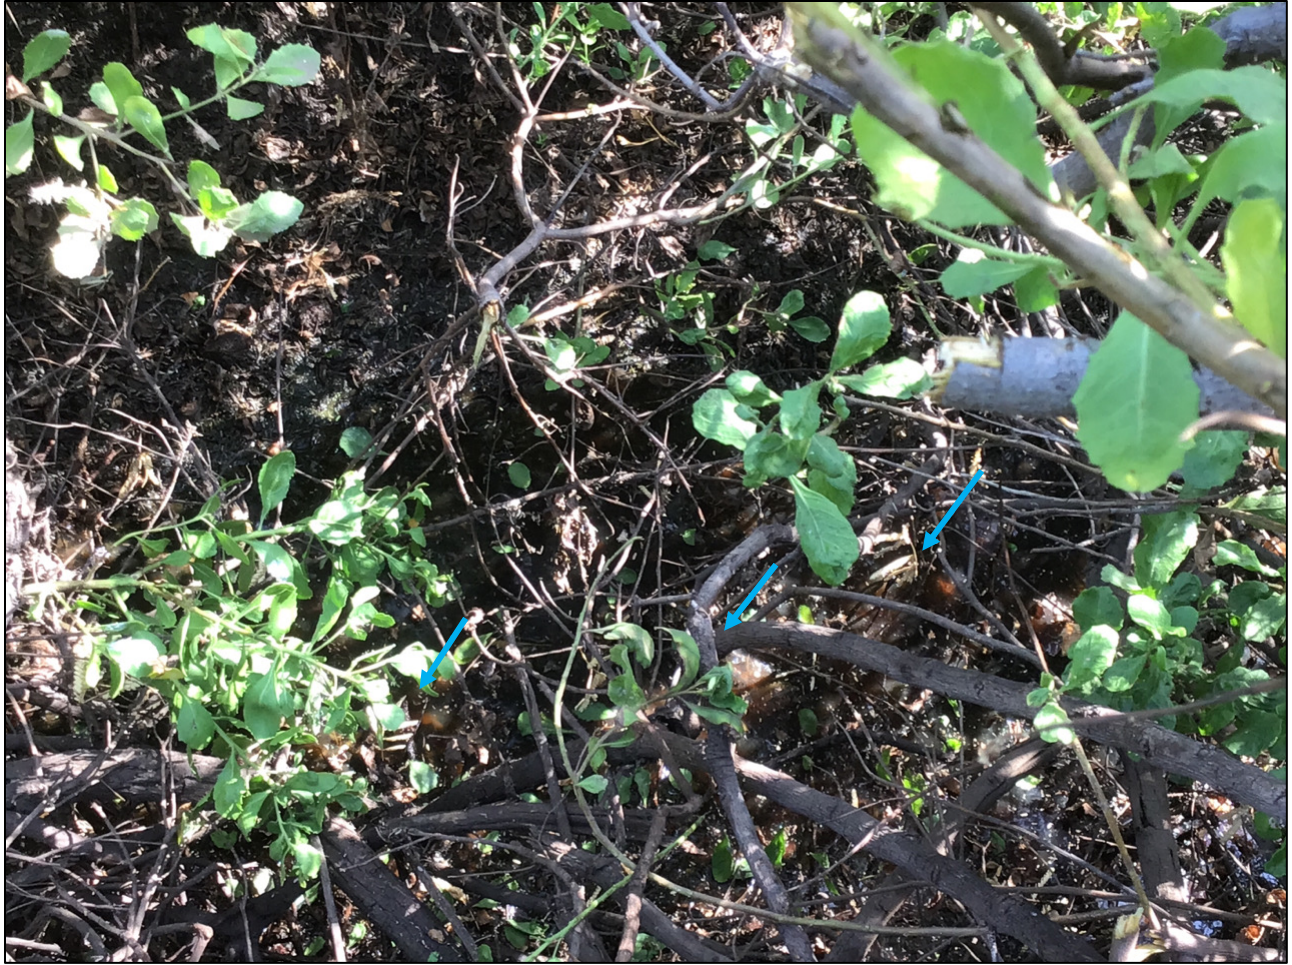
**Ditch 14**—This feature is located in parcel 6 of the 2025 BSA (Appendix A, Figures 2 and 8). It enters the parcel at the northwestern corner, bends to the west and abruptly ends (Appendix C, Photos 16-19). The ditch was heavily overgrown with dense thickets of facultative *Pluchea* spp. shrubs that made access and observations of OHWM features challenging. At one corner standing water was seen with break in bank and water-stained leaves along the top of the bank as OHWM indicators. As seen on the aerial imagery and based on field observations, Ditch 14 is connected to Ditch 9 that was delineated during the 2023 wetland study and has a continuous surface connection to the Pacific Ocean (H. T. Harvey & Associates 2023). Ditches D7 and D14 have year-long flows and probably deriving from hydrology from Ukumehame Stream (Appendix C, Photos 16-19). The dense cover of vegetation perhaps also helps retain water year-round in the ditches outside of rain events.

**Photo 18.** Brown (reflecting in photo her; blue arrows) Water in Ditch 14 under thickets of facultative *Pluchea* shrubs.

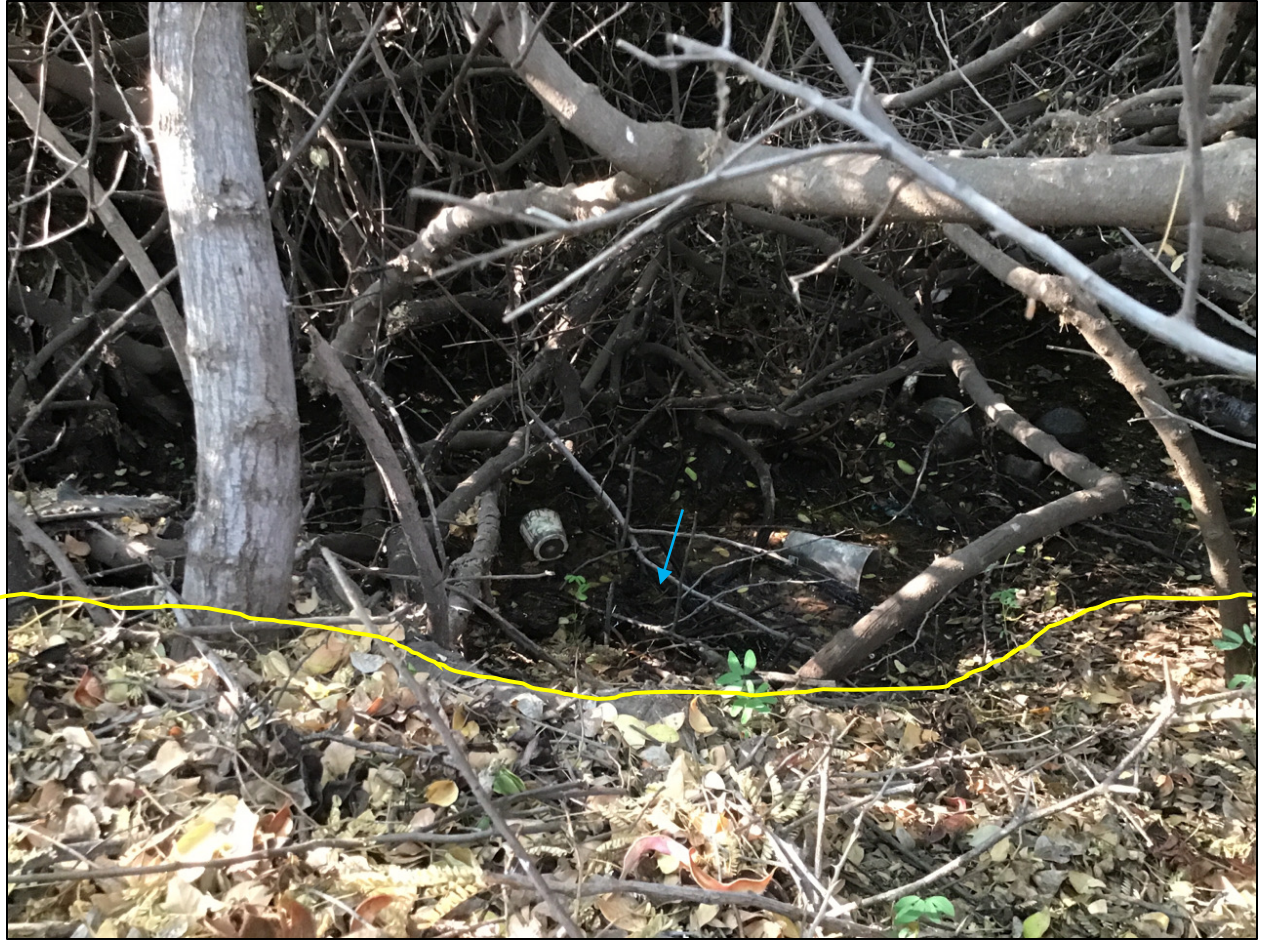
**Photo 19.** OHWM (yellow line) observed at Ditch 14 with water stained leaves on the bank. Blue arrow shows where standing water was observed.

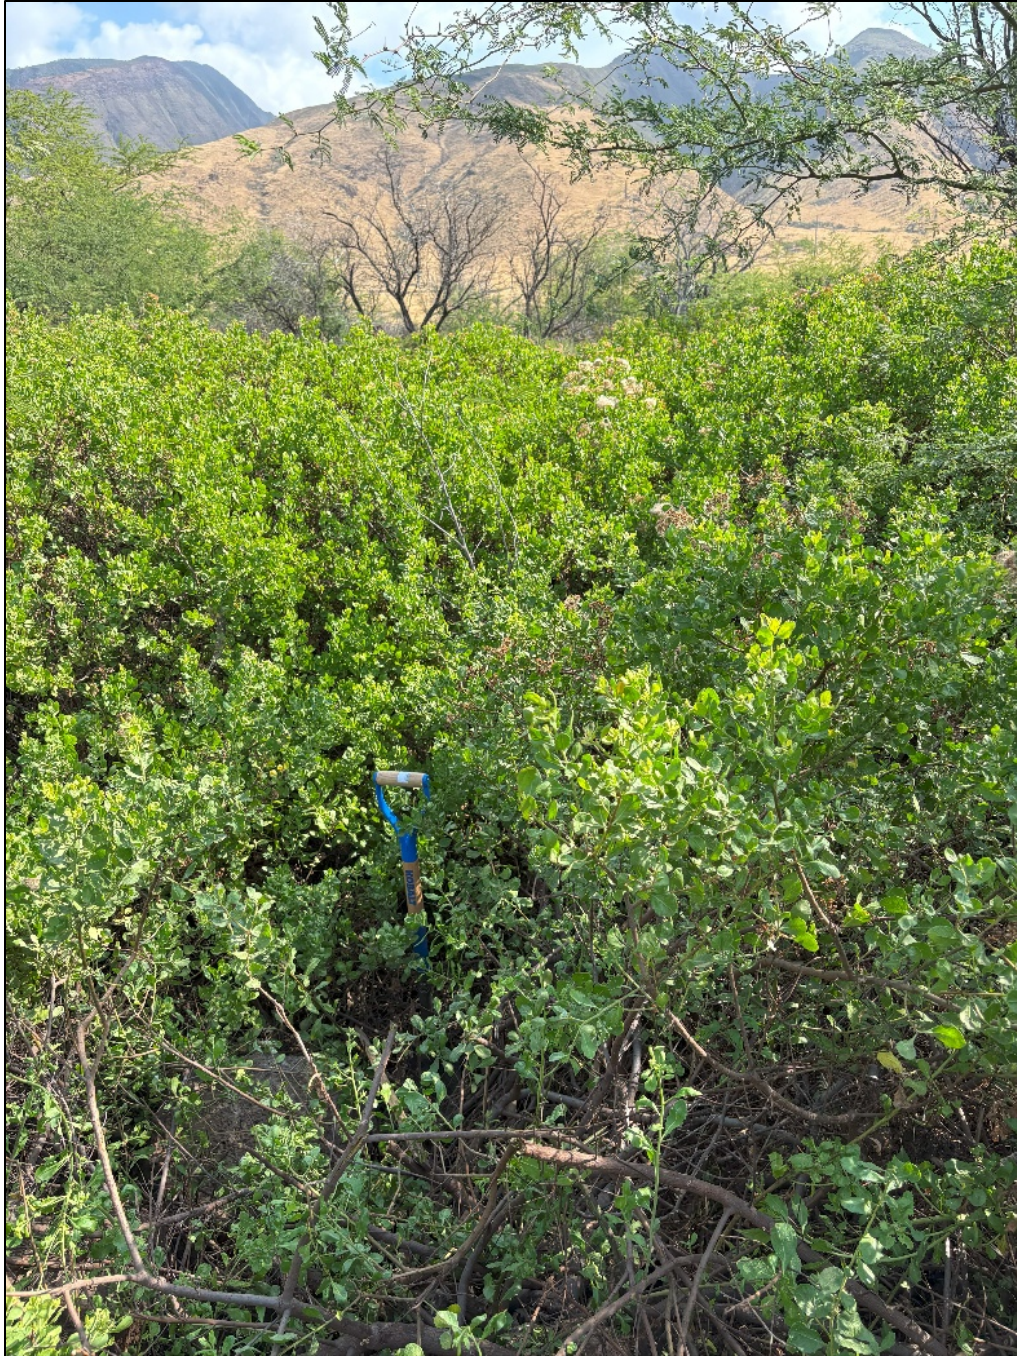
**Photo 20.** Ditch 15 overgrown with thickets of *Pluchea* spp. (*Pluchea x foxbergii* and *Pluchea indica*). Shovel indicates the location of the ditch under the dense vegetation.

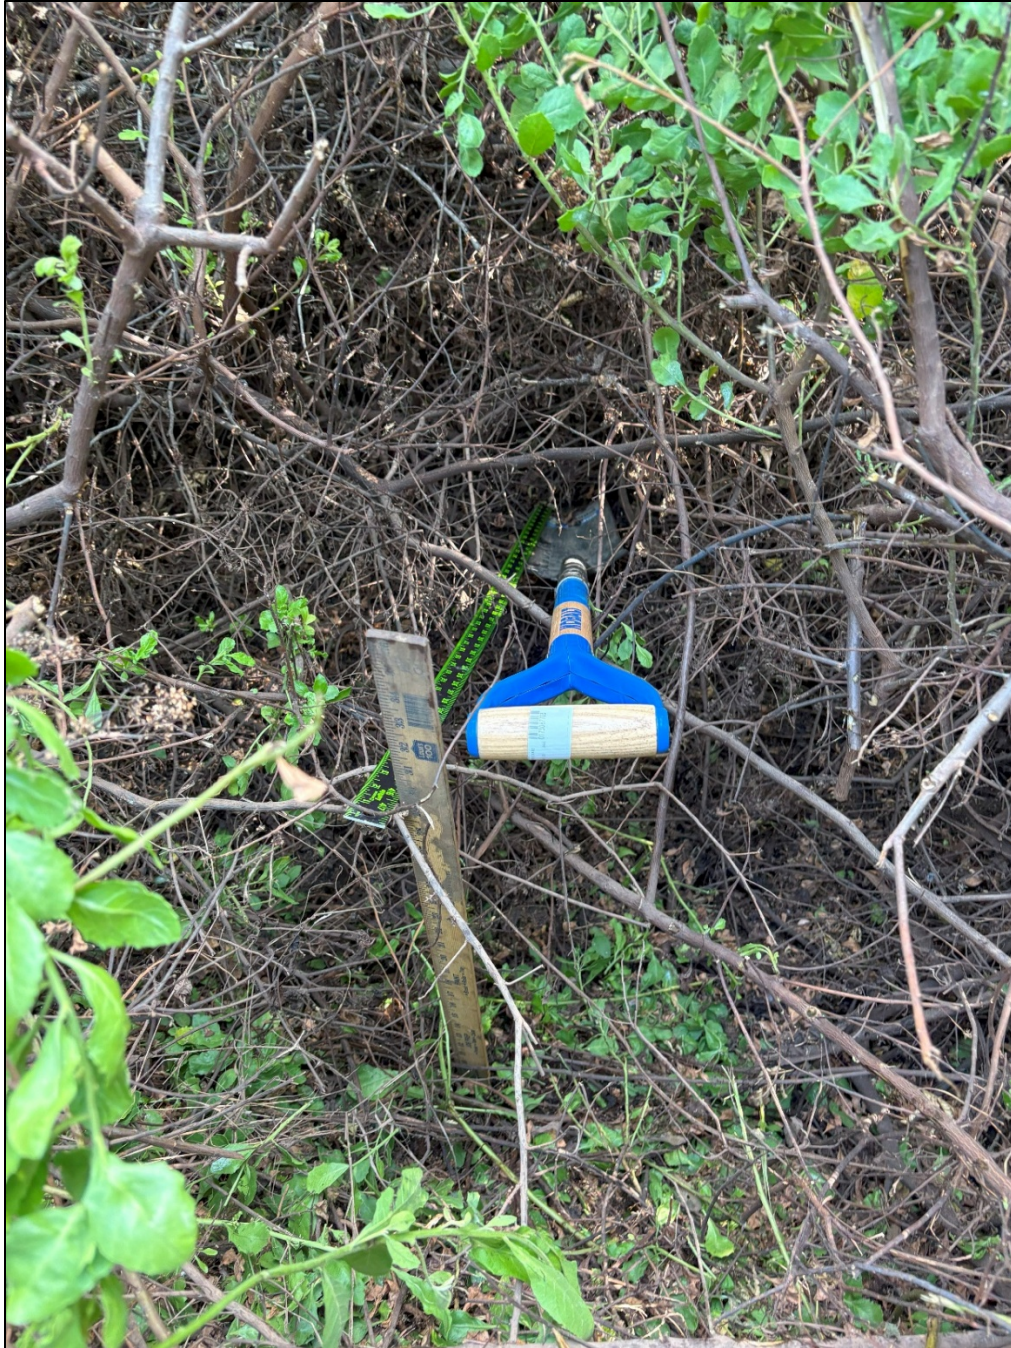
**Photo 21.** Ditch 15 - Dense vegetation made it very difficult to identify the OHWM indicators. Break in slope (shovel on top of bank) and saturated bed were used to identify the OHWM level. A ruler could be easily inserted down to about a foot in bed but not on the banks.

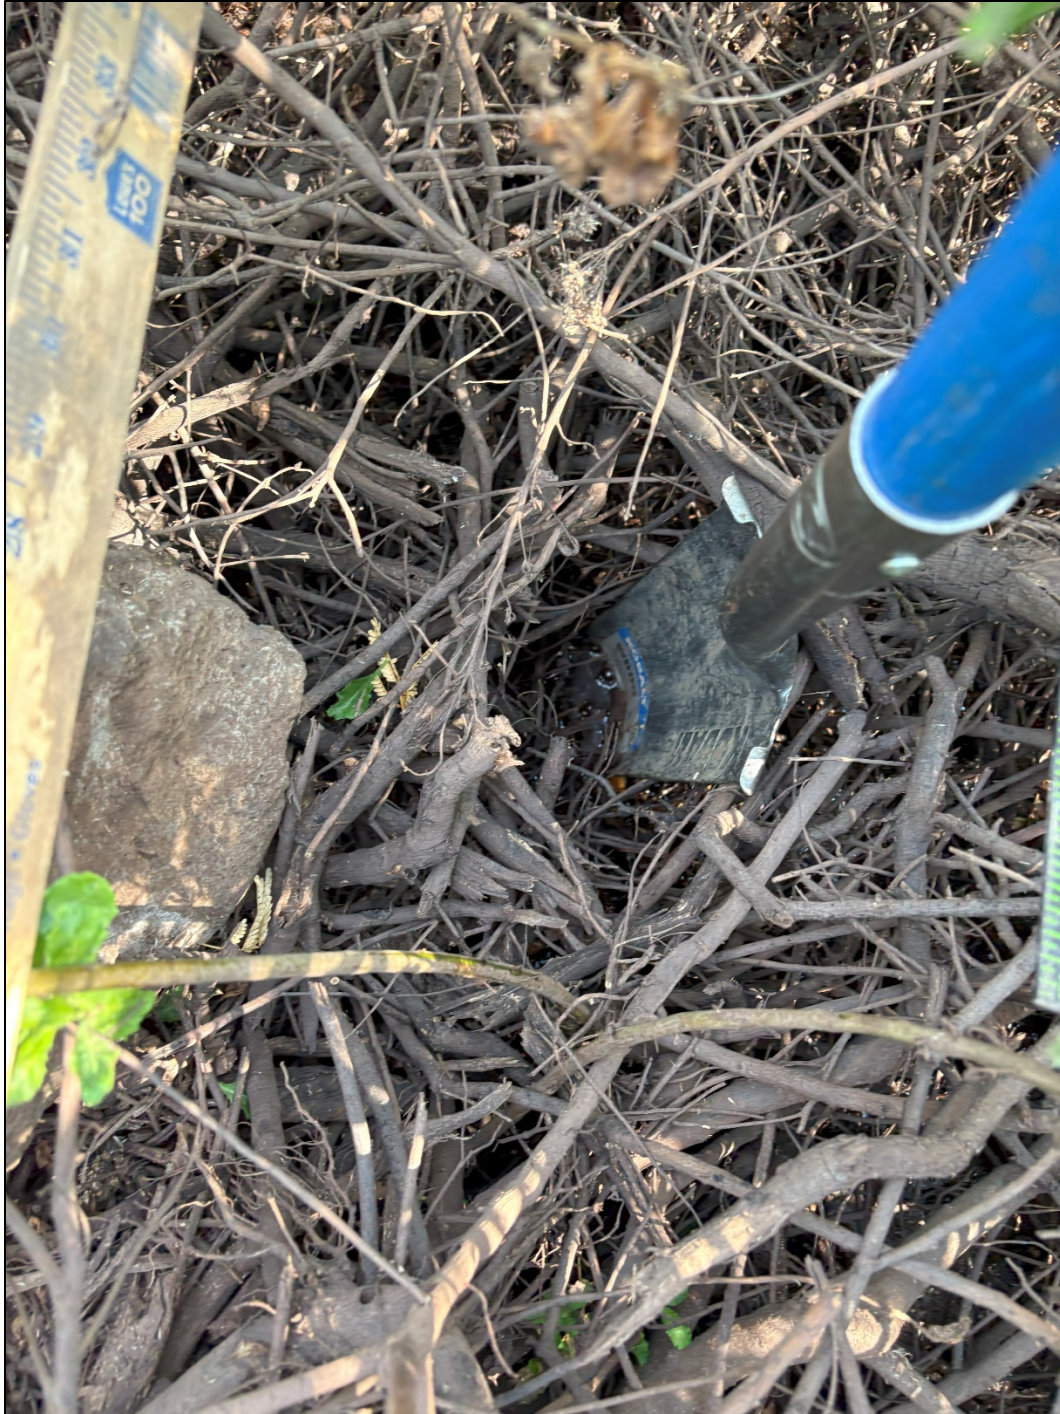
Photo 22. Water in Ditch 15 was covered by dense woody debris.

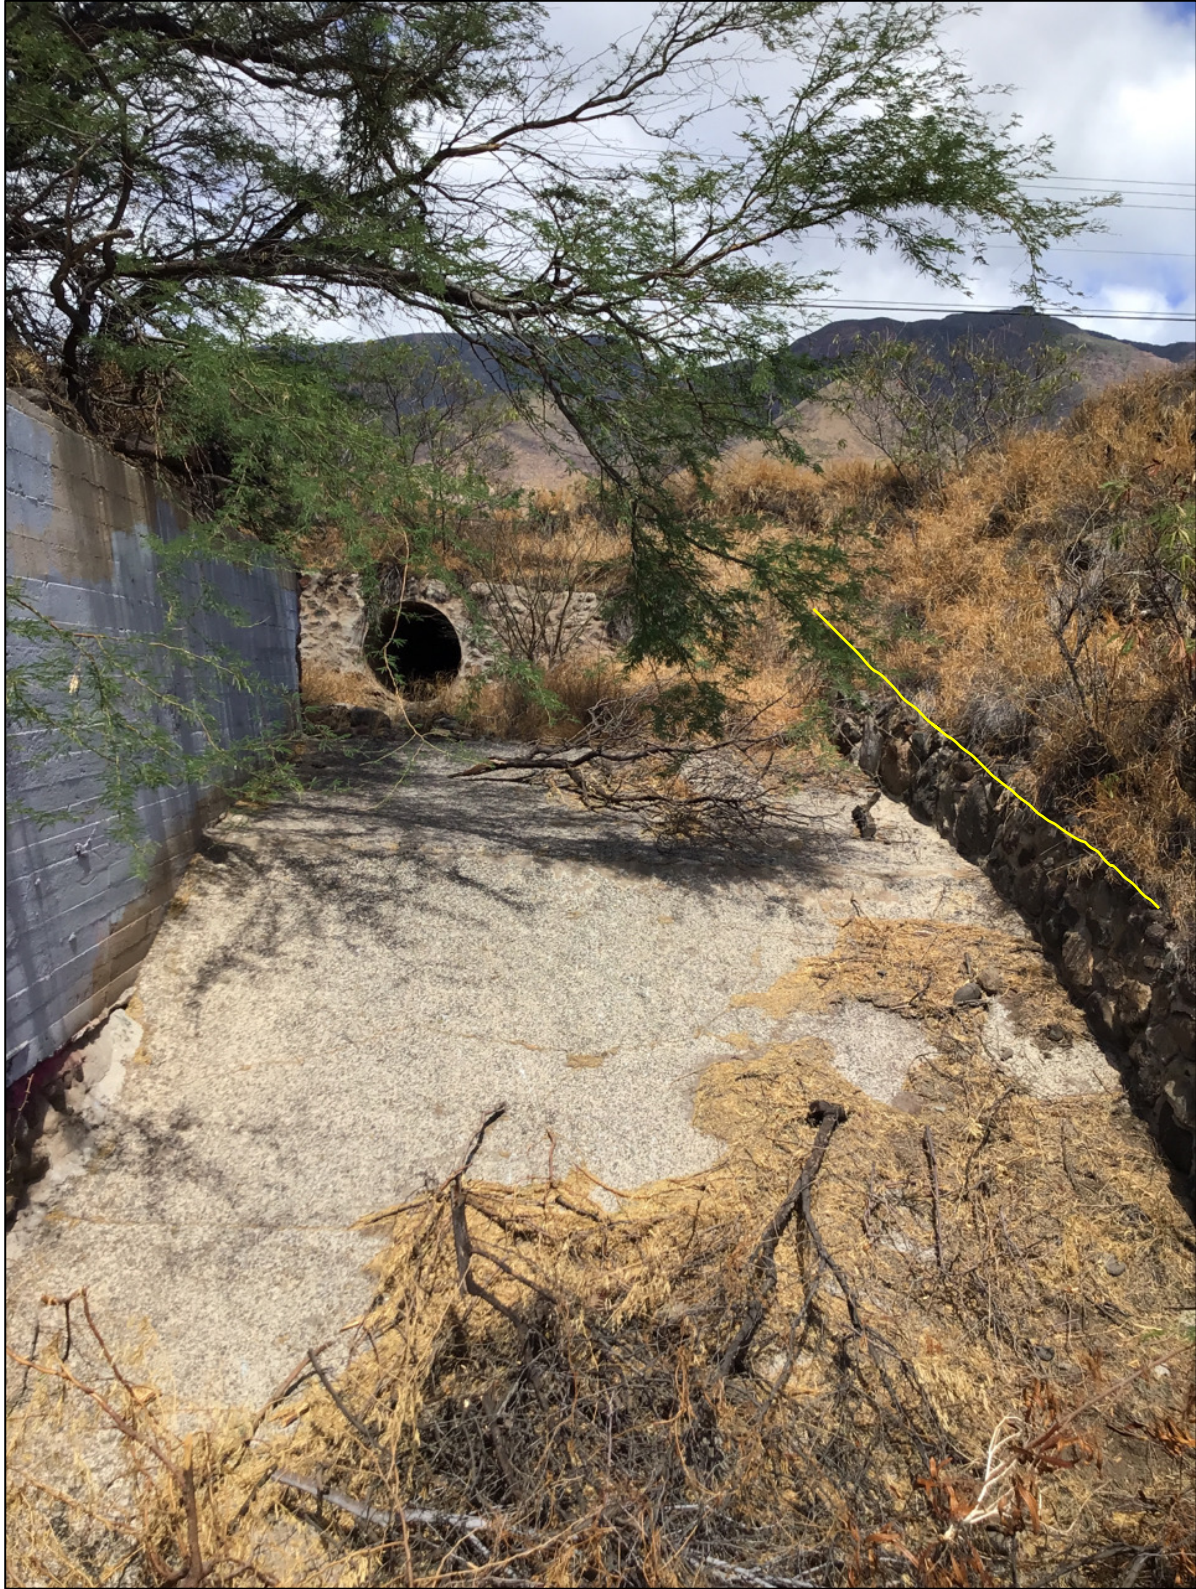
**Culvert – Awalua Stream**—The Awalua Stream Culvert is situated in the northernmost parcel 13 of the 2025 BSA on the east side of the existing Honoapiilani Highway (Appendix A, Figures 2 and 10). This culvert carries Awalua, an ephemeral stream, under an inner road that runs parallel to and on the east side of the existing Honoapiilani Highway (Appendix C, Photos 23 and 24). This is a large concrete culvert that is continuous with the Awalua Stream delineated during the 2023 wetland study. Awalua Stream and this culvert have a continuous surface connection to the ocean. The northern side of this culvert is a concrete wall while the southern side is a rockwall with both, concrete bed and rock bed, that runs between the inner road and the existing Honoapiilani Highway. These features were used to identify the OHWM level in the field. No signs of water were observed during the survey. The Vegetation surrounding this culvert is composed of mostly upland plant species of kiawe, buffle grass, uhaloa (*Waltheria indica*), haole koa.

**Photo 23.** Awalua Stream concrete culvert (east view) location of transect between the inner (unnamed) paved road and the Honoapiilani Highway. The south side rock wall feature (yellow line) with the vegetated bank was used to determine the OHWM level here.

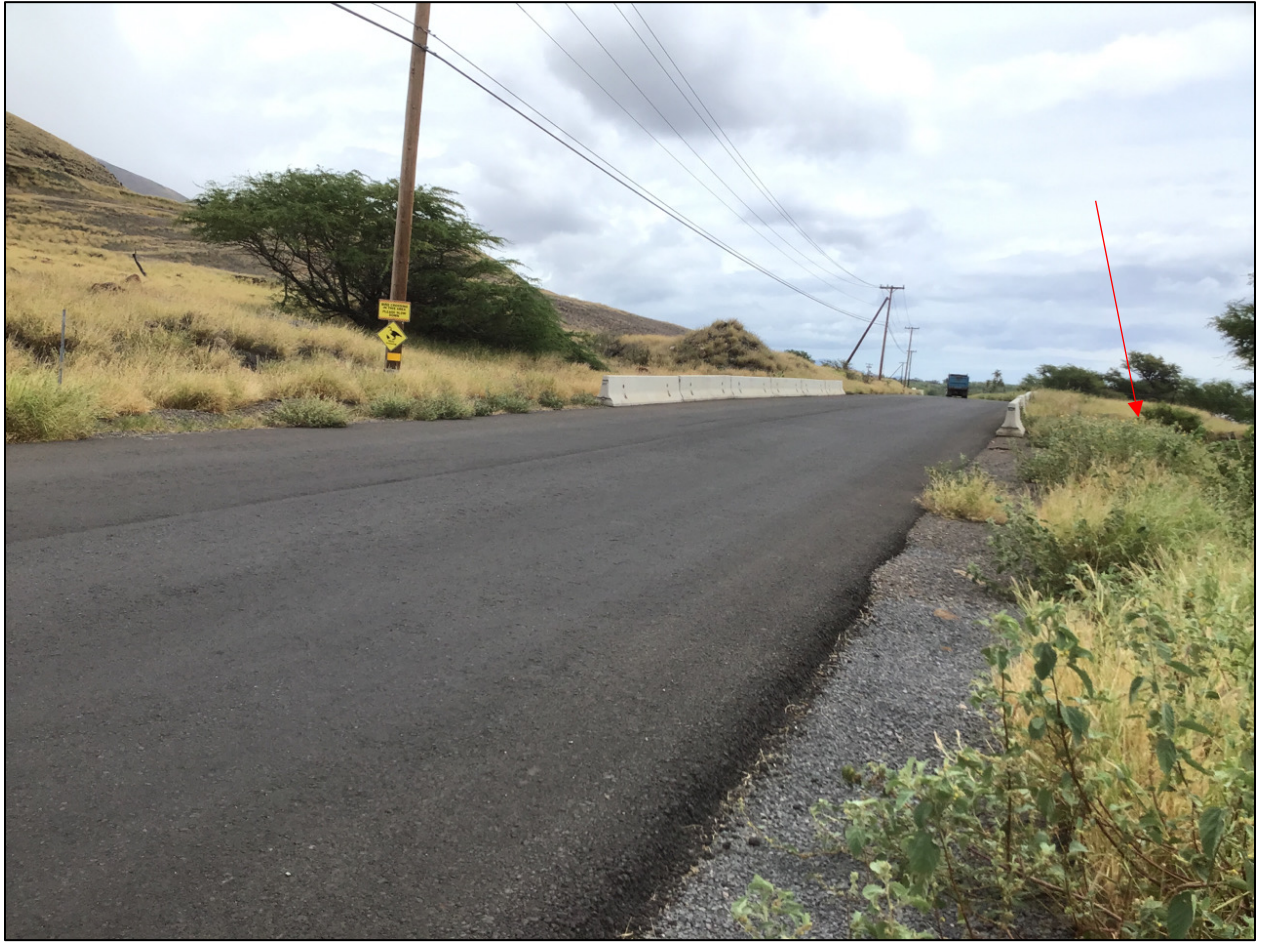
**Photo 24.** Landscape location (red arrow) of the delineated culvert feature on the west side of the inner (unnamed) road that runs parallel to the Honoapiilani Highway (not seen here). Awalua Stream flows in the east-west direction under this inner road.

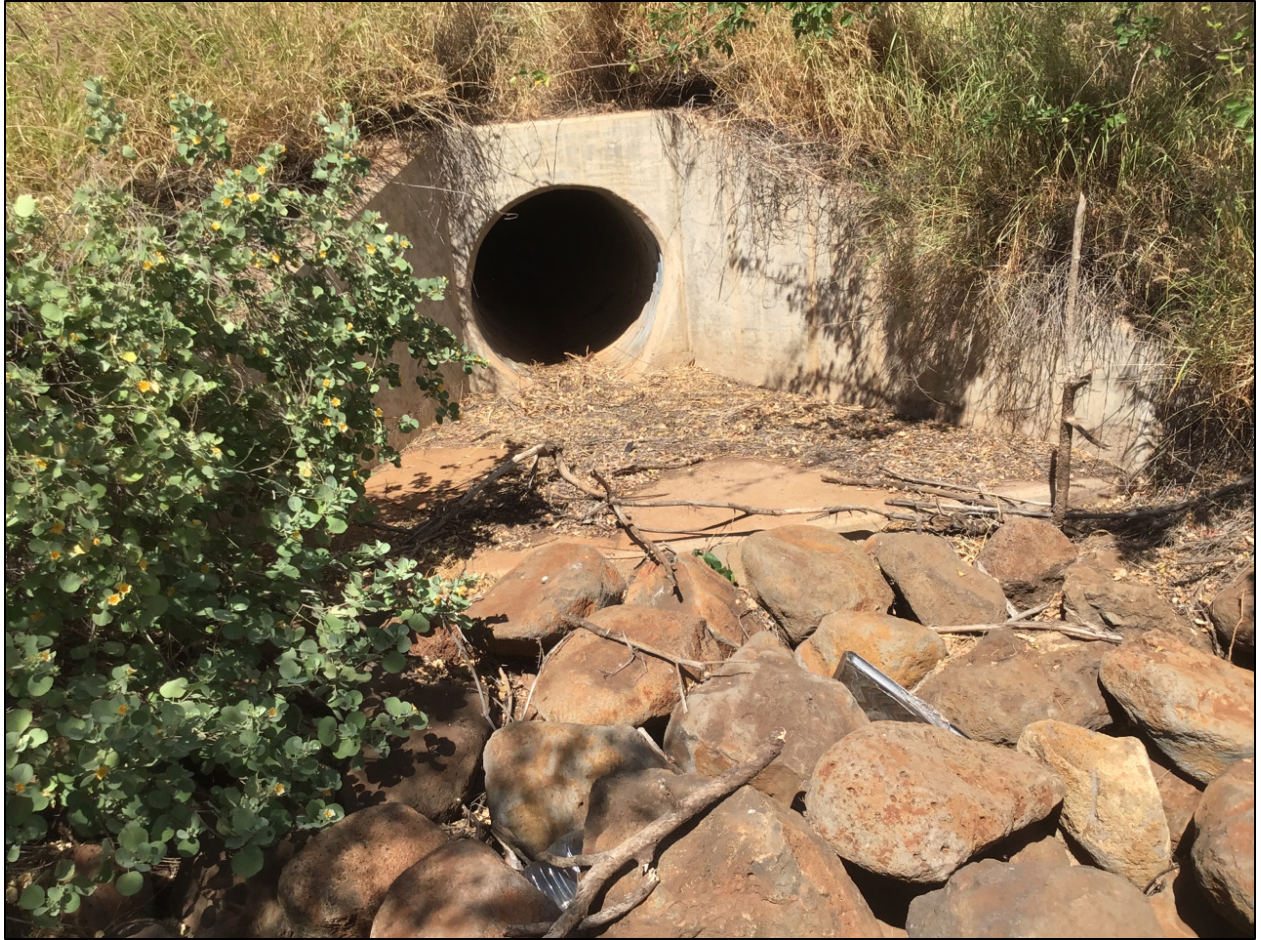
**Culvert – Vicinity of Lahaina Bypass**—This feature is in parcel 13 in the northernmost section of the BSA in the vicinity of the Lahaina Bypass (Appendix A, Figures 2 and 10). The beam of the concrete culvert and the wings of the culvert were used to identify the OHWM level at this feature. Large rocks were placed in the spillway and the culvert opening under the Highway did not appear to be blocked (Appendix C, Photo 25). But dense vegetation of mostly upland plant species such as kiawe, buffel grass, and ilima (*Sida fallax*) surrounded the culvert and the rocks. No continuous surface connection to the ocean was found. Ditch 12, a perennial but isolated (no continuous surface connection to the ocean) feature delineated in 2023 and situated on the opposite and east side of the existing Honoapiilani Highway, possibly has an underground hydrological connection to this culvert.

**Photo 25.** The top beam and the wings of the concrete culvert were used to delineate the OHWM level at this feature.
